## **Appendix 2.12.3, Excerpted from Safety Analysis Report for the Century Champion Type B Package Immersion Test**

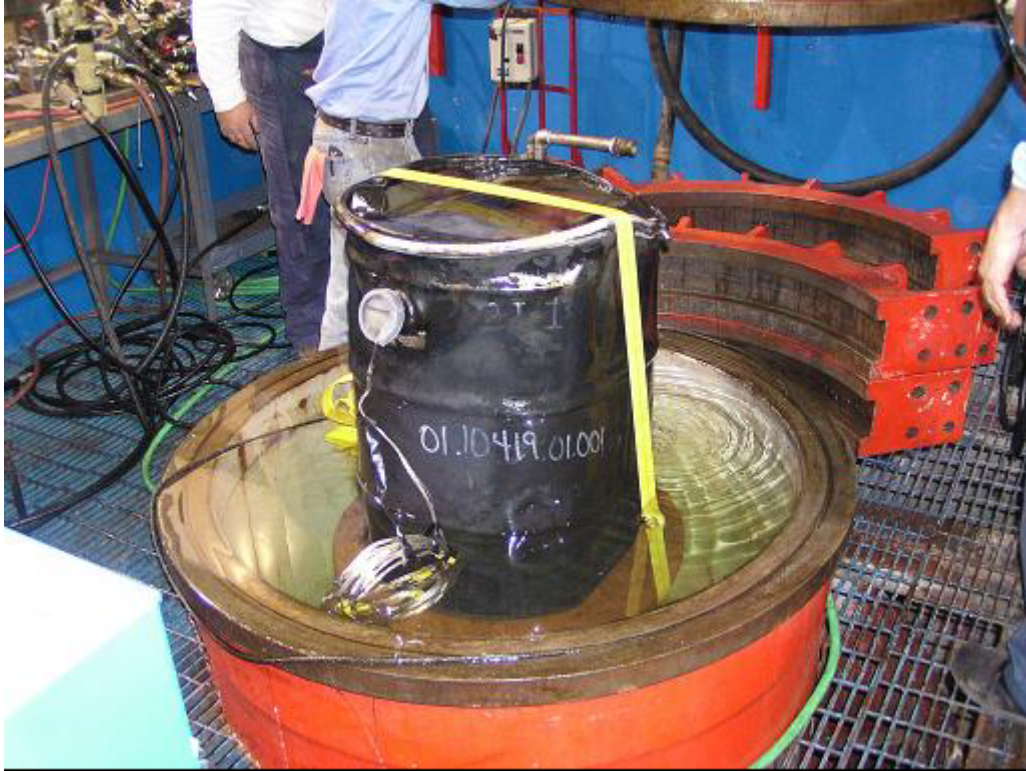
**Figure 2.5.3-1 Champion Package on Test Stand – View from Thermocouple Shielding Tube**

Figure 2.5.3-1 shows the Century Champion Package rigging post-thermal test. Figure 2.5.3-2 displays the package being loaded into the pressure chamber. Figure 2.5.3-3 displays the package during the immersion testing.

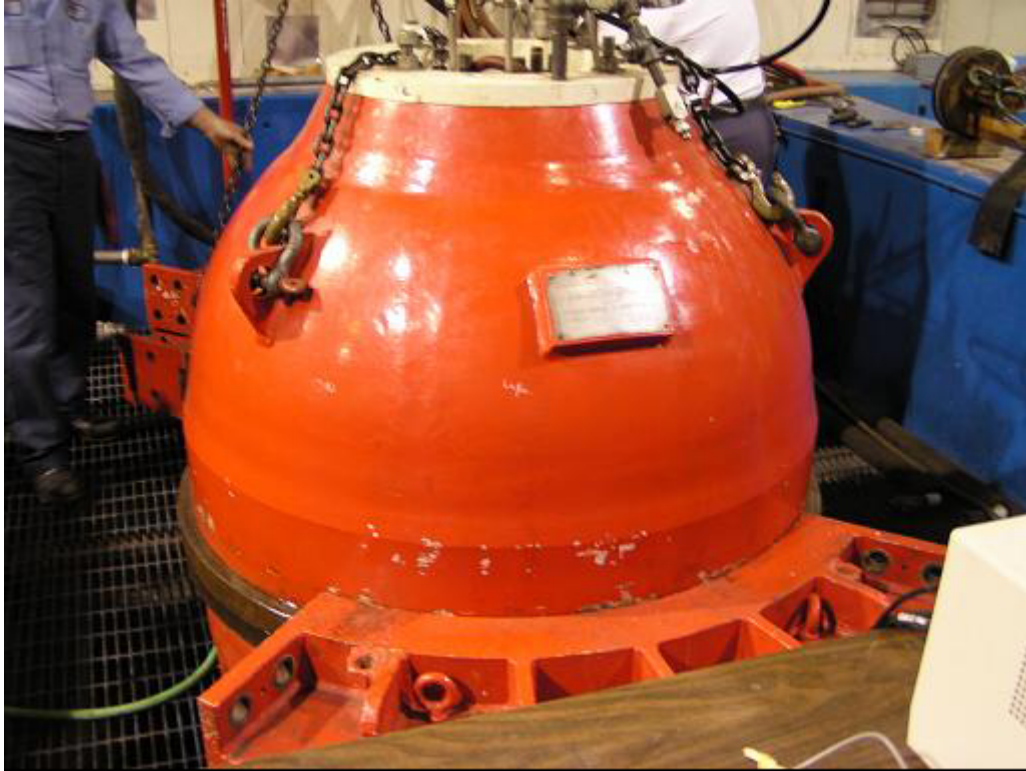
**Figure 2.5.3-3 Champion Package during Immersion Test**

Pages 15 and 16 of the Champion Safety Analysis Report are provided as pages 5 and 6 to Appendix 2.5.3. The test results indicate that immersion testing of a damaged prototype package to a pressure of  $23.0 \pm 1.0$  psig during a 15-minute produce no additional damage.
