Subject: Duke Energy Carolinas, LLC
Catawba Nuclear Station, Unit 1
Docket Nos. 50-413
Licensee Event Report 413/2010-02, Revision 0
Problem Investigation Process No. C10-01020

Attached is Licensee Event Report (LER) 413/2010-002 Revision 0 entitled "Discovery of Reactor Coolant System Pressure Boundary Leak at Therrnowell 1NCTW5850 Seal Weld".

4. TITLE
Discovery of Reactor Coolant System Pressure Boundary Leak at Thermowell 1NCTW5850 Seal Weld.

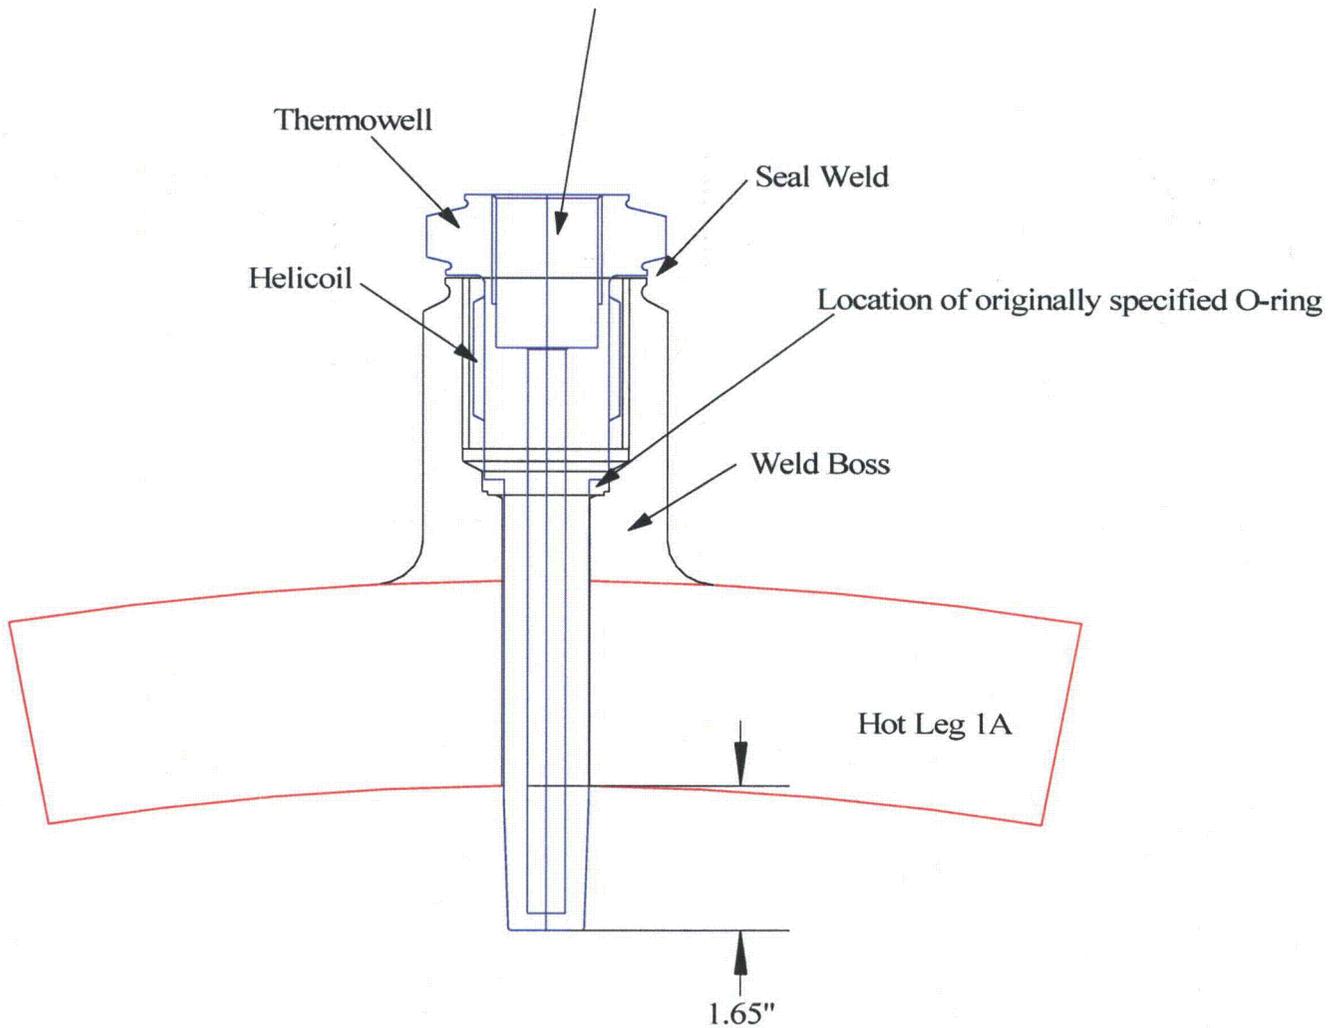
The cause of the failed seal weld was inadequate weld control when the weld was fabricated during initial construction. The weld failure resulted from the presence of a discontinuity involving a metal removal process (i.e. local grinding or manual filing). Applied loads (primarily high strain - low cycle fatigue pressure loads) to this weakened local area of the weld led to the eventual failure. This observation was supported by the original weld documentation. The initial seal weld was rejected both visually and by a liquid penetrant test. The weld was later accepted, presumably after only surface conditioning (i.e. the addition of weld material was not required) where manual filing or grinding of the surface was performed to clear the rejectable location.

The original design of this thermowell configuration included a metal o-ring which provided pressure boundary. During thermowell installation, the o-ring was removed to allow fitment for welding. By removing the o-ring, the seal weld became the pressure retaining boundary (see attached figure). The configuration change was reviewed and approved by the NSSS vendor.

Adaptor and RTD instrument are not shown.

Following a reduction in RCS pressure, repair welding was started at approximately 1200. The areas were sealed and follow-up welding was performed to yield a near flush configuration of the boss and thermowell.
