## EMD JACKET WATER PUMP WITH INCORRECT IMPELLER ORIENTATION

**Report No. 10CFR21-0100**

**10CFR21 REPORTING OF DEFECTS  
AND NON-COMPLIANCE**

COMPONENT: EMD water pumps

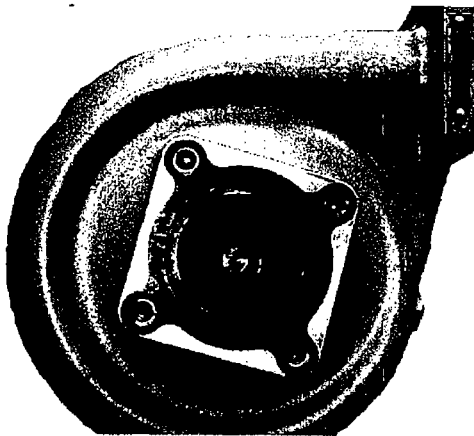
It was reported by Grand Gulf that "while troubleshooting low Div III DJ jacket water pressure it was discovered that the wrong impeller was supplied in the P81C007A pump. The supplied impeller was intended to rotate in the opposite direction as the pump rotation. This appears to be the cause of low jacket water pressure in the A engine."

Subsequently, the water pump was returned to ESI for further inspection. It was apparent from a visual inspection that the incorrect impeller was installed for this pump. P/N 8324589 corresponds to a right hand rotation, left bank water pump for use on a 12-cylinder EMD 645E4 or E4B engine. As shown in Photos 1 and 2 below, the housing corresponds to a right hand rotation pump, but the impeller is for left hand rotation. Figure 3 shows the correct impeller for a right hand rotation pump.

**Photo 1:** Water Pump Returned by Customer (note impeller fin orientation)

As noted above, ESI supplied this water pump in 1997. Since that time ESI is unaware if any rework or refurbishment activities have been performed on the pump but it was noted that paint had chipped off the heads of the capscrews, indicating that the screws had been removed at some time. There exists a possibility that the pump impeller may have been previously removed.

ESI recommends that as a precaution, all customers with an EMD water pump in stock which was supplied by ESI prior to April 2000 should perform a visual inspection to ensure the correct impeller is installed. A pump which has been installed on the diesel engine is considered acceptable based on successful operation of the diesel engine. The impeller inspection is easily performed, without disassembly, by looking into the inlet port of the pump to confirm the orientation of the impeller matches the pump housing. A listing of the various part numbers supplied prior to April 2000 is included in Table 1. Figures 4 and 5 contain visual guidance to ensure the impeller corresponds to the installed pump housing.

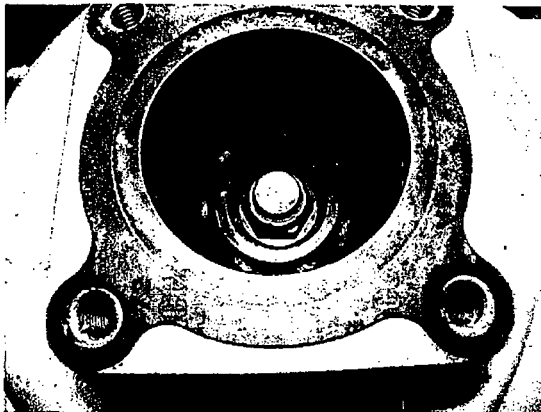
**Photo 2:** Close-up of Water Pump (note impeller fin orientation)

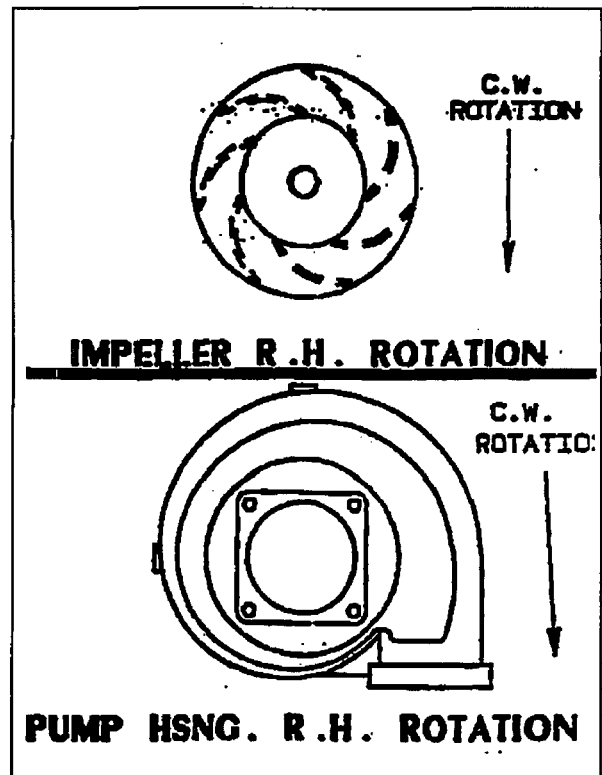
**Figure 3:** Correct Housing and Fin Orientation for RH Rotation

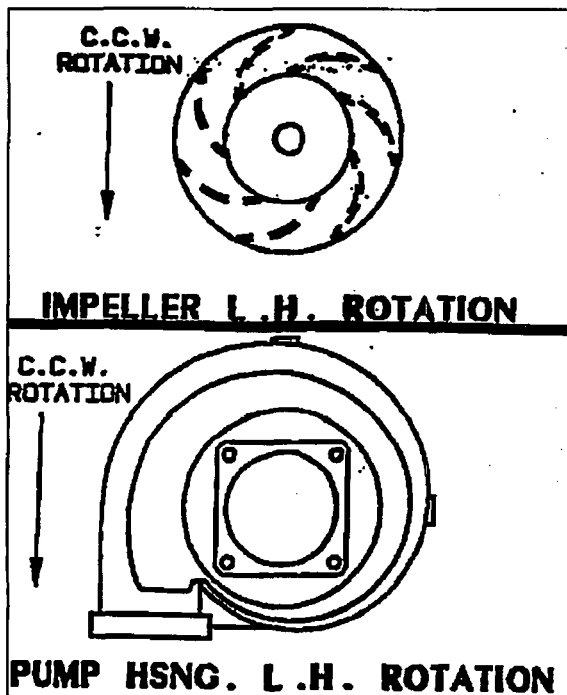
**Figure 4: Correct Housing and Fin Orientation for LH Rotation**

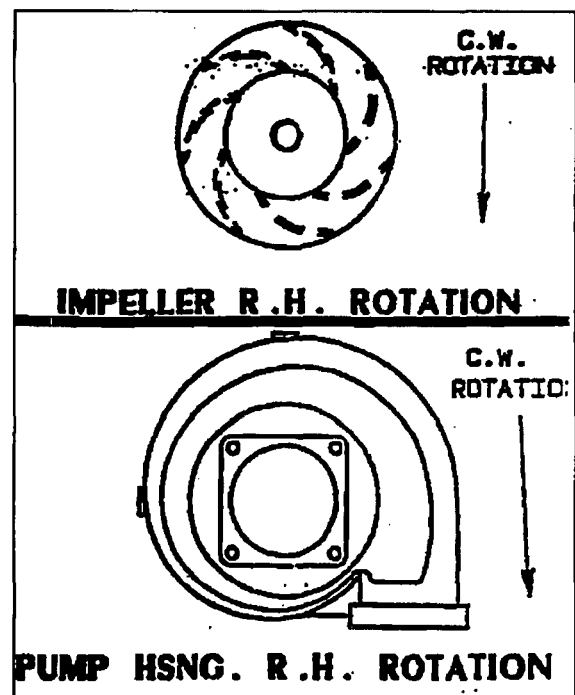
**Figure 5: Correct Housing and Fin Orientation for RH Rotation**
