Crystal River - Crack on Exterior Containment Wall

1.) Crystal River - Crack on Exterior Containment Wall (10/5) - Update

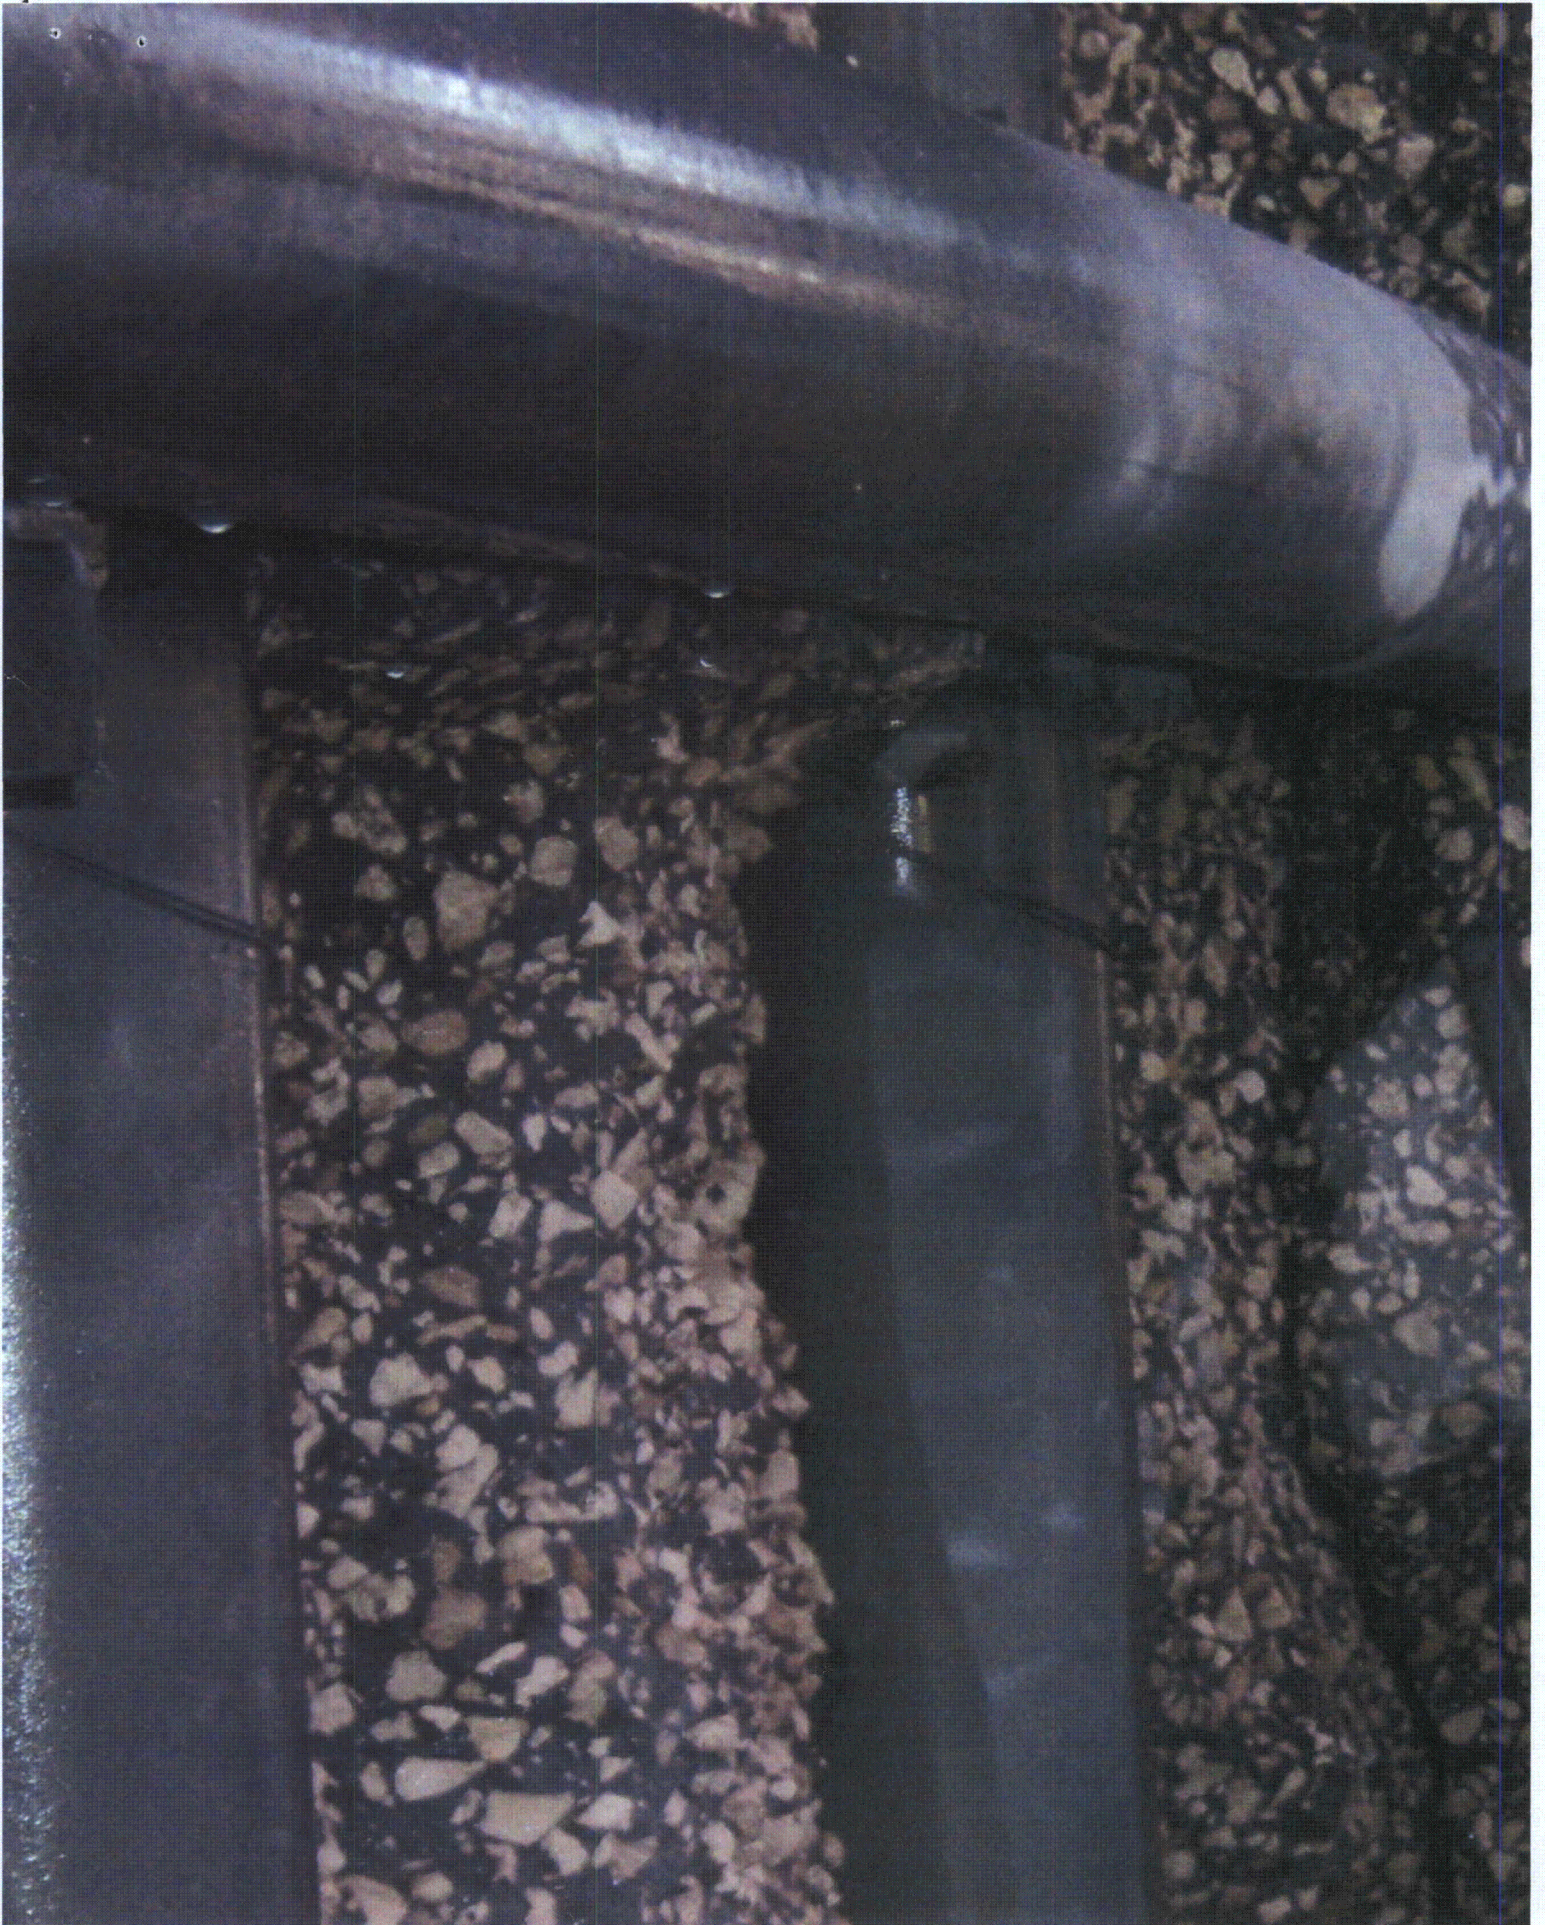
[Picture 032.jpg](#)

Hydro-demolition of the RB opening was restarted on Friday morning. Licensee reports hydro-demolition is nearing the liner plate. Licensee is investigating a vertical crack (1/2" wide, about 18" deep) found in the area of hydro-demolition that extends outside the area being worked as evidenced by water leaking through the crack and coming out an area that is outside the hydro-demolition work area. A root cause investigation is in progress. Sargent and Lundy is involved with the investigation and corrective actions. This issue will be turned over to the Steam Generator Replacement (SGR) inspection team (led by R.Chou) who will be on-site today. (Continue to follow, pass to Containment TRG and Structural TRG Lead, Goutam Bagchi; assigned to Dave Garmon)

The licensee believes that the crack in the concrete on the containment exists all the way around the containment and all the way up and down (360 degrees, full height of containment). This is per site VP discussion with Region II. Crack was found while making an approximately 25 ft X 25 ft concrete cut for the Steam Generator Replacement project. All indications are that the liner is still intact, and there are no indications of liner problems. Crack is about 1/2 inch wide and 10 inches in from outside edge of concrete - running around the containment - located just at the layer of horizontal tendons. Licensee is assessing and evaluating implications (polar crane support, S/G lift device support, as well as operability of containment).

Hydro-demolition for the containment opening continues. Licensee will perform a modification to support outside lift system as a result of the crack identified in concrete. A root cause investigation is in progress. Sargent and Lundy is involved with the investigation and corrective actions, as well as operability and functionality determinations.
