TECHNICAL REPORT NO. 7154

CIRCUMFERENTIAL WELD BOAT SAMPLE FROM
STEAM GENERATOR 32, INDIAN POINT 3
NUCLEAR POWER PLANT

POWER AUTHORITY OF THE STATE
OF NEW YORK

June 24, 1982

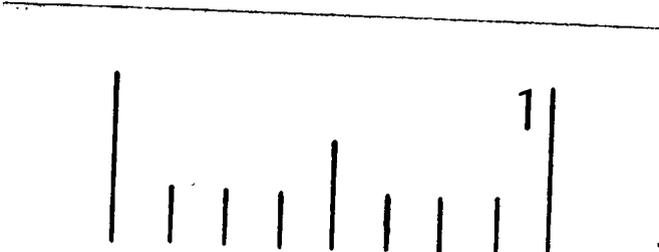
Fig. 3

SIDE VIEW OF BOAT SAMPLE

Photograph showing the circumferential crack penetration as seen in the side of the boat sample.

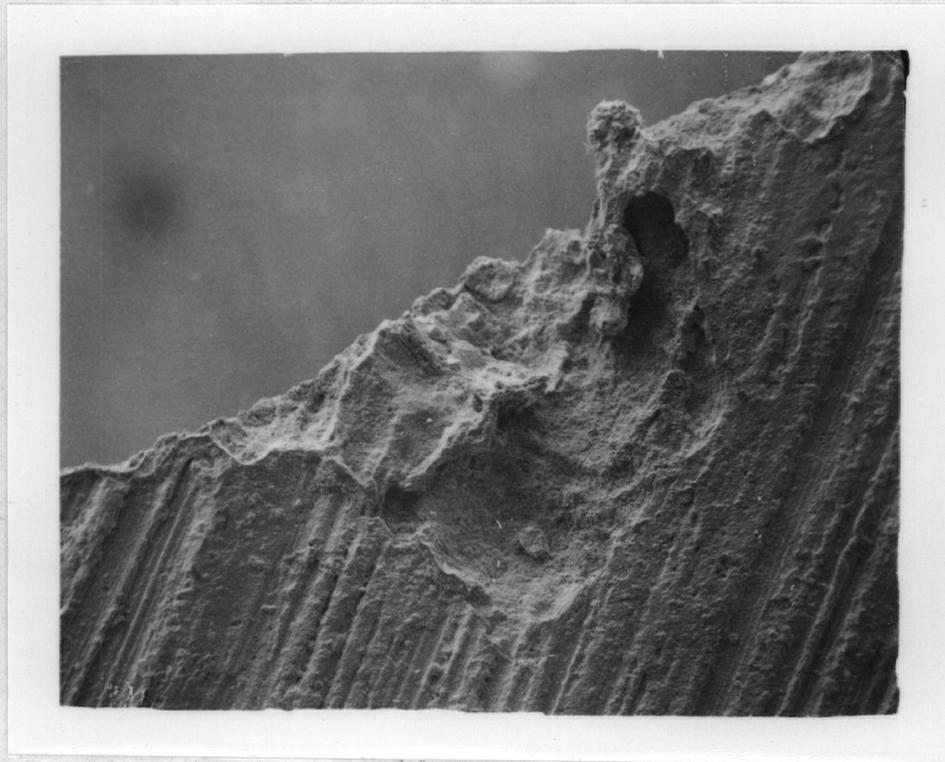
Scanning electron microscopy of the inner surface at the origin site of the fracture surface confirmed the presence of corrosion attack at the origin site. Fig. 5 is a scanning electron micrograph showing the fracture origin pit as seen on the inner surface; Fig. 6 is a scanning electron micrograph showing the pit penetration as seen on the fracture surface.

CORROSION PIT - INNER SURFACE

Scanning electron micrograph showing corrosion pit as viewed from the inner surface. The fracture passes through the corrosion pit (lower left to upper right). The inner surface exhibits numerous fine, parallel score marks, the result of original grinding performed on the girth weld.

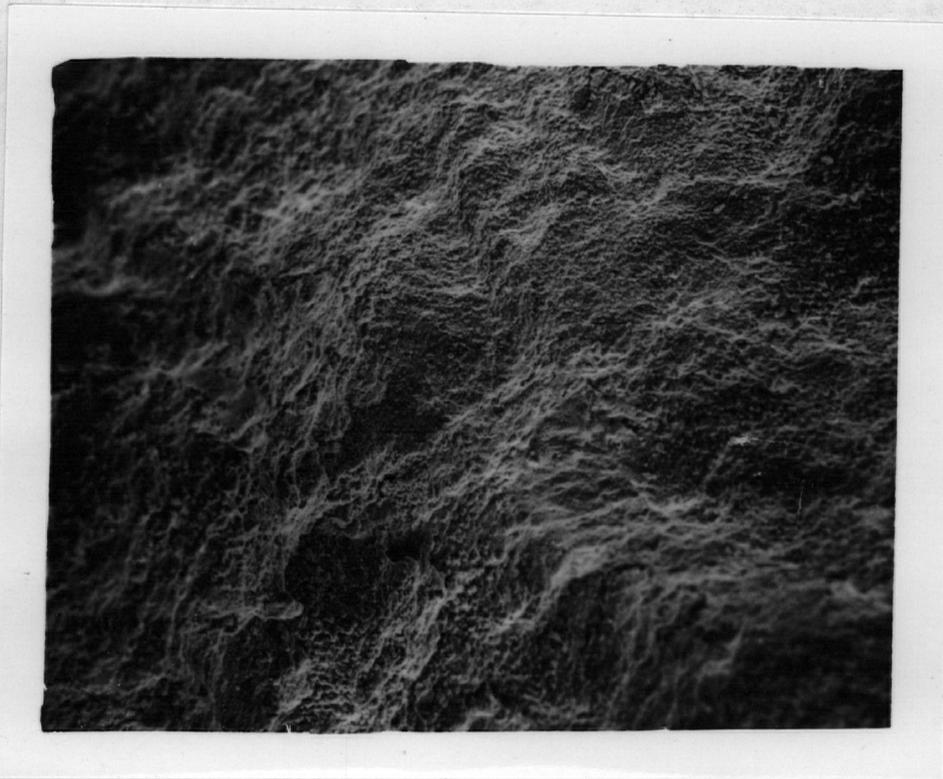
Fig. 7

Scanning electron microscopy of the fracture surface below the pit origin revealed the fracture to be smooth and to contain a thin, oxide preventing the observance of any discernible striation lines as shown in Fig. 7.

FRACTURE SURFACE

Scanning electron micrograph of the as-exposed circumferential crack fracture surface. Although the fracture surface is covered with an oxide corrosion product, the surface is generally smooth as is characteristic of corrosion fatigue cracking.

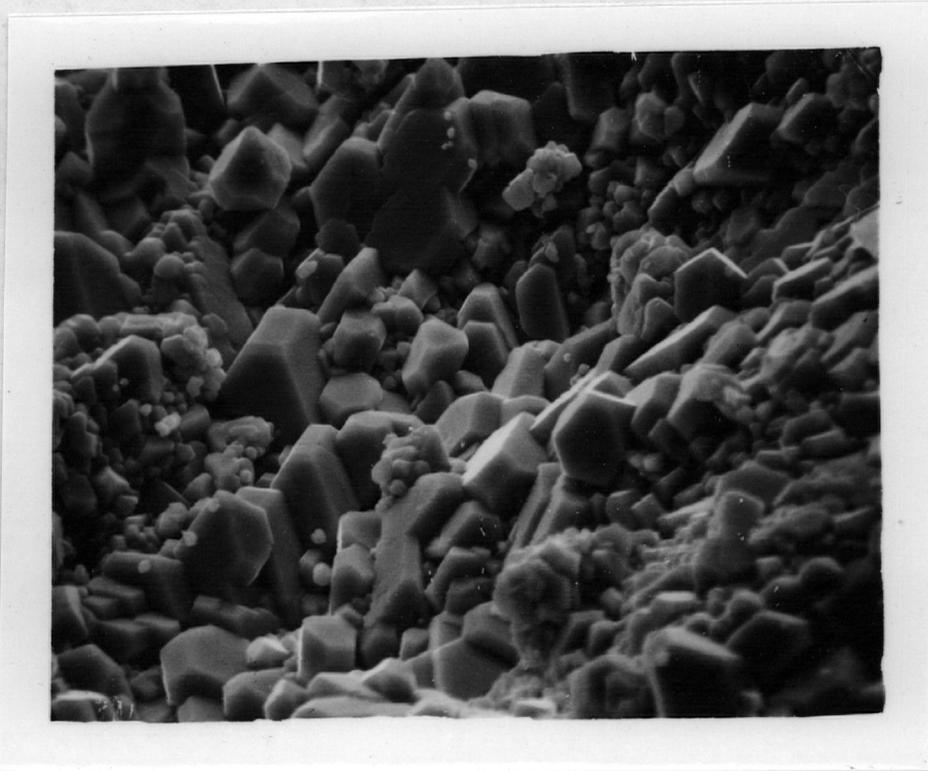
Fig. 8

At higher magnification, the presence of discrete crystals of what probably was iron oxide were observed on the fracture surface. These crystals are shown in Fig. 8.

Qualitative analysis of deposits on as-exposed fracture surfaces indicated the deposits to consist essentially of base metal oxides. The existence of discrete crystals of iron oxides was considered evidence of rapid anodic reaction typical of corrosion attack in high temperature water containing oxygen.

FRACTURE SURFACE CORROSION PRODUCT

Scanning electron micrograph of area shown in Fig. 7 but at higher magnification showing discrete crystals (probably iron oxide) on the as-exposed fracture surface which is evidence of corrosion attack in high temperature water containing oxygen.
