TECHNICAL REPORT NO. 7154

CIRCUMFERENTIAL WELD BOAT SAMPLE FROM  
STEAM GENERATOR 32, INDIAN POINT 3  
NUCLEAR POWER PLANT

POWER AUTHORITY OF THE STATE  
OF NEW YORK

Subject: CIRCUMFERENTIAL WELD BOAT SAMPLE FROM  
STEAM GENERATOR 32, INDIAN POINT 3  
NUCLEAR POWER PLANT

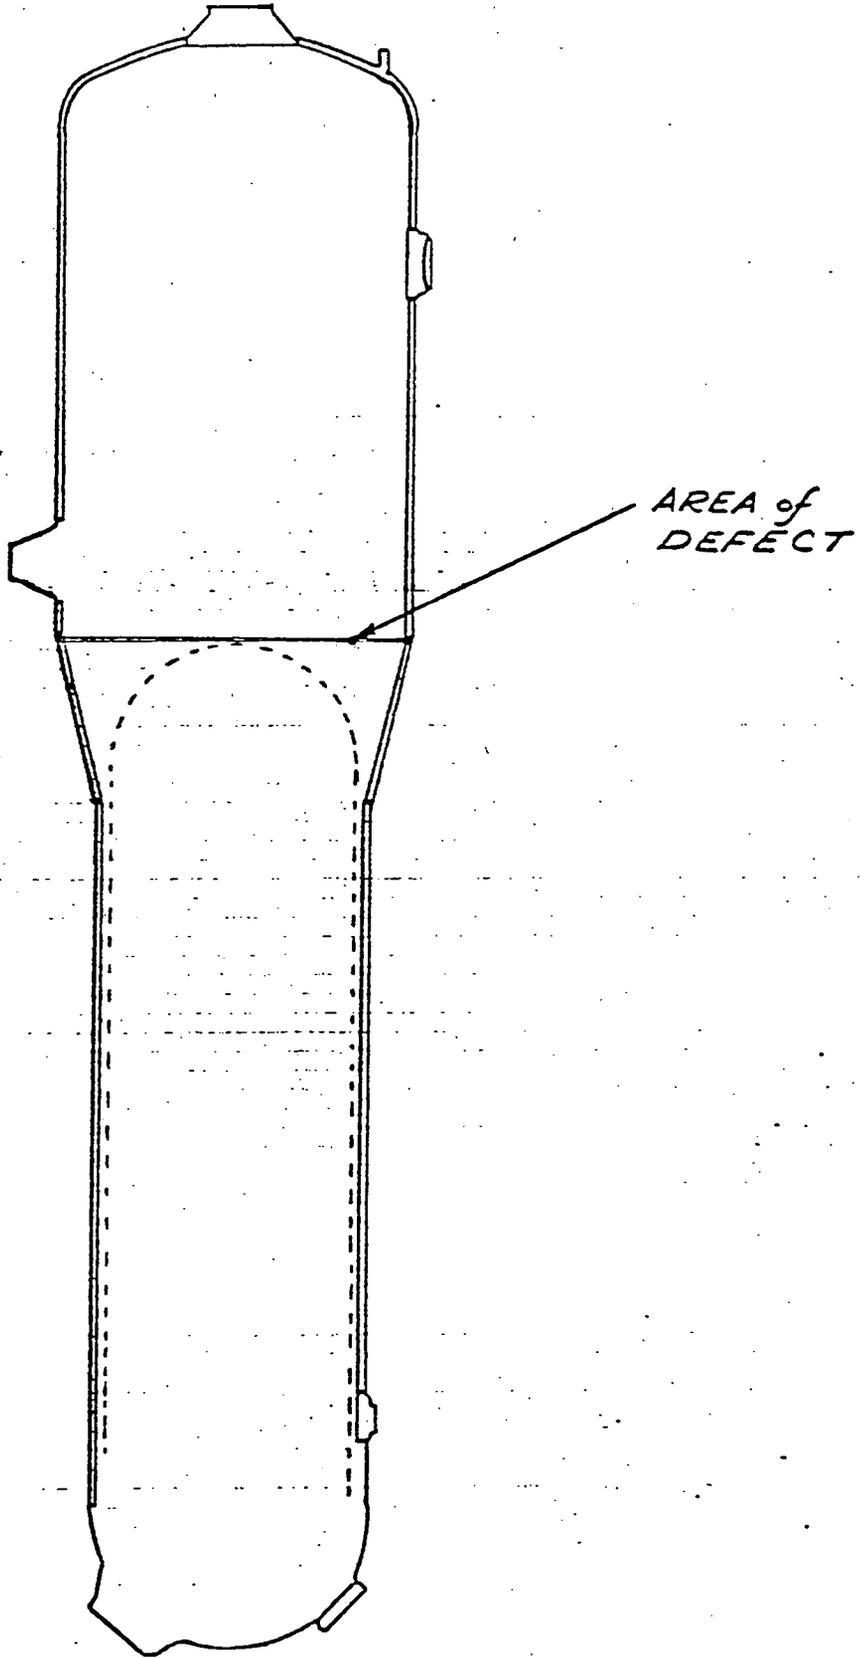
Fig. 1 GIRTH WELD BOAT SAMPLE LOCATION

The location of the girth weld from where the boat sample was taken is shown in Fig. 1. Taking of the sample was witnessed by an LPI engineer.

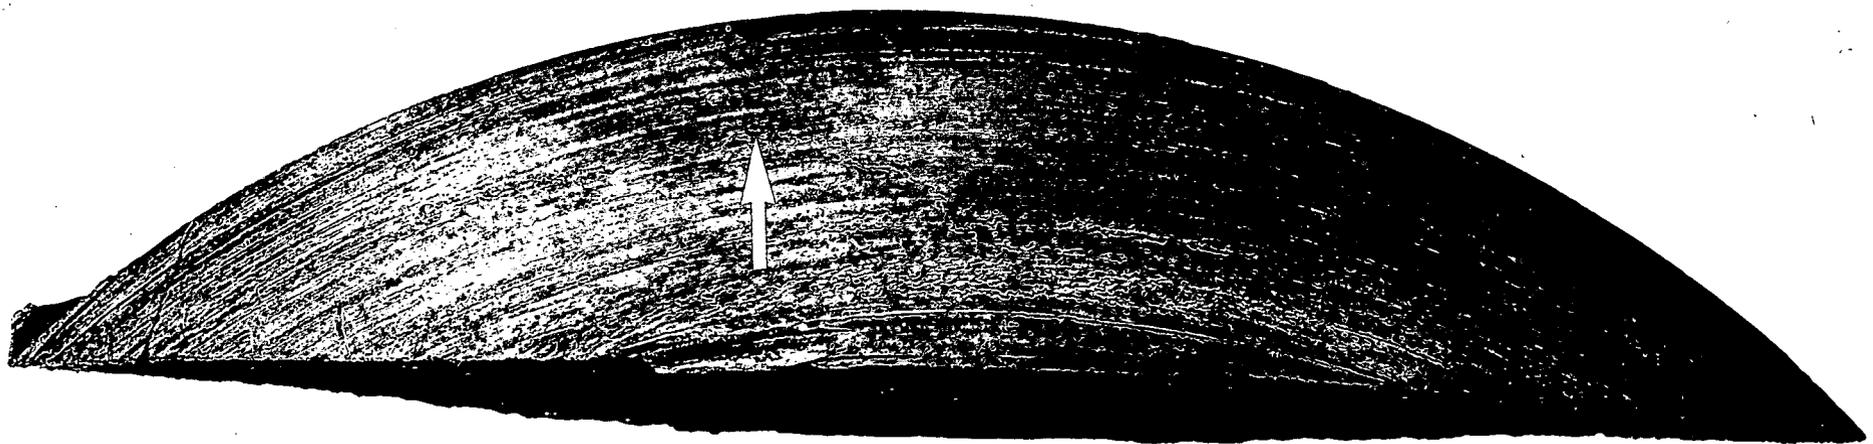
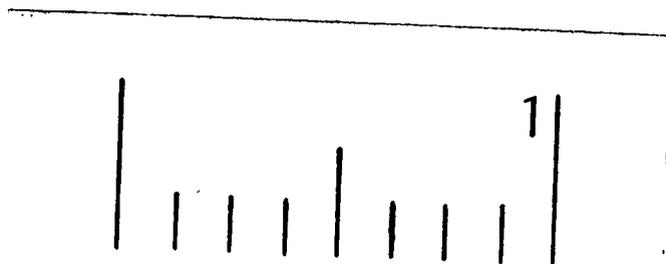
Fig. 3

SIDE VIEW OF BOAT SAMPLE

Photograph showing the circumferential crack penetration as seen in the side of the boat sample.

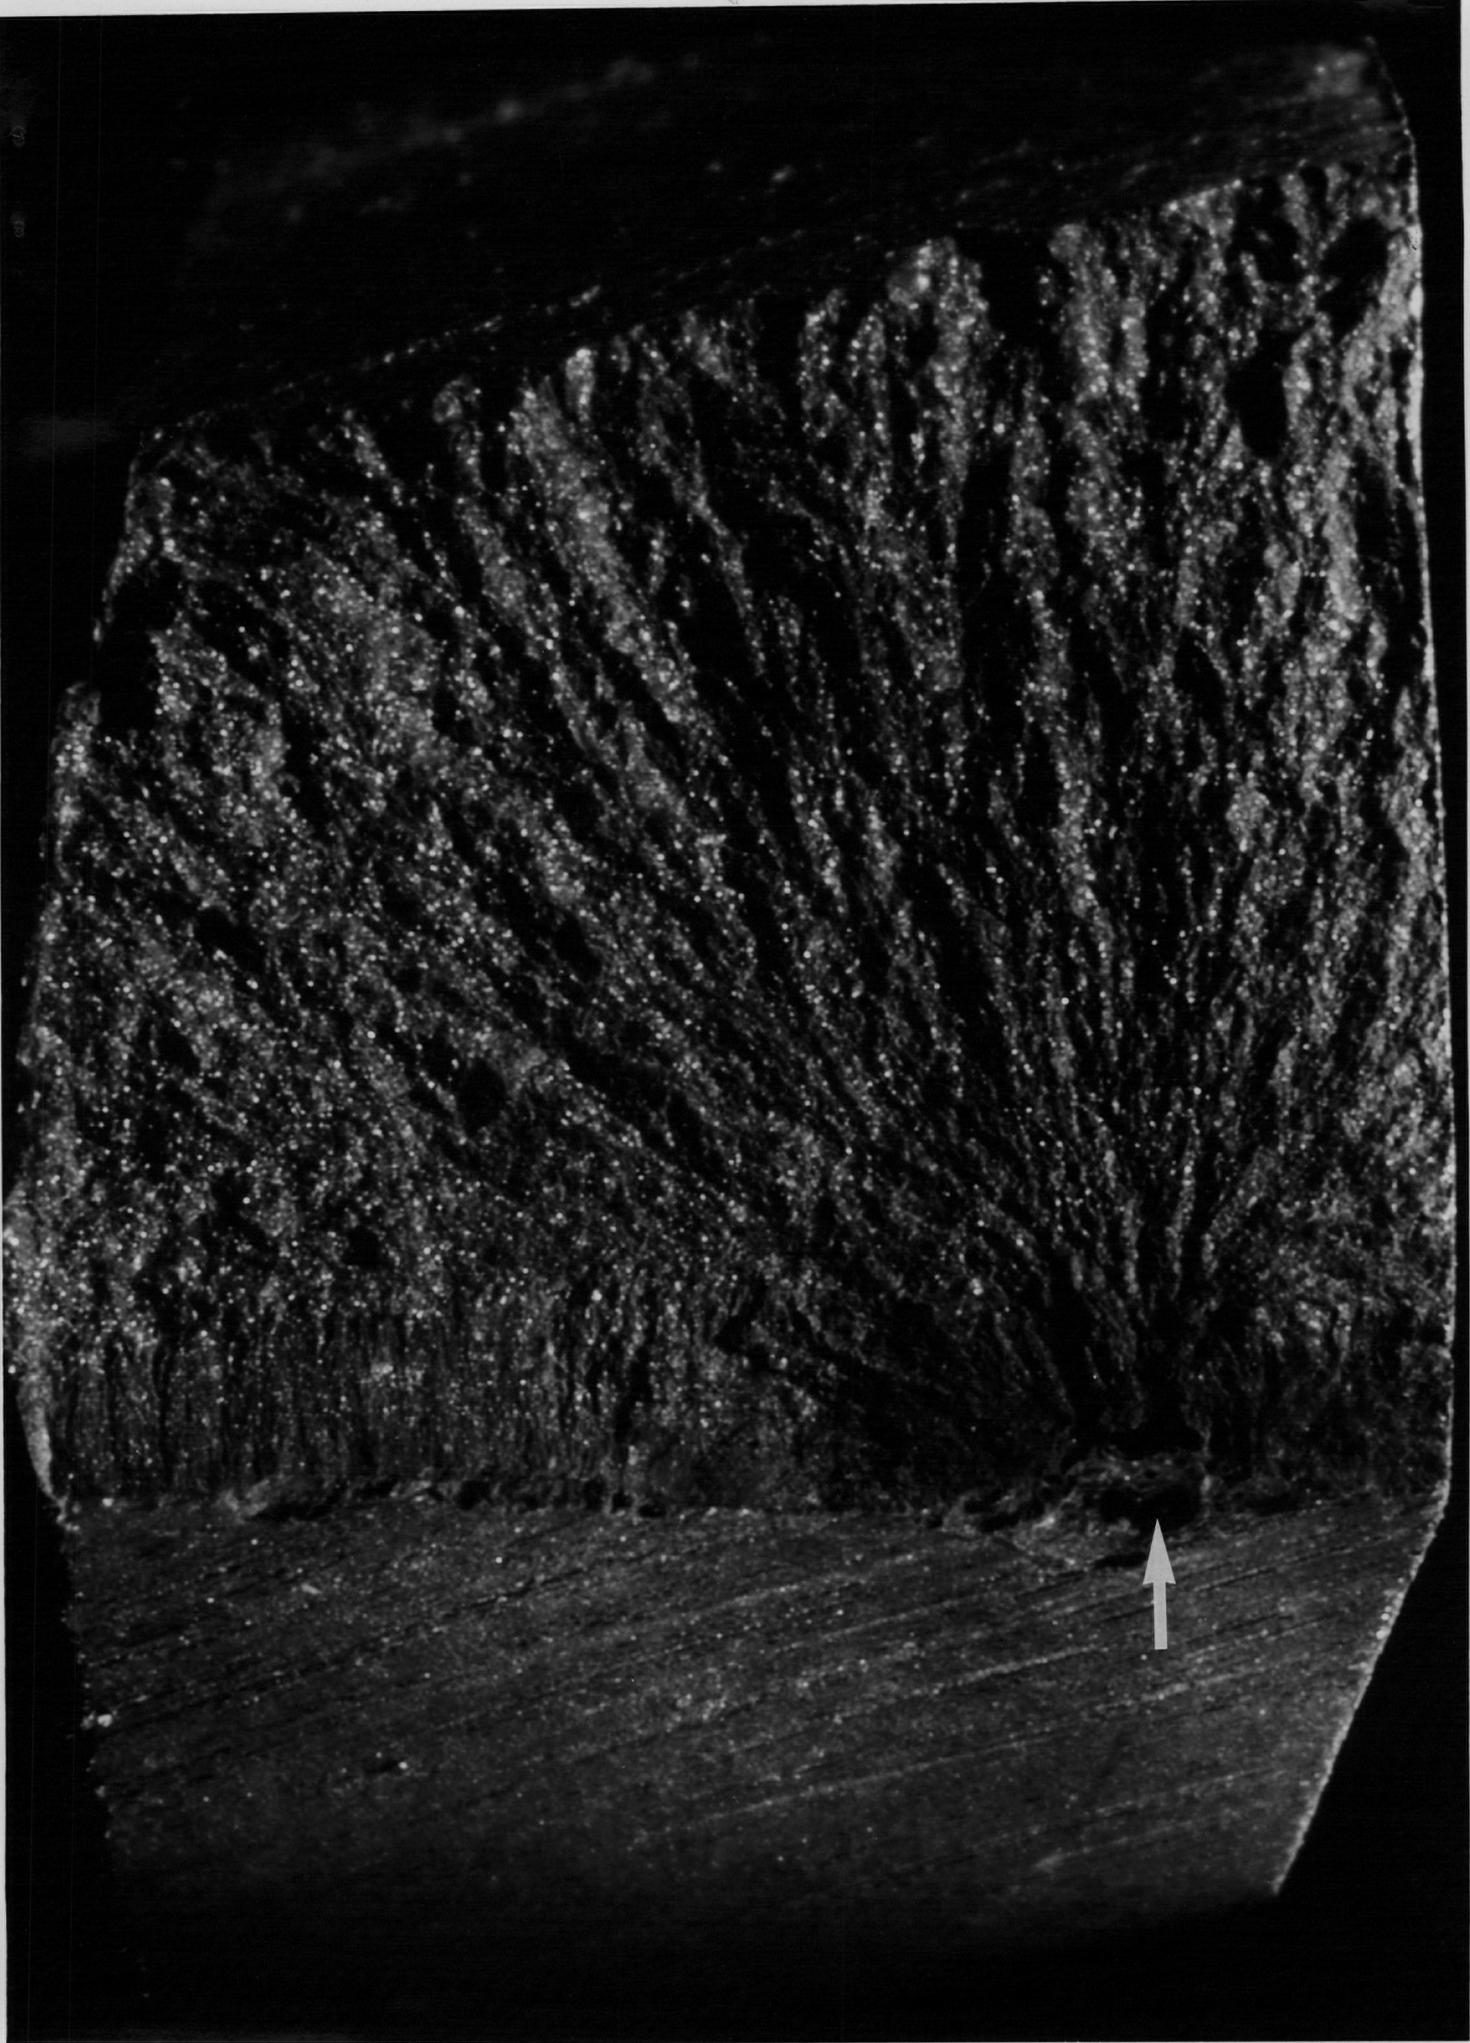
Fig. 4 is a close-up photograph showing the fracture surface at the origin site of the circumferential crack.

FRACTURE SURFACE

Close-up photograph showing the fracture surface of the circumferential crack exposed after cutting through the crack at one end. The fracture origin (dark zone) is associated with a corrosion pit in the inner surface. Faint beach-like marks and radiating ridges characteristic of progressive or fatigue cracking emanate from the pit origin site.

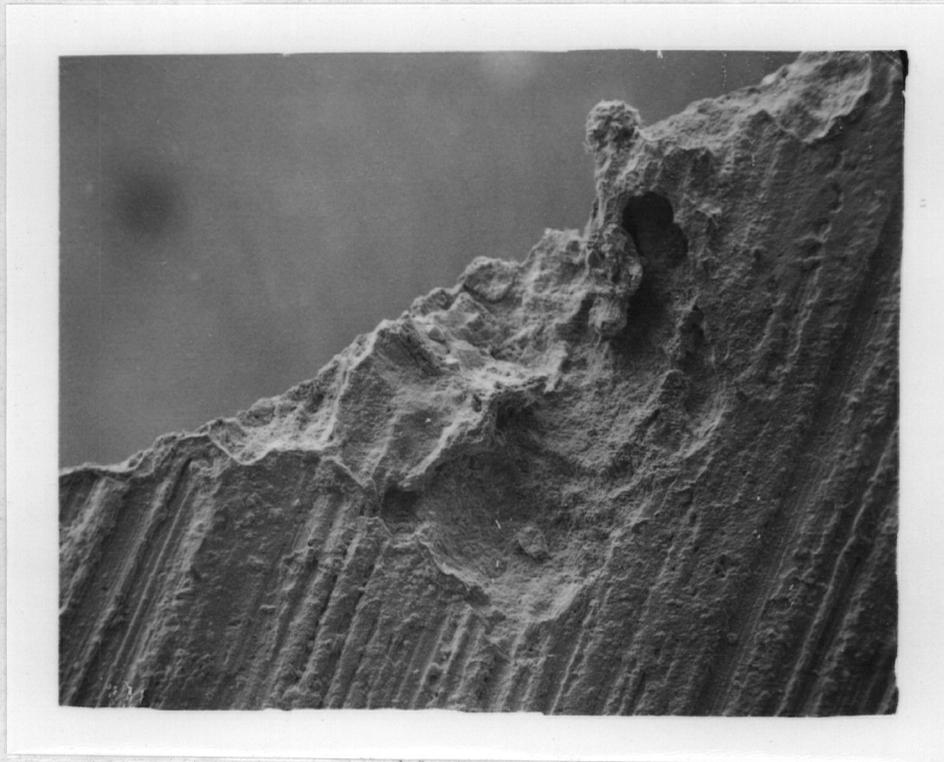
Fig. 5

CORROSION PIT - INNER SURFACE

Scanning electron micrograph showing corrosion pit as viewed from the inner surface. The fracture passes through the corrosion pit (lower left to upper right). The inner surface exhibits numerous fine, parallel score marks, the result of original grinding performed on the girth weld.

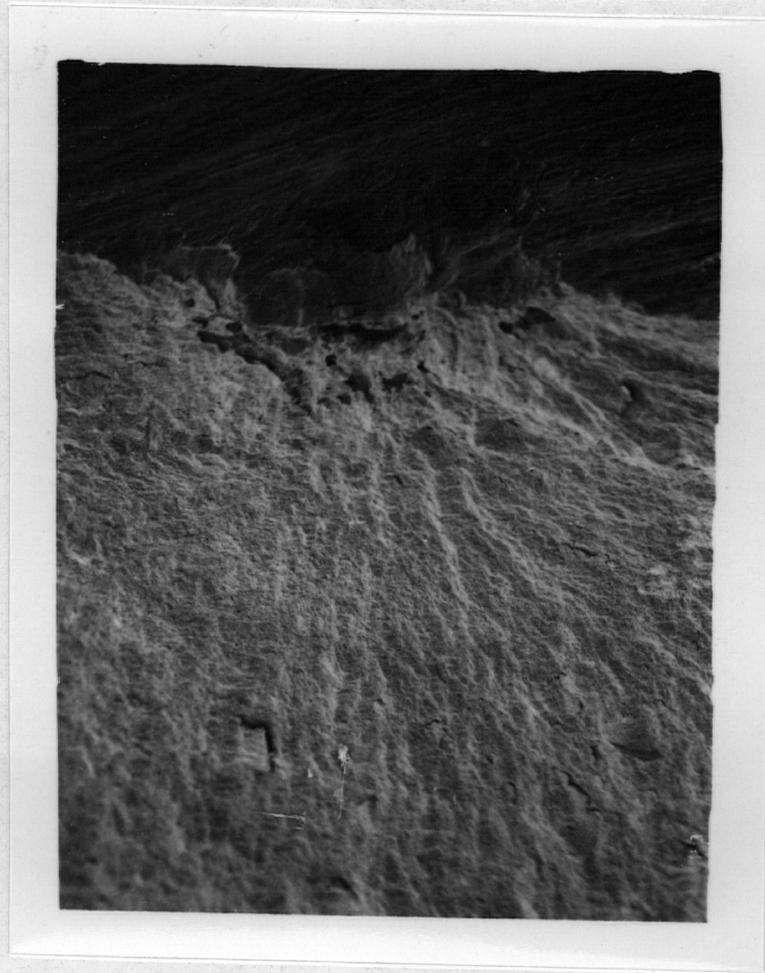
Fig. 6

CORROSION PIT - FRACTURE SURFACE

Scanning electron micrograph showing the corrosion pit at the fracture origin.

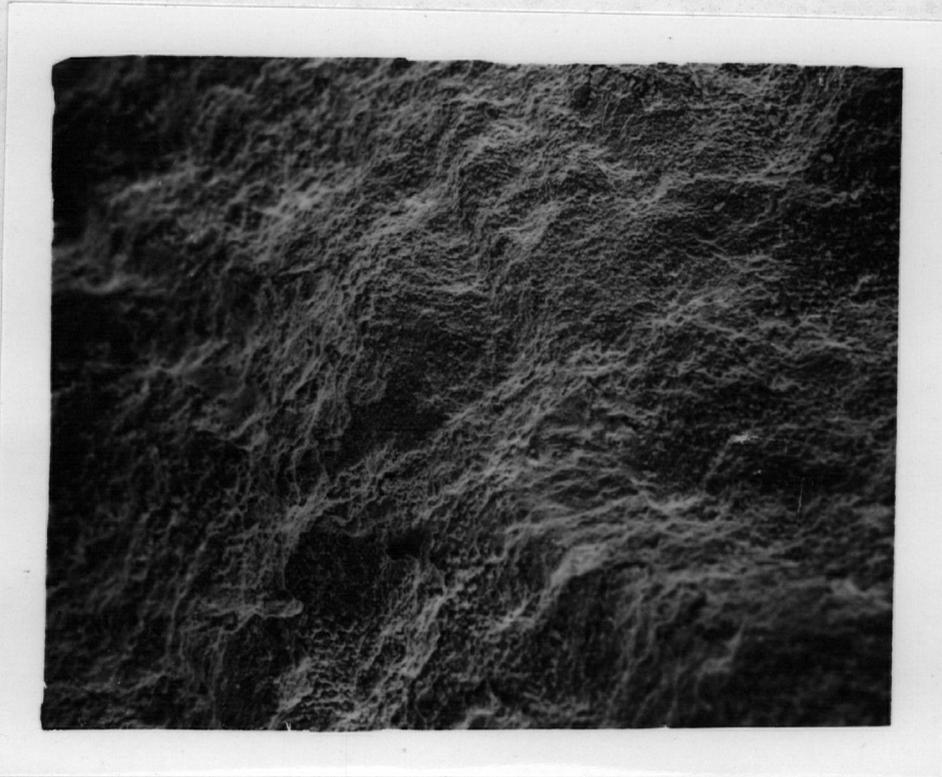
Fig. 7

Scanning electron microscopy of the fracture surface below the pit origin revealed the fracture to be smooth and to contain a thin, oxide preventing the observance of any discernible striation lines as shown in Fig. 7.

FRACTURE SURFACE

Scanning electron micrograph of the as-exposed circumferential crack fracture surface. Although the fracture surface is covered with an oxide corrosion product, the surface is generally smooth as is characteristic of corrosion fatigue cracking.

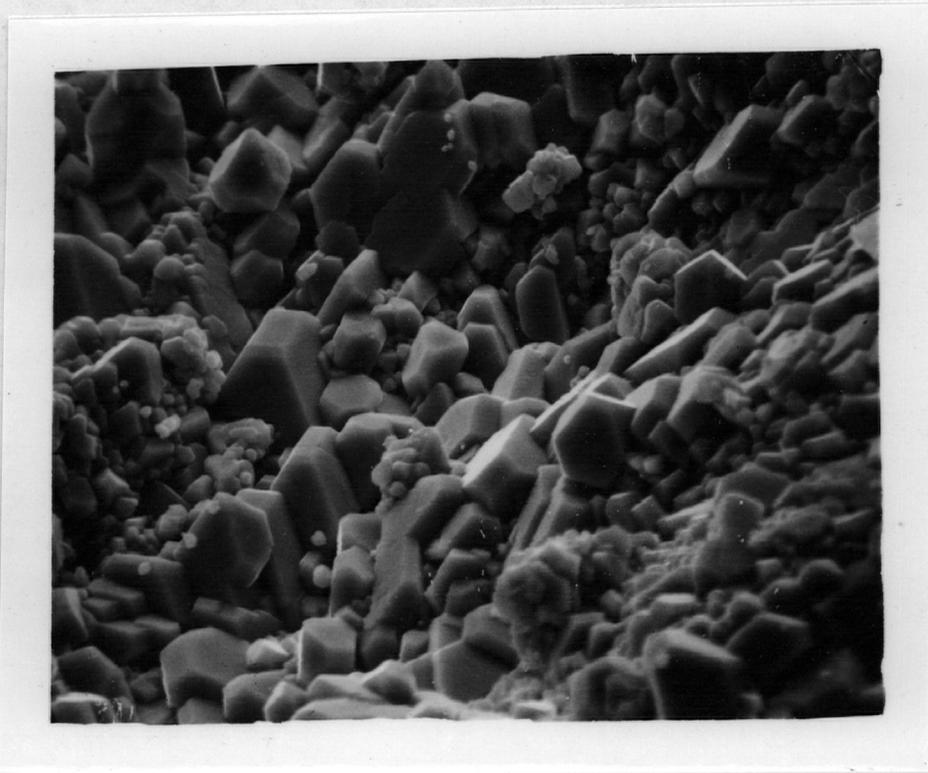
Fig. 8

At higher magnification, the presence of discrete crystals of what probably was iron oxide were observed on the fracture surface. These crystals are shown in Fig. 8.

Qualitative analysis of deposits on as-exposed fracture surfaces indicated the deposits to consist essentially of base metal oxides. The existence of discrete crystals of iron oxides was considered evidence of rapid anodic reaction typical of corrosion attack in high temperature water containing oxygen.

FRACTURE SURFACE CORROSION PRODUCT

Scanning electron micrograph of area shown in Fig. 7 but at higher magnification showing discrete crystals (probably iron oxide) on the as-exposed fracture surface which is evidence of corrosion attack in high temperature water containing oxygen.
