Subject: 10CFR21 Reporting of Defects and Non-Compliance -
Engine Systems, Inc. Report No. 10CFR21-0100, Rev. 0

EMD Water Pump, P/N 8324589

Report No. 10CFR21-0100

COMPONENT: EMD water pumps

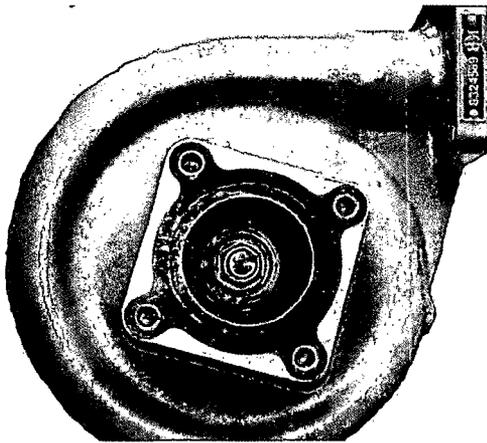
It was reported by Grand Gulf that "while troubleshooting low Div III DJ jacket water pressure it was discovered that the wrong impeller was supplied in the P81C007A pump. The supplied impeller was intended to rotate in the opposite direction as the pump rotation. This appears to be the cause of low jacket water pressure in the A engine."

Subsequently, the water pump was returned to ESI for further inspection. It was apparent from a visual inspection that the incorrect impeller was installed for this pump. P/N 8324589 corresponds to a right hand rotation, left bank water pump for use on a 12-cylinder EMD 645E4 or E4B engine. As shown in Photos 1 and 2 below, the housing corresponds to a right hand rotation pump, but the impeller is for left hand rotation. Figure 3 shows the correct impeller for a right hand rotation pump.

Photo 1: Water Pump Returned by Customer
(note impeller fin orientation)

ESI recommends that as a precaution, all customers with an EMD water pump in stock which was supplied by ESI prior to April 2000 should perform a visual inspection to ensure the correct impeller is installed. A pump which has been installed on the diesel engine is considered acceptable based on successful operation of the diesel engine. The impeller inspection is easily performed, without disassembly, by looking into the inlet port of the pump to confirm the orientation of the impeller matches the pump housing. A listing of the various part numbers supplied prior to April 2000 is included in Table 1. Figures 4 and 5 contain visual guidance to ensure the impeller corresponds to the installed pump housing.

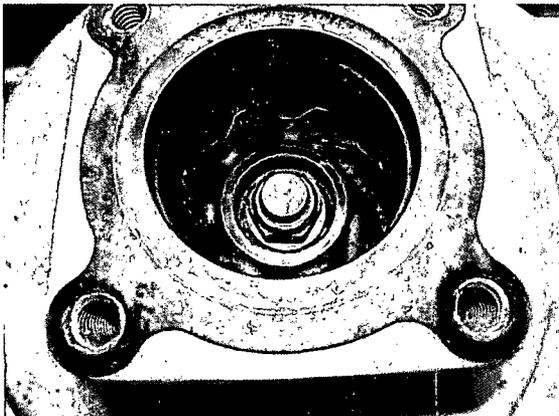
Photo 2: Close-up of Water Pump
(note impeller fin orientation)

As noted above, ESI supplied this water pump in 1997. Since that time ESI is unaware if any rework or refurbishment activities have been performed on the pump but it was noted that paint had chipped off the heads of the capscrews, indicating that the screws had been removed at some time. There exists a possibility that the pump impeller may have been previously removed.

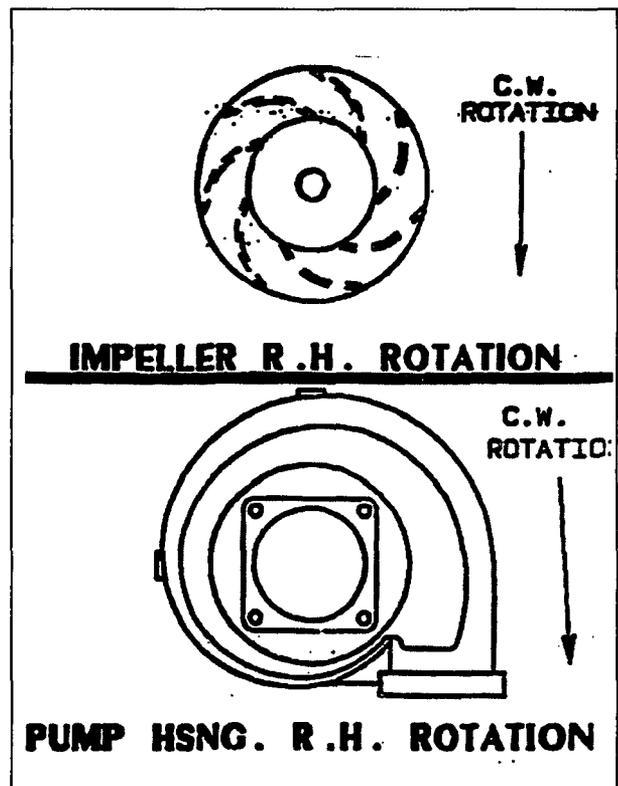
Figure 3: Correct Housing and Fin
Orientation for RH Rotation

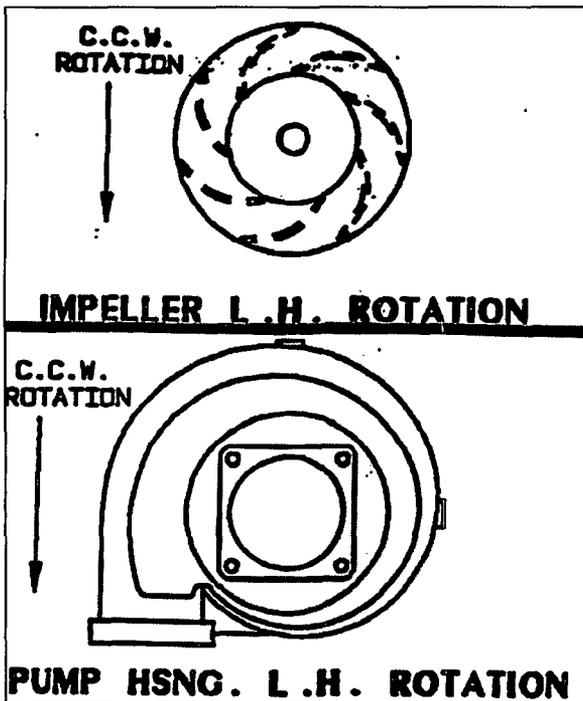
Figure 4: Correct Housing and Fin Orientation for LH Rotation

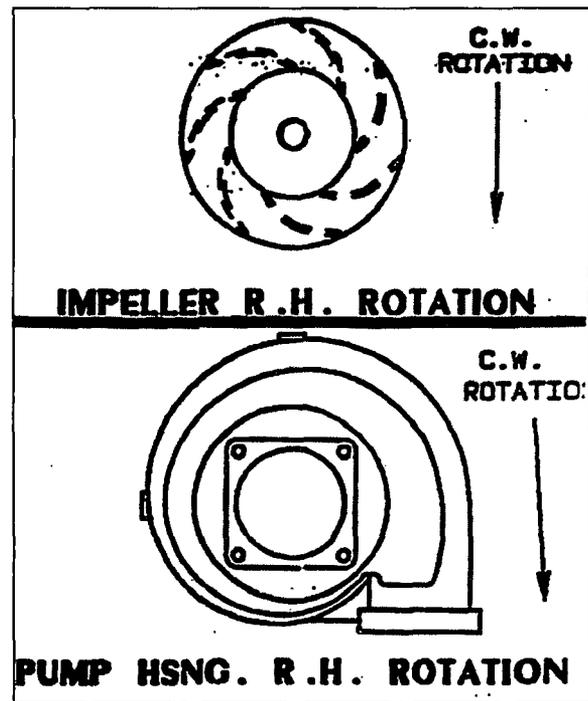
Figure 5: Correct Housing and Fin Orientation for RH Rotation
