**Joseph Giantelli** (10/2/2008 2:53:36 pm)

### River Bend - Wind Forces Exceed Turbine Building Siding Construction

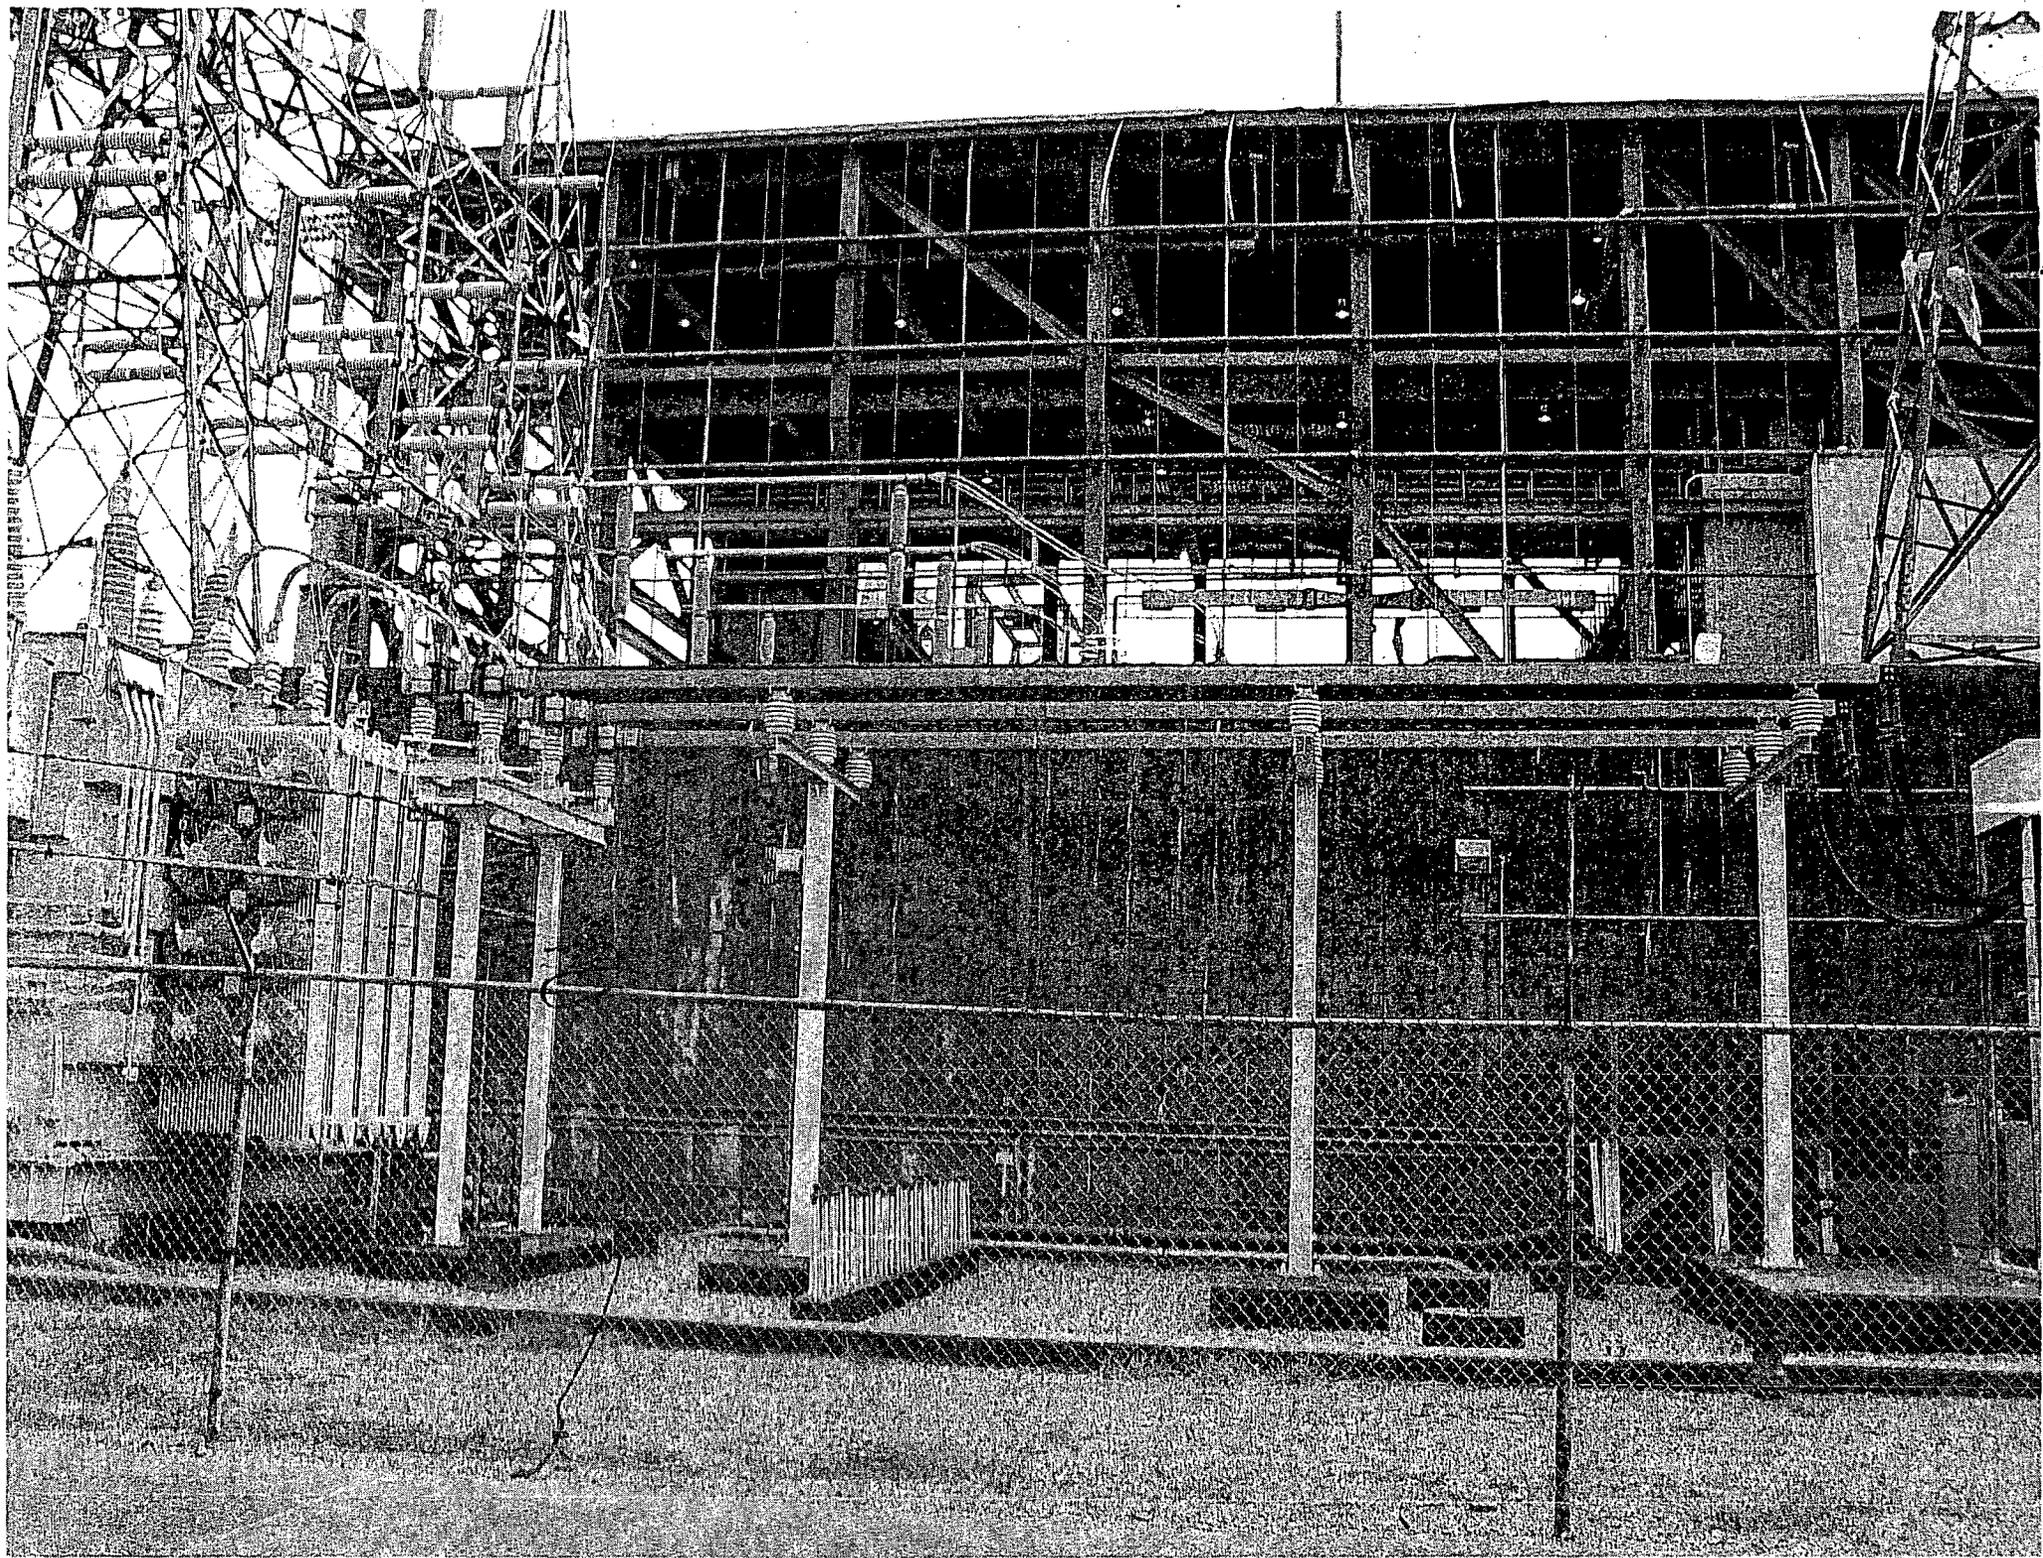
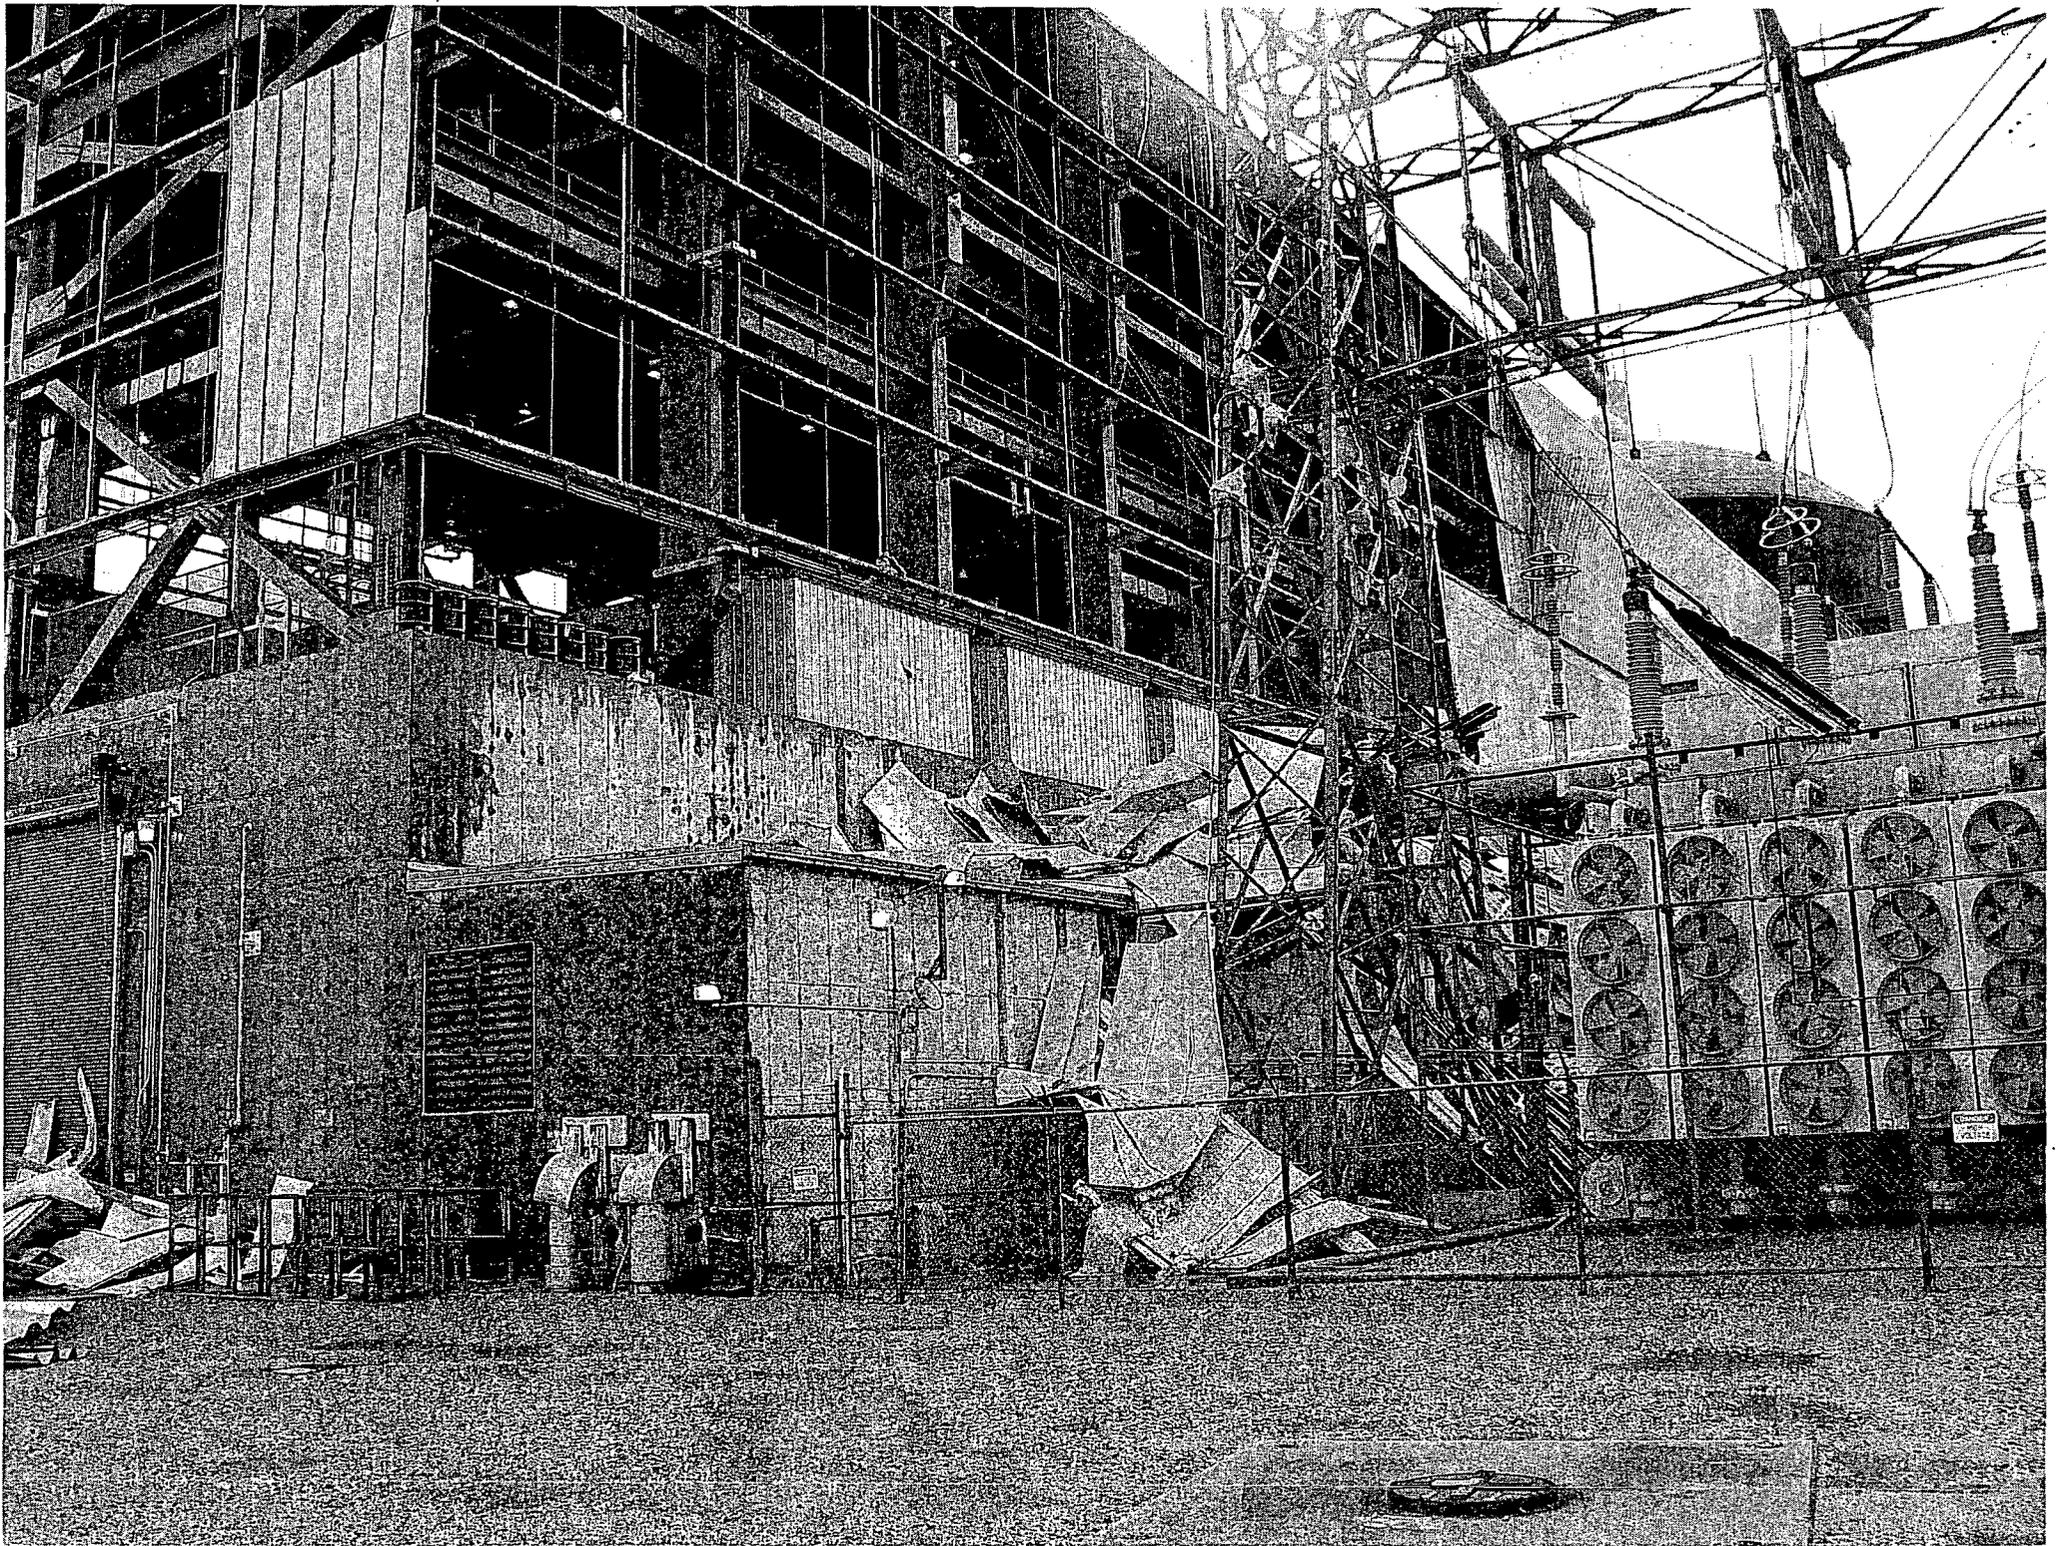
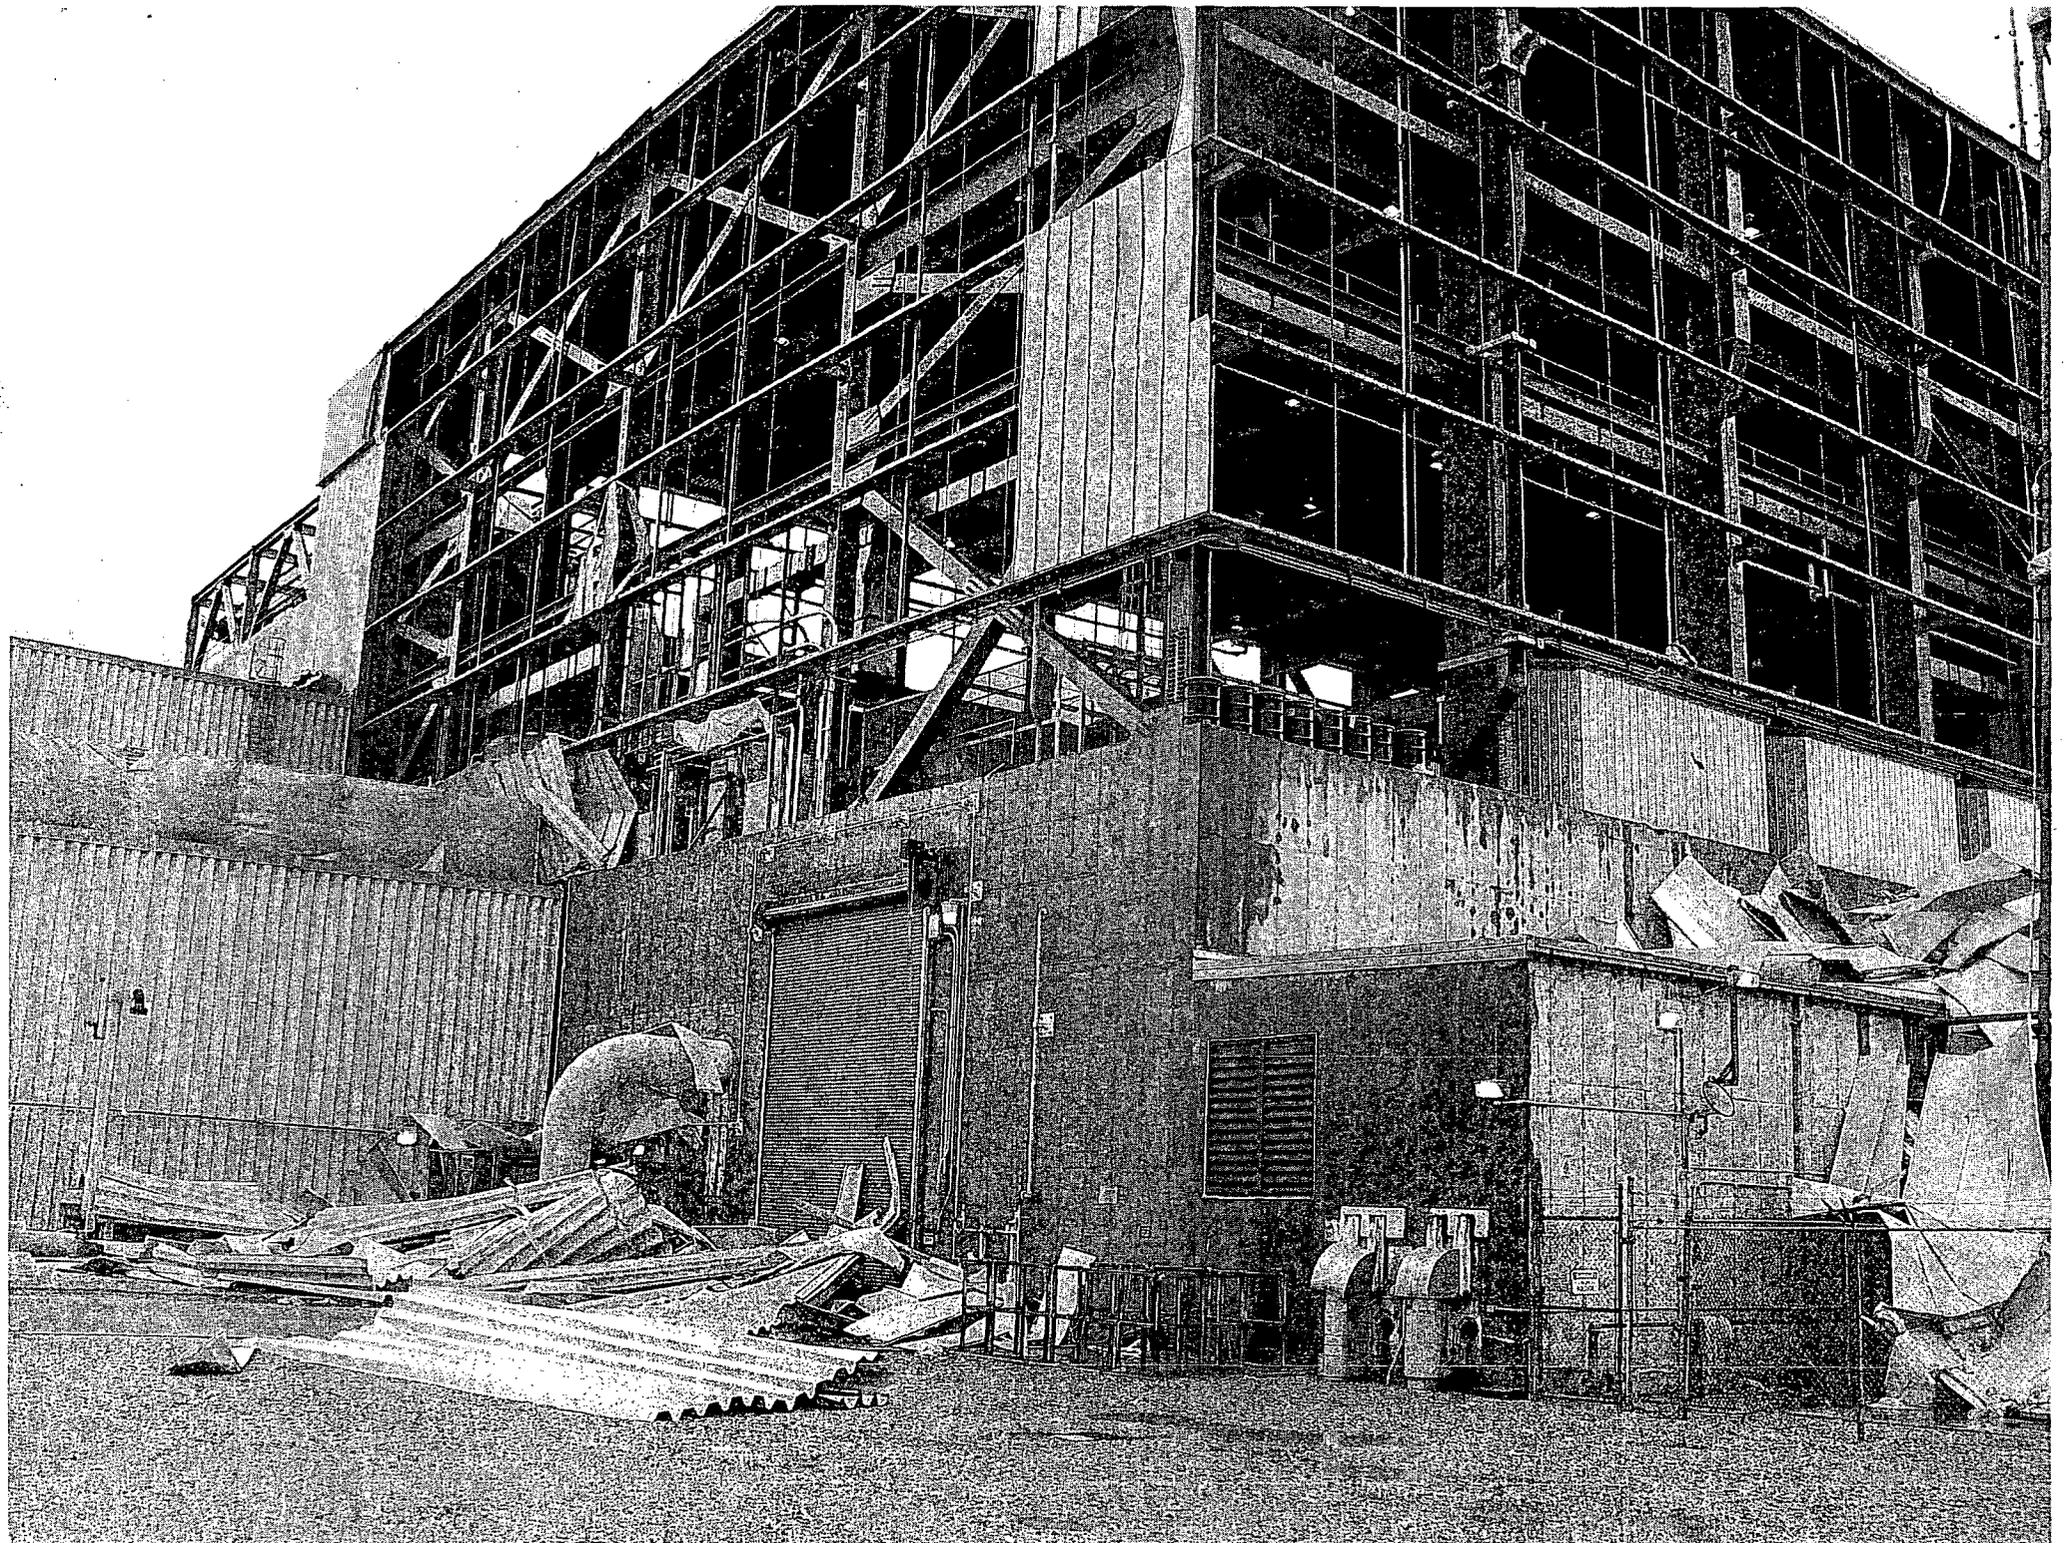
During the high winds a piece of the siding landed on the main transformer. Notice siding and insulation lying in the area. A piece of siding is laying on a transformer bushing. Potentially this could have led to an electrical fault if the licensee continued power generation. The insulation in the pictures can be seen spread out in several locations.

- 1) The panels were not installed according to specifications - large variance in fastener spacing and angle
- 2) The wind consultants brought in by Entergy to review the turbine building failure identified an error in their calculations related to the attachment points of the outer skin. As such, they have revised their estimates to conclude the siding failed at a wind pressure of approximately 31 psf, which is less than the design criteria.
- 3) Higher localized wind gusts capable of achieving detachment pressure appear to have occurred, as evidenced by collateral damage to plant facilities and environs (e.g., cooling tower, building canopy, signage, pine trees, etc.).

The field investigation and repairs by the licensee is expected to reinforce the turbine building corners for higher wind pressures, reevaluate the fastener design and angle, reduce fastener spacing, install missing girt supports, conduct metallurgical testing, and laboratory analysis.

The replacement siding installed by River Bend meets design criteria, and River Bend has taken actions to raise the strength of the remaining originally installed siding to meet design criteria, so this does not represent an ongoing concern.
