CAMECO RESOURCES CROW BUTTE OPERATION

May 11, 2010

On May 10, 2010, during routine 5-year Mechanical Integrity Testing (MIT), well number P-4231 in Mine Unit 9, Wellhouse 45 failed the MIT criteria. Using isolation techniques, it has been determined that the failure is the casing joint at the 240-foot level. Jenny Abrahamson, Groundwater Geologist UIC/ME, at Nebraska Department of Environmental Quality (NDEQ), Dave Carlson, of the NDEQ field office in Chadron, and Ron Burrows, NRC Project Manager were notified concerning this well on May 10, 2010.

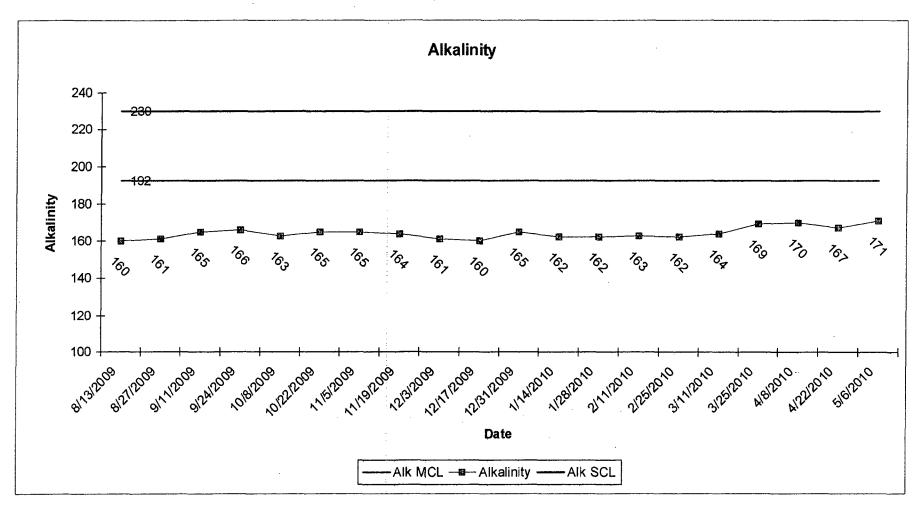
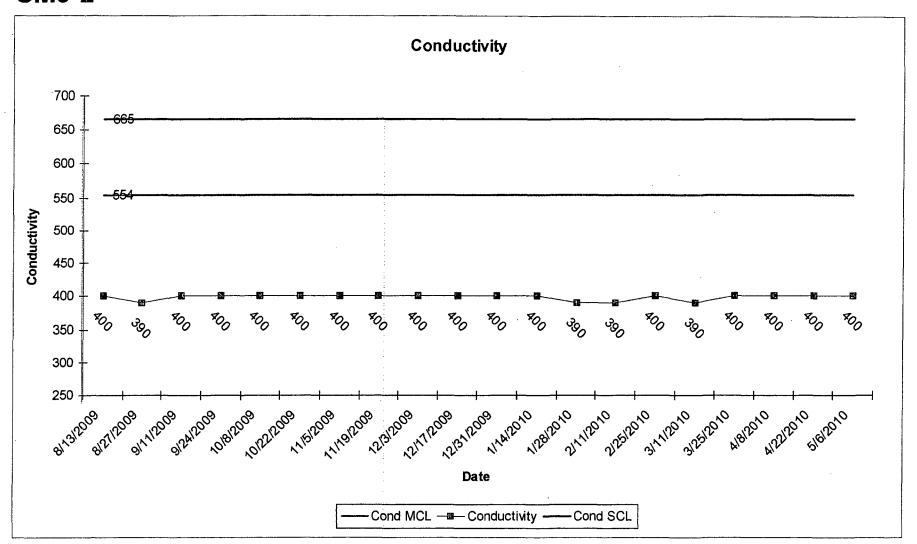
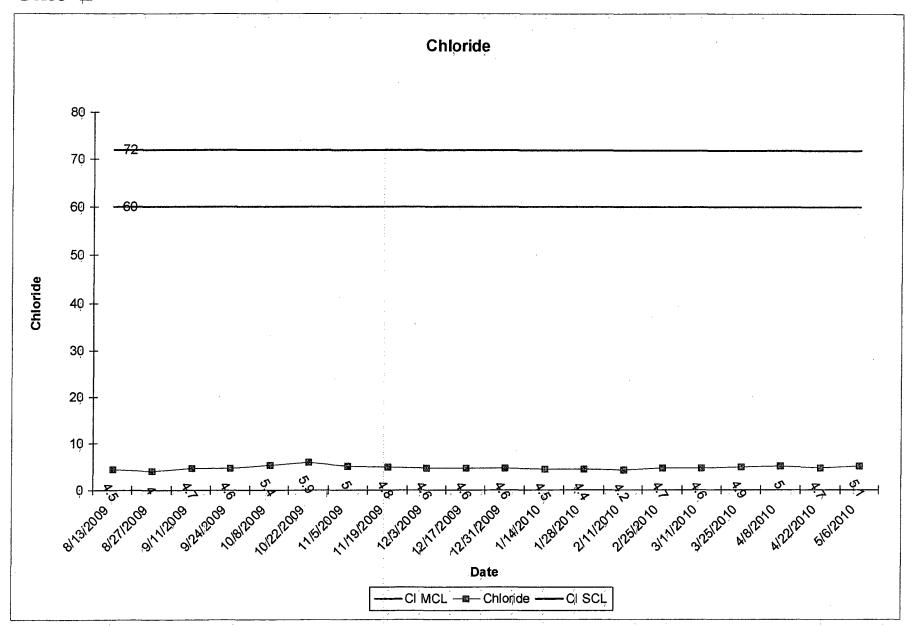
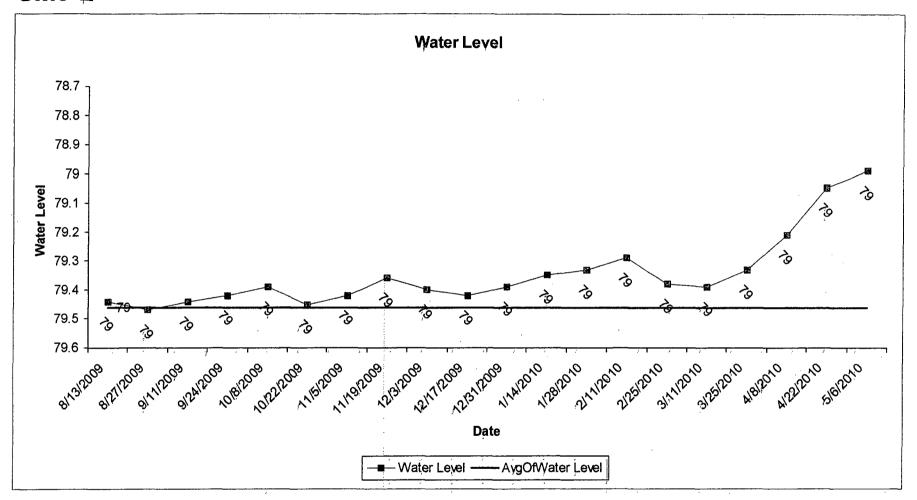
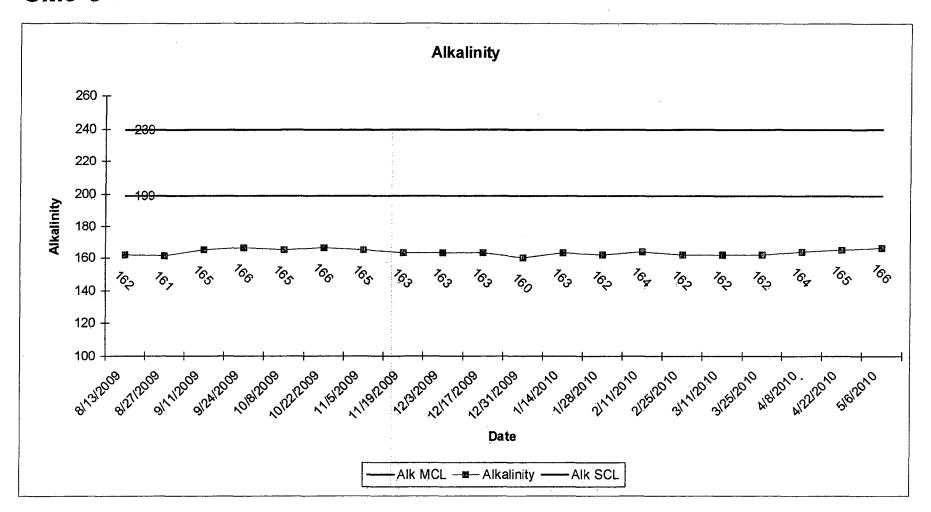
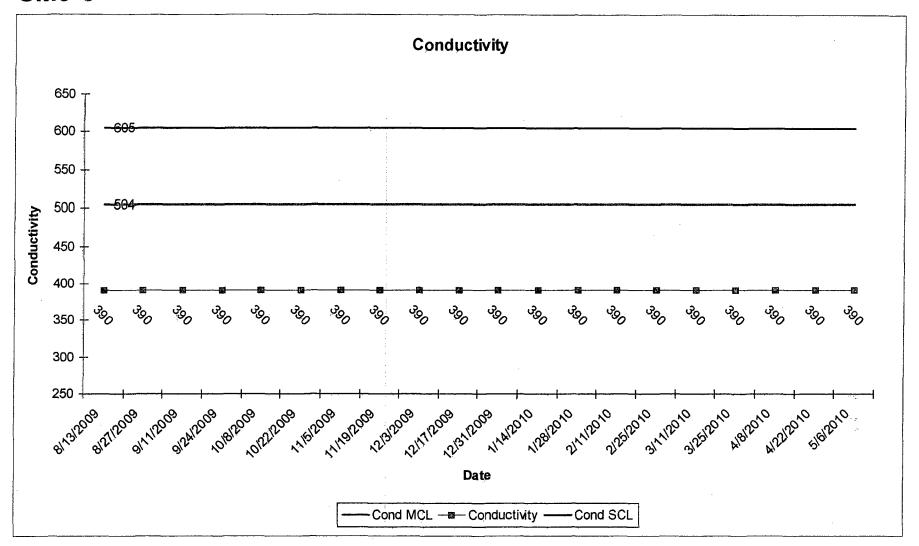
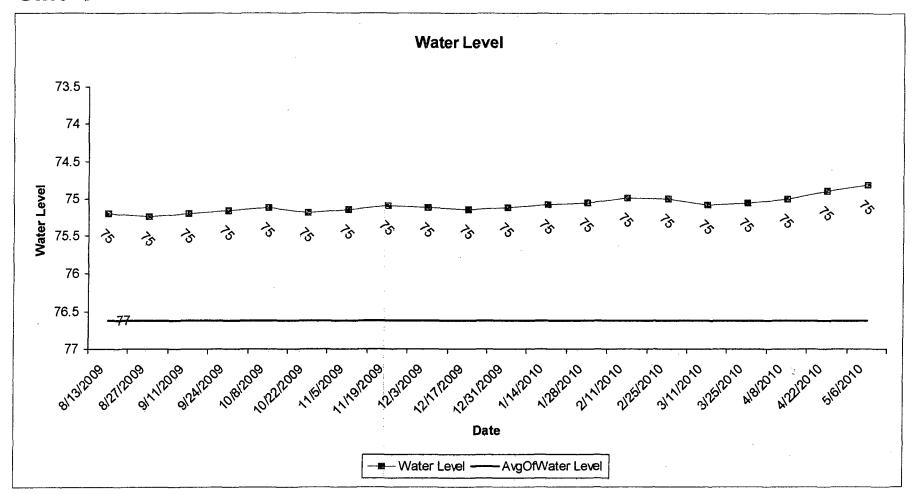
The nearest Shallow Monitor (SM) wells to P-4231 are SM9-2 and SM9-3. I have enclosed graphs of the latest results from these Shallow Monitors for your review.
