RS-10-094

Braidwood Station, Units 1 and 2
Facility Operating License Nos. NPF-72 and NPF-77
NRC Docket Nos. STN 50-456 and STN 50-457

Byron Station, Units 1 and 2
Facility Operating License Nos. NPF-37 and NPF-66
NRC Docket Nos. STN 50-454 and STN 50-455

Subject: Additional Information Supporting License Amendment Request to Change Fire Protection Program Requirements for Upper Cable Spreading Rooms

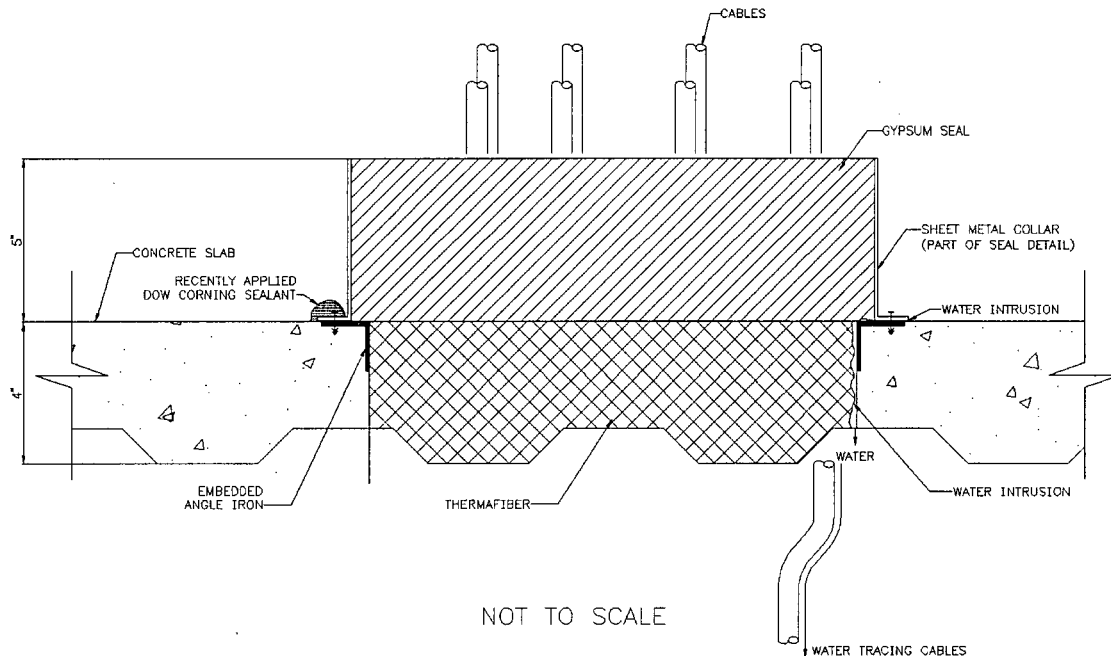
Figure: Typical UCSR Cable Riser Floor Seal

The configuration of a typical cable riser floor fire seal in the UCSRs is shown in the figure below. The configuration of the subject fire seals consists of a 5" high, 18 gauge, sheet metal collar anchored to the floor surrounding the floor opening. The collars are approximately 1" to 2" longer and wider than the opening, creating a horizontal overlap between the gypsum and the concrete. During installation, damming material was installed inside the opening below the collar, and the gypsum material was then poured into the collar, starting flush with the surface of the concrete floor, overlapping the concrete horizontally approximately 1" to 2" around the perimeter of the seal, and rising up within the collar to form a seal around the penetrating items. The installed gypsum overlaps the opening on each side, but does not extend below the top surface of the floor into the opening.

The seals have been qualified as 3-hour fire seals per IEEE 634, "Standard Cable-Penetration Fire Stop Qualification Test," and ASTM E119, "Standard Test Methods for Fire Tests of Building Construction and Materials." The fire seal testing included multiple hose stream tests per ASTM E119, which verified that a hose stream would not dislodge a fire seal and would not project water beyond the unexposed surface of the fire seal. Note that these fire seals are also rated as ventilation seals; however, these seals do not have a flood seal rating.

Flood-rated seals were not installed in this application since the UCSR elevation 463'-5" floor is not designed as a flood rated barrier. This is due to the only source of water being the Fire Protection piping to the installed hose stations. The probability of failure of this system is considered low since it is a low pressure system not subject to transients. Flood calculations performed for each of the UCSR compartments show that the floor drains are sized for expected releases or in-flow of water to the area without significant buildup of standing water. The calculated height (i.e., less than two inches) is less than the height of the metal collars surrounding the penetrations; therefore, leakage is not expected.

Recently, two instances of water leakage at Byron Station from the UCSRs into either the MCR or the Unit 1 AEER were documented in IRs 934040 and 1046792. These IRs were initiated on June 23, 2009, and on March 24, 2010, respectively. Water leakage from hose stations resulted in some quantities of standing water on the UCSR floor. The standing water was able to migrate between the metal surfaces of the concrete embedded angle iron and the sheet metal fire seal collar. The seal installation details, as shown in the above figure, call for the gypsum seal to overlap the surface of the concrete opening. It is this interface that eventually allowed water to pass through the seal. The standing water then leaked into the MCR or AEER. The identified leakage path was at the fire seal-floor interface, and not through the depth of the poured gypsum.

A potential leak path for the standing water would be through the interface between the collars and the floor. However, actions are being taken to caulk this interface to address the concern about water leakage through the collar/floor interface. Since water levels above the top of the curbed openings or fire barrier collars are not expected, the caulked fire/ventilation seal configuration will be sufficient to prevent potential water intrusion/leakage events during normal plant operation (i.e., postulated line breaks or hose station leakage) and during fire fighting conditions where water spray may be used.

Since the recent events at Byron Station, both stations have taken actions in accordance with the Corrective Action Program to improve the water resistance of the UCSR floor penetrations. Byron Station recently completed the process of applying sealant at the floor to collar interfaces, bolt holes, and vertical seams. During this process, additional potential sources of in-leakage (i.e., conduit sleeves, ventilation ducts, and support base plates with through-bolted floor attachments) were also sealed.

The fire/ventilation seal configuration was modified at Braidwood Station in 1987 via the design change process due to water leakage issues identified during original construction activities. The design change added a requirement to provide a sealant at floor to collar interfaces, bolt holes, and vertical seams to provide a barrier to prevent water intrusion/in-leakage. This requirement is documented on drawing 20E-0-3600, Note 208 BR, and was implemented in 1987. Additionally, sealant was also applied to various ventilation and equipment hatch configurations during this evolution. The application of this sealant eliminates the leakage/seepage paths between the collar to floor interfaces. Additional information regarding the 1987 Braidwood Station events is provided below in response to NRC Request 9.c, along with a discussion of Byron Station's review of the events.
