H. B. ROBINSON STEAM ELECTRIC PLANT, UNIT NO. 2  
DOCKET NO. 50-261/LICENSE NO. DPR-23

LICENSEE EVENT REPORT NO. 2010-002-00  
PLANT TRIP DUE TO ELECTRICAL FAULT

Plant Trip due to Electrical Fault

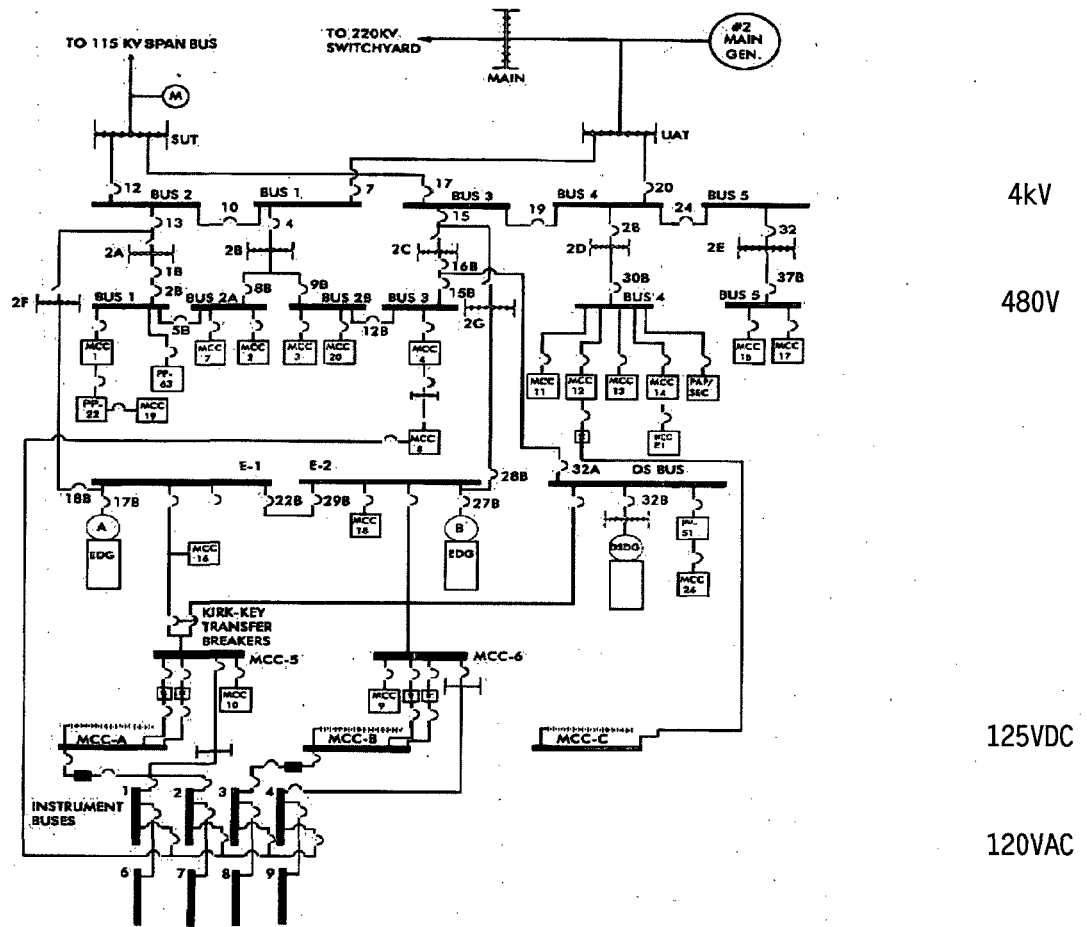
Figure 1 - Simplified Electrical Distribution

The following figure illustrates the electrical distribution system:
