Prairie Island 2R26 Outage

NRC Phone Call and NRC Discussion Points

April 28, 2010

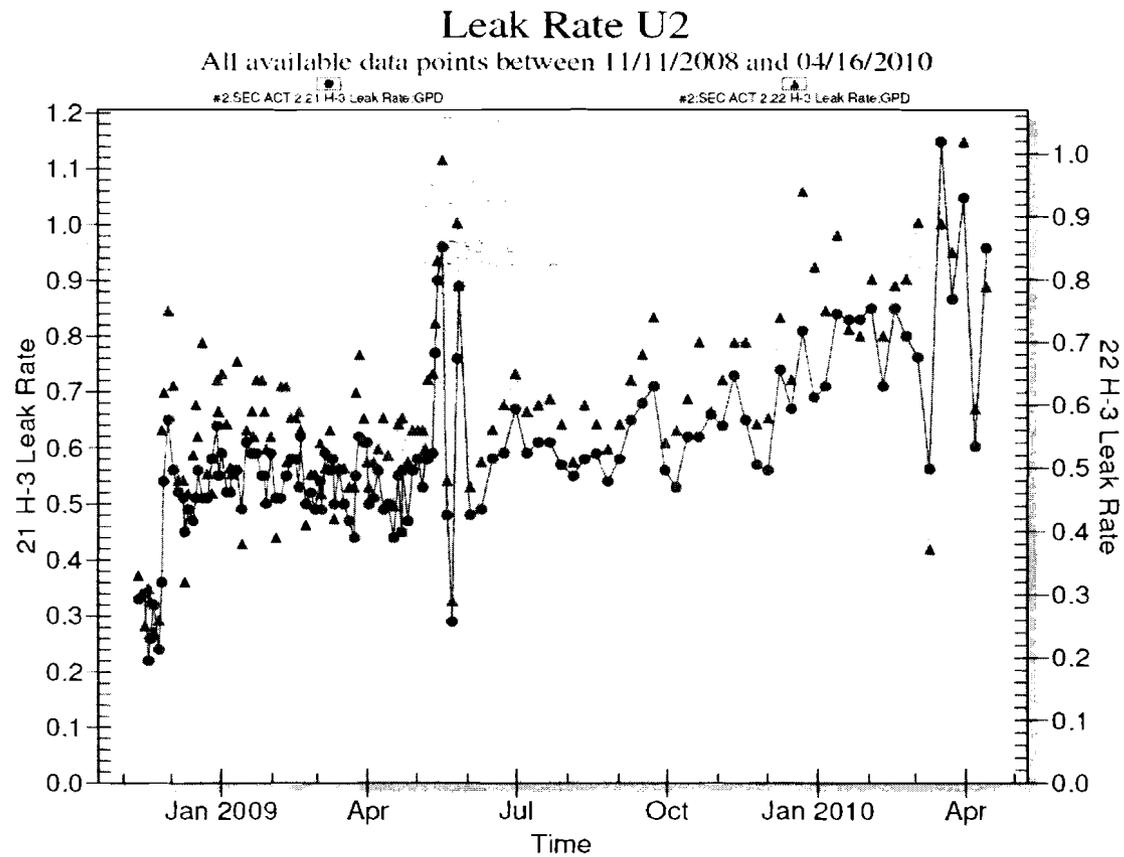
- 21 Steam Generator maximum steady state leakage by tritium was less than detectable to ≤ 1.1 gallons per day over the last cycle.
- 22 Steam Generator maximum steady state leakage by tritium was less than detectable to ≤ 1 gallon per day over the last cycle.
- Steam Generator Tube Leakage is similar to leakage over the last three cycles.
