Issue

Disposal Cell 2B developed damp areas while cell was filling and during performance of the Water Tightness Test.

June 3, 2010

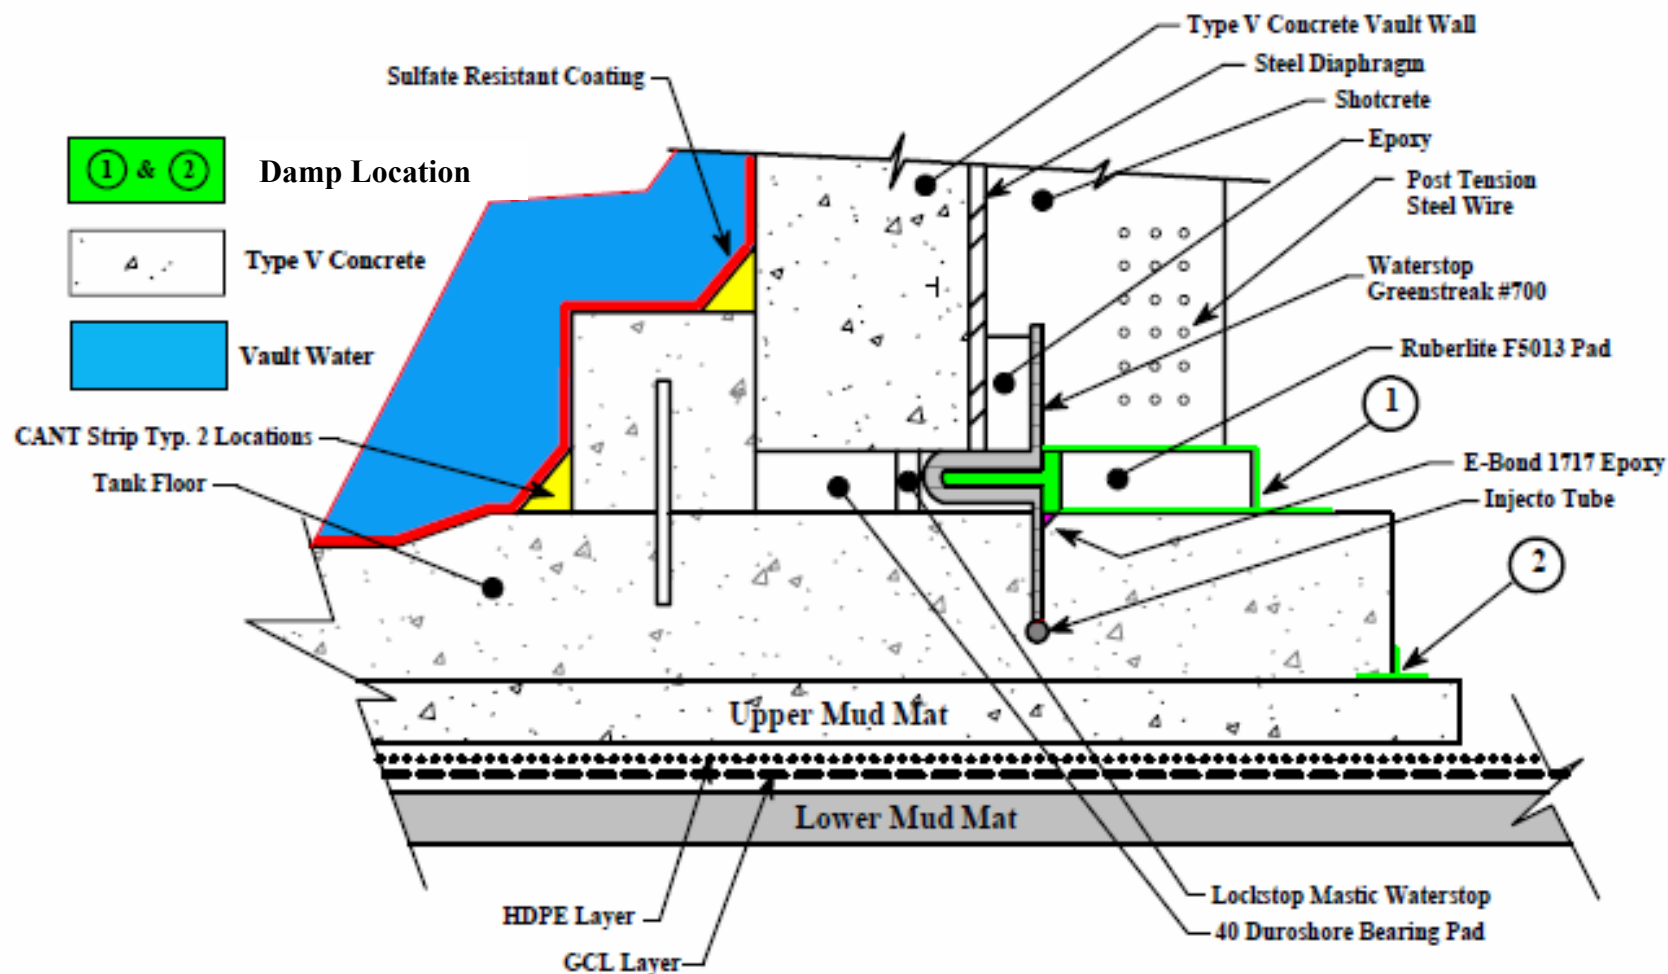
Schematic

- Wall-Tank floor repairs - Damp areas have undergone repair with no recharge.
- Tank floor-Upper mud-mat interface – area was cleaned to allow re-baseline; dampness persists.
- 2B Status: Water removal complete; inspection of cell interior in progress.
- 2A Status: Filling with domestic water (in progress); initiation of 96 hour Water Tightness Test to follow.

- Performing interior inspections of Cell 2B.
- Evaluate interior condition.
- Implement current installation repair procedure or select alternate solution(s) based on results of interior inspections.
- Verify Cell 2B water tightness post repair.

- Incorporate lessons learned into Units 3/5 contract Scope of Work.
 - Examples:
 - Coating application sequencing (i.e., column to floor)
 - Design mod to reduce Ruberlite Pad thickness at shotcrete wall base
 - Minimize of shotcrete overspray at wall base (riberlite pad); slope exterior tank floor to promote drainage.
 - Material of Const. – Seismic cable sheath
