June 10, 2010  
GDP 10-1025

**Paducah Gaseous Diffusion Plant (PGDP)  
Docket No. 70-7001, Certificate No. GDP-1  
USEC Event Report ER 10-03**

## EVENT REPORT ER 10-03

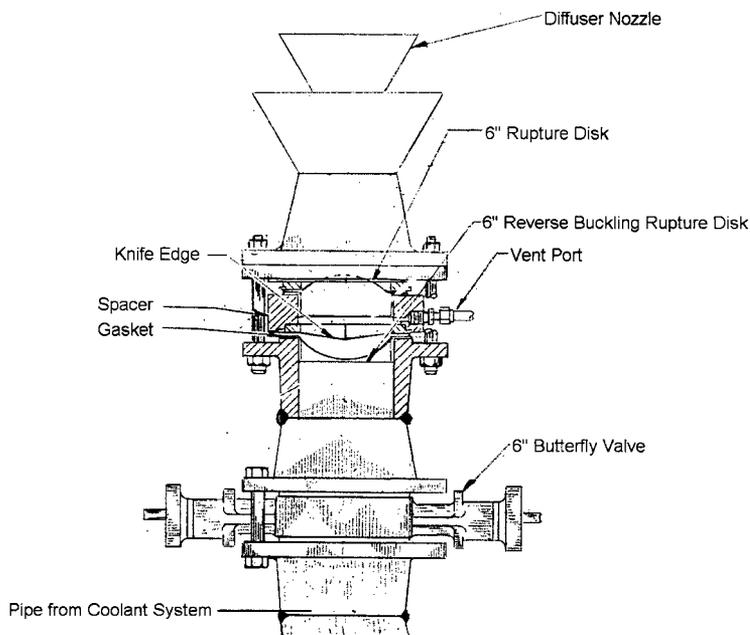
convenient size, each serving a cascade cell (a group of cascade stages) or in some cases two coolant systems per cell. Each individual coolant system is provided with a pressure relief system, which consists of either a single or dual rupture disk system. A typical dual system is depicted below, and represents the style of 6-inch rupture disk assemblies impacted by tar and/or FME caps. This system is designated as important to safety (AQ) so as to limit the pressure increase in an over-heated system to prevent damaging the coolant-to-UF<sub>6</sub> pressure boundary, a condition that might lead to a subsequent UF<sub>6</sub> release to atmosphere. The coolant systems are covered under a Safety Limit (TSR SL 2.4.2.2), and Limiting Control Setting (TSR LCS 2.4.3.4) and Limiting Conditions for Operation (TSR 2.4.3.4 for the impacted systems of this event).

Each coolant pressure relief system also contains a diffuser nozzle. This nozzle was not a part of the original design installed circa 1975, but was added in 1978 to address concerns that actuation of the system would expose the facility roof over the disk outlet port (which discharges upward) to damage. The diffuser nozzle changes the coolant relief spray pattern enough to avoid such damage.
