Re: Incident Report

Re: Incident Report
Materials License No. 24-24459-01, Amendment N0. 07

TARLTON CORPORATION
Incident Investigation Written Report

RADIOACTIVE SEALED SOURCE LEAK TEST REPORT

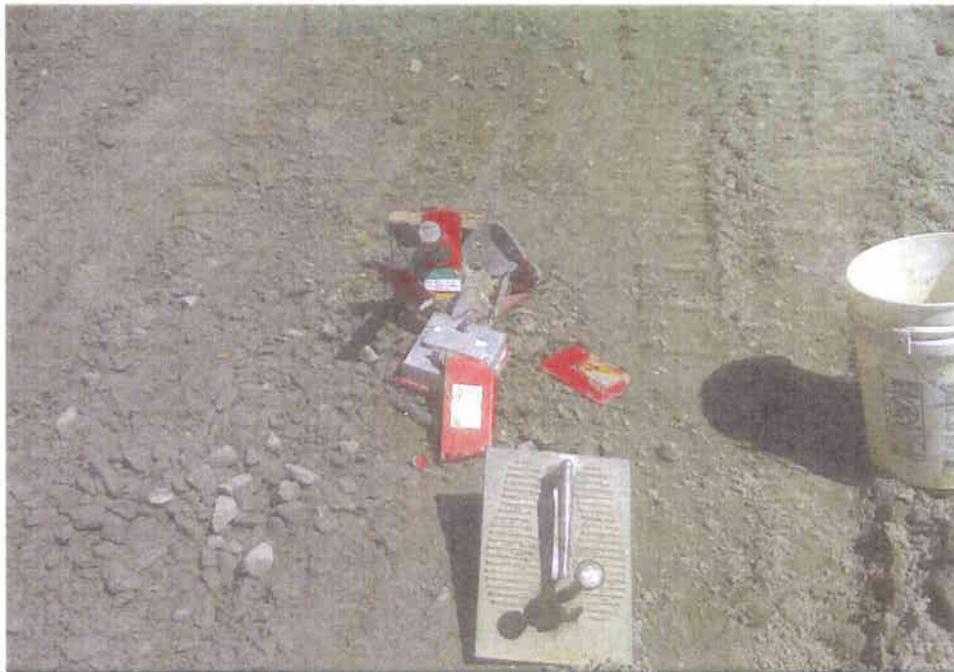
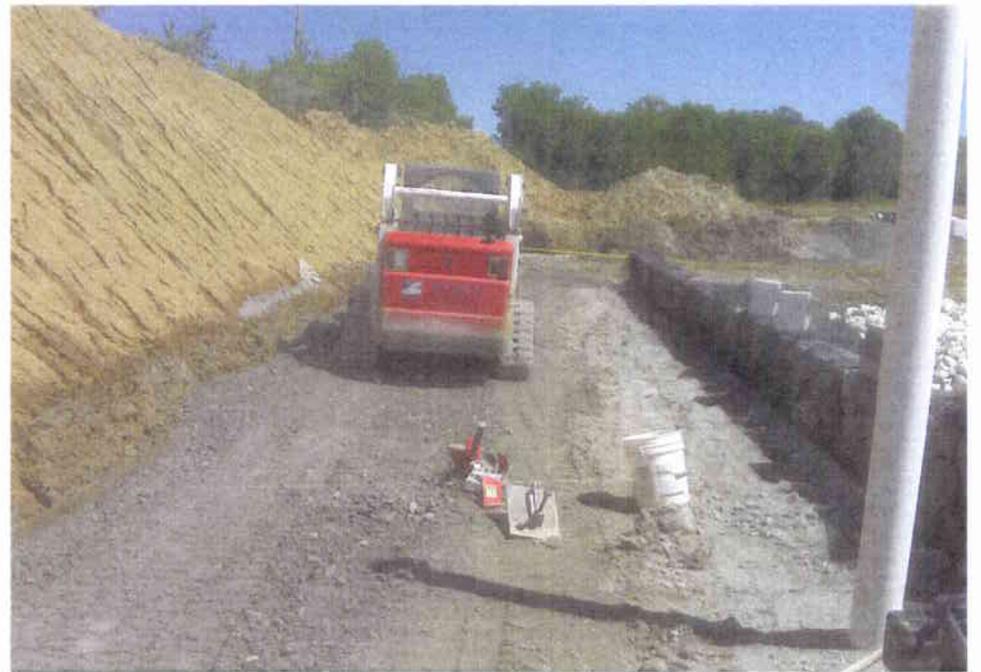
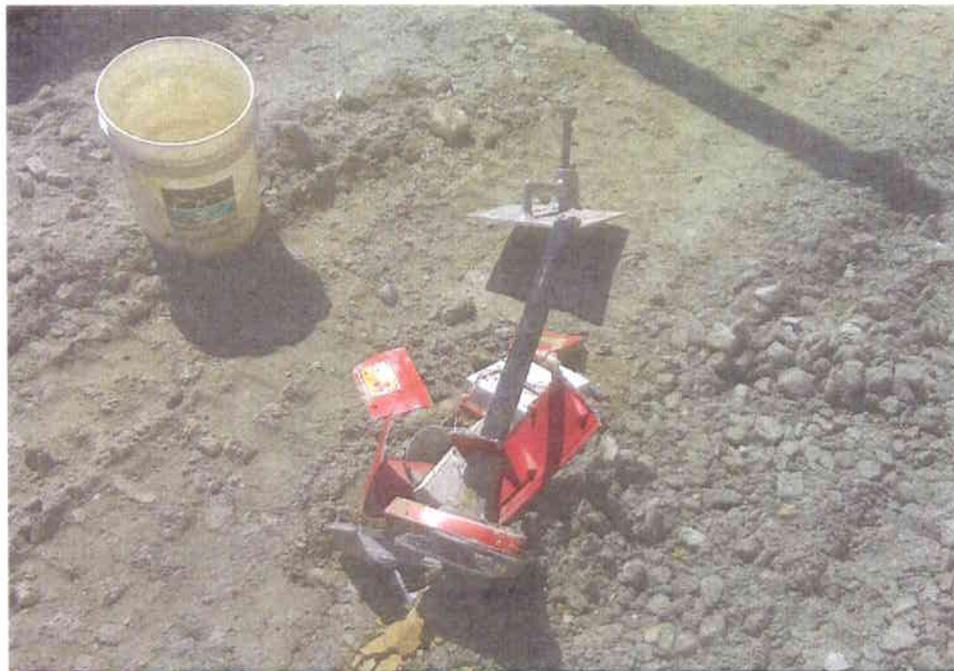
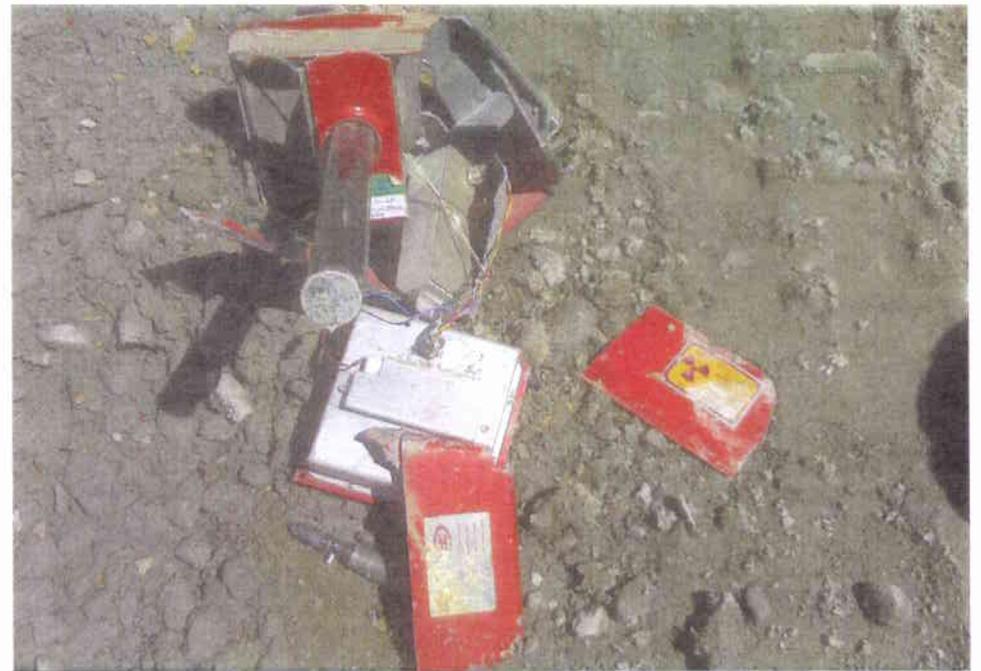
I and Geotechnology's Corporate Safety Officer, Mr. Joe Darmody, arrived at the scene of the accident at approximately 10:20 hours. Mr. Steiner had used yellow caution tape to cordon off an approximately 50-foot radius area around the damaged gauge, a Campbell Pacific MC3 (Serial Number M36046717). The Bobcat was approximately 15 feet from gauge, the point to which it had pulled forward after backing into Mr. Steiner and the gauge. I approached the of the gauge while using a MC1K Radiation Detector manufactured by S.E. International, Inc. (Serial #45356, calibrated February 17, 2010) to monitor radiation. No radiation was detected to within 3 feet of the damaged gauge, at which point I placed the detector on the damaged gauge and measured an activity level of 0.05mR/hr. Observing that the sources were in tact (source rod was still in its shield), and concluding that there was no leakage, I instructed Mr. Steiner to put all of the pieces of the gauge into the gauge transport case and return the gauge to the lockup cage at Geotechnology's office. After the gauge was removed, I checked the ground surface where the gauge had been sitting when struck by the Bobcat and detected no radiation. I then checked the rubber-cleated tracks of the Bobcat and detected no radiation, at which point I released the equipment and all personnel involved in the incident.

Prior to leaving the construction site, all parties involved in the incident attended a post-incident safety debriefing in the contractor's office trailer. A copy of the incident investigation report generated from the minutes of the safety debriefing is attached for your reference. Photographs of the Bobcat in proximity to the damaged gauge are also attached.

Density tester was runover and destroyed. Information about the model, cost and degree of damage is forthcoming from Geotechnology.
