## PART 21 REPORT CONCERNING FAILURE OF OIL-FILLED CAPACITOR

Subject: Part 21 Reportable Condition Notification – 70 $\mu$ F Oil-Filled Capacitor

Project Number: **FAR-65155**

Subject: **Failure Analysis of an Oil-Filled Capacitor.  
Manufacturer: Ronken, Part#: P91D23706H05,  
Purchase Order#: FN092345**

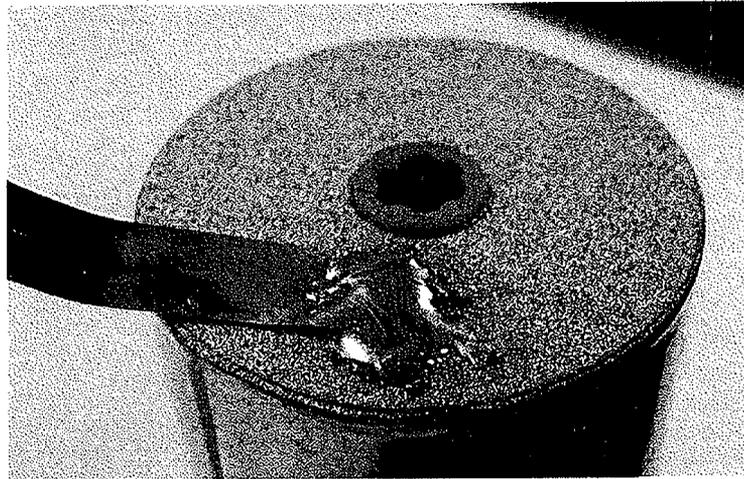
Photo of solder connection for high RMS current applications

For corrective action on this 70 MF capacitor, Ronken Industries will hand solder the tab to winding connection on all future orders.

The date code above (06-06) is the last date code to use the resistance only method on this 70 MF design. Ronken started using the method of adding solder with date code 07-38. See the below photo that illustrates the soldered connection.

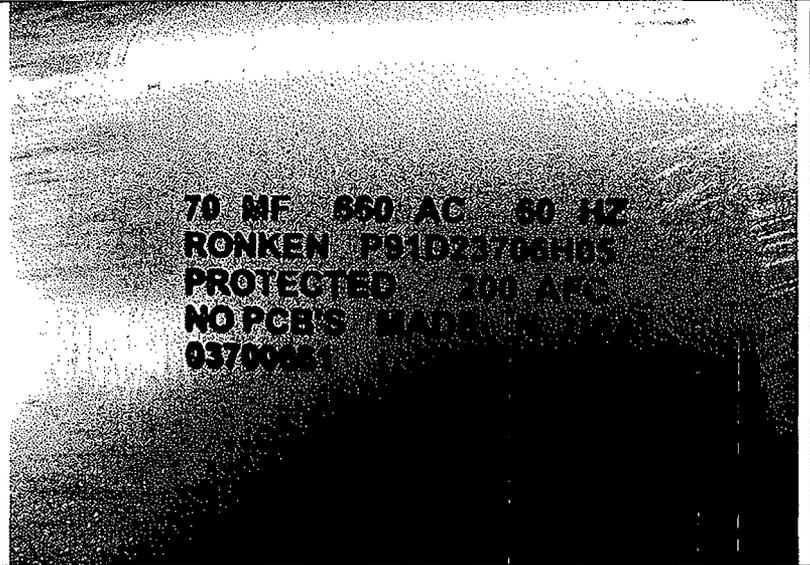
**Photograph 1: Nameplate Data**

**Manufacturer:** Ronken  
**Part:** P91D23706H05  
**Ratings:** 70 MFD, 660 VAC @ 60Hz.  
**Date Code:** 06-06

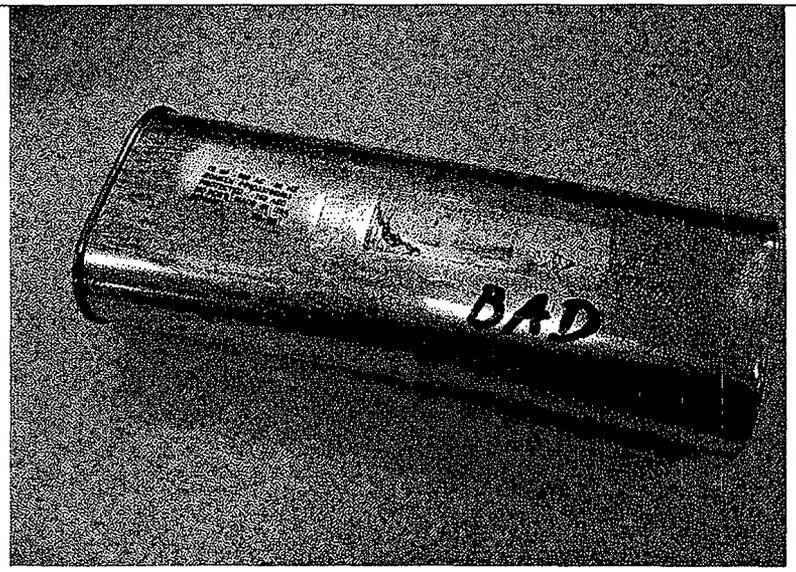
**Photograph 2: Exterior Condition**

The capacitor was bulged, primarily at the center area, which is the typical indication of internal pressure due to arcing or a fault event. The can was not breeched in any area, and no oil was observed on the outer surface.

There was no bulging or deformation in the area of the terminals at the top of the can.

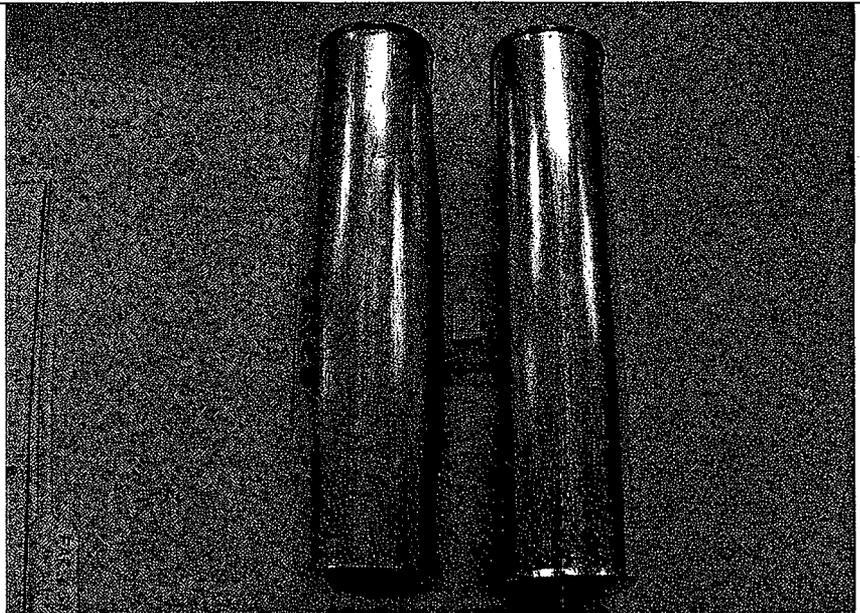
**Photograph 4:  
Comparisons With New  
Capacitor**

An unused and identical model capacitor was supplied with the failed subject capacitor. They were placed side by side for comparison purposes. Although it is clear the subject capacitor experienced some internal overpressure, the extent of the can deformation is not as extensive as has been observed in other similar type capacitor failures.

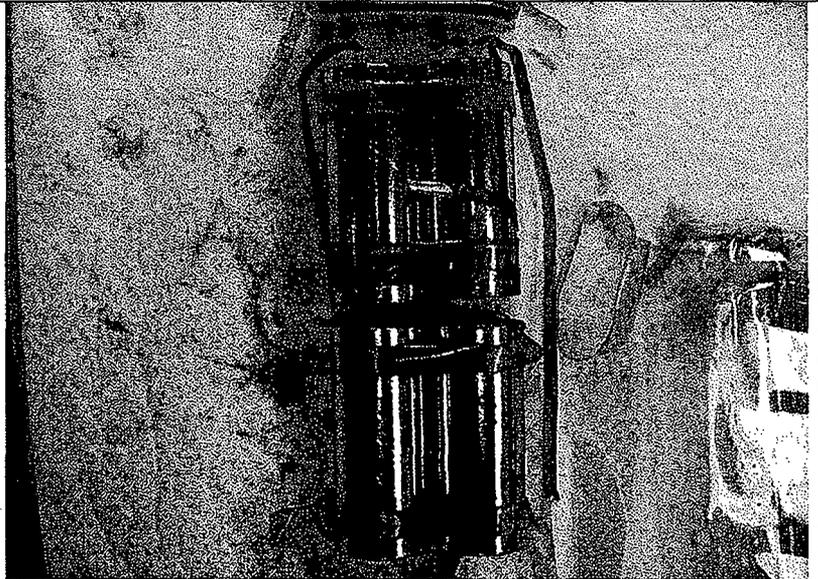
The oil within the can was darkened to a black color.

None of the (4) individual capacitors exhibited signs of catastrophic failure.

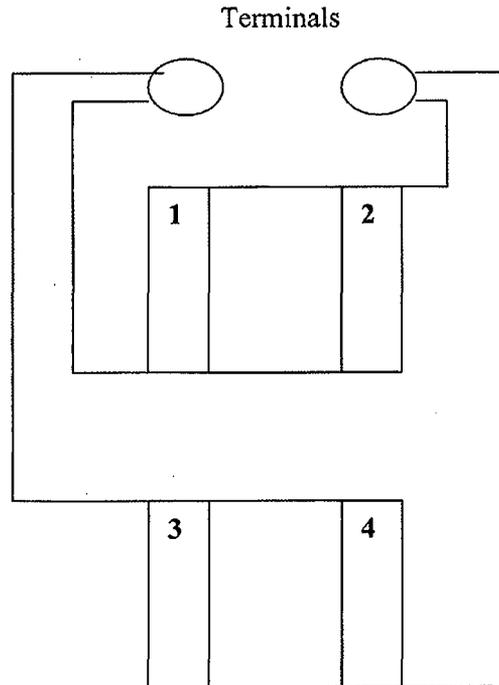
**Figure 1**

Each of the four capacitors was given a unique identifier (#1 through #4), and the internal connection scheme is provided below in Figure 1.

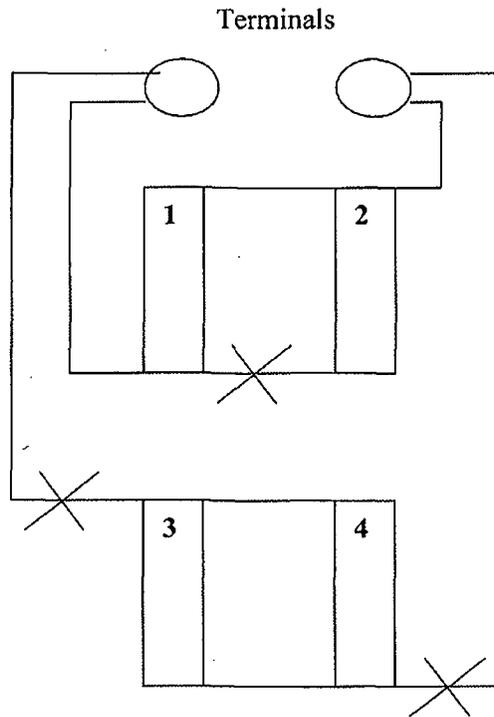
**Figure 2**

None of the capacitors failed in a catastrophic manner. Instead the spot-welded connections to the capacitors disbonded. Figure 2 below shows where the open circuits occurred

The 'X' locations denote where the open circuits occurred in the capacitive network. Capacitor #1 remained connected, which explains the as-found measured capacitance of 17.35 MFD in Table 1. Capacitors 3 and 4 were completely removed from the network with both ends being disconnected, and capacitor #2 had its lower lead disconnected.

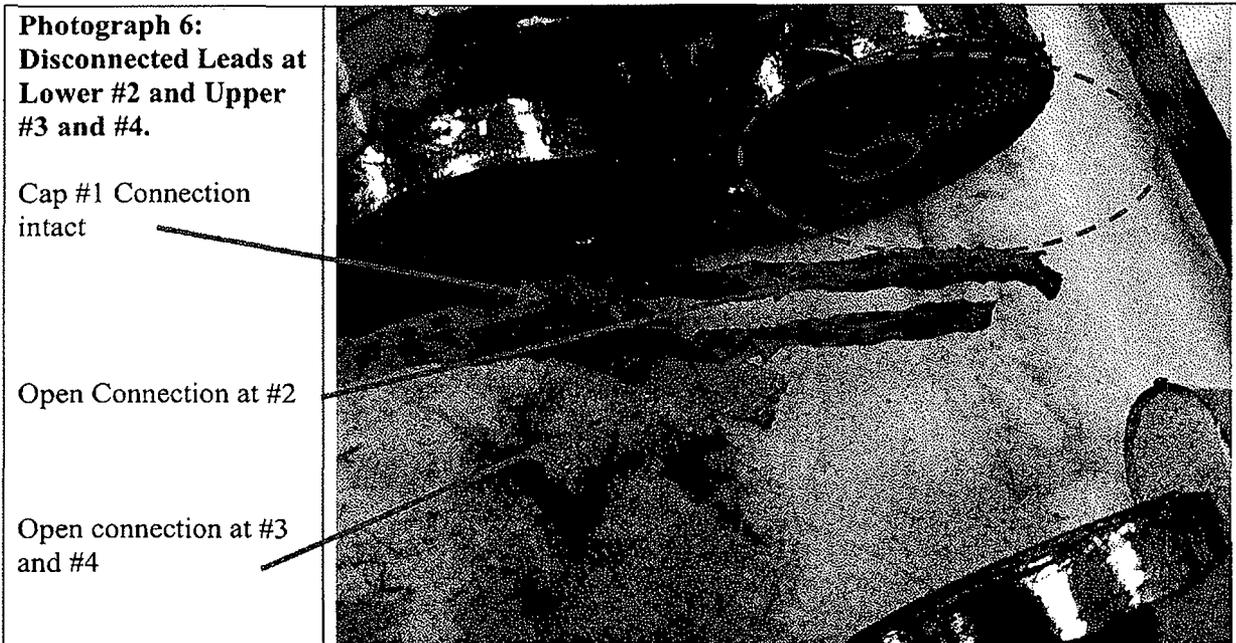
The circled area at the bottom of capacitor #2 indicates the presence of electrical arcing occurring as the connection degraded. Also, note disfigured appearance of the (2) ribbon conductors. Both ribbons exhibited indications of electrical arcing occurring, with metal erosion occurring. Most likely, the arcing and overheating gradually became worse over time eventually culminating in open circuits.

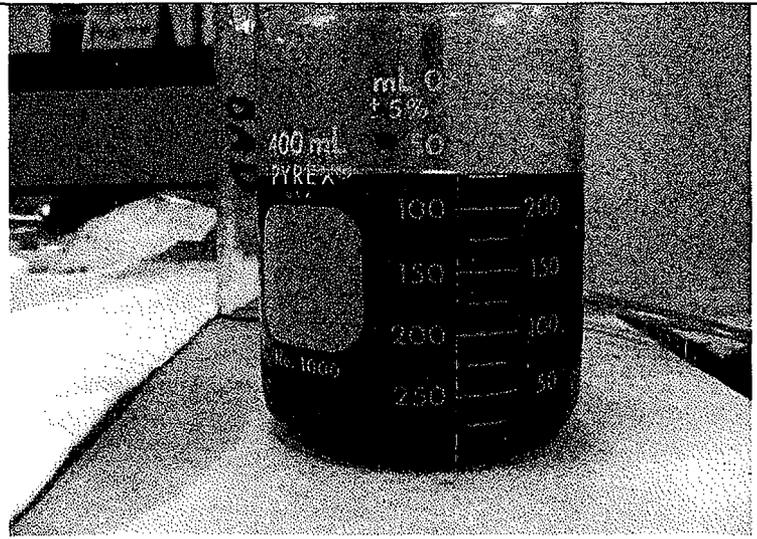
**Photograph 9: Open Circuit at Bottom of #4**

The oil that was removed from the capacitor had a darkened/black appearance, which indicative of arcing occurring over a period of time.

The oil normally has a clear/transparent appearance.

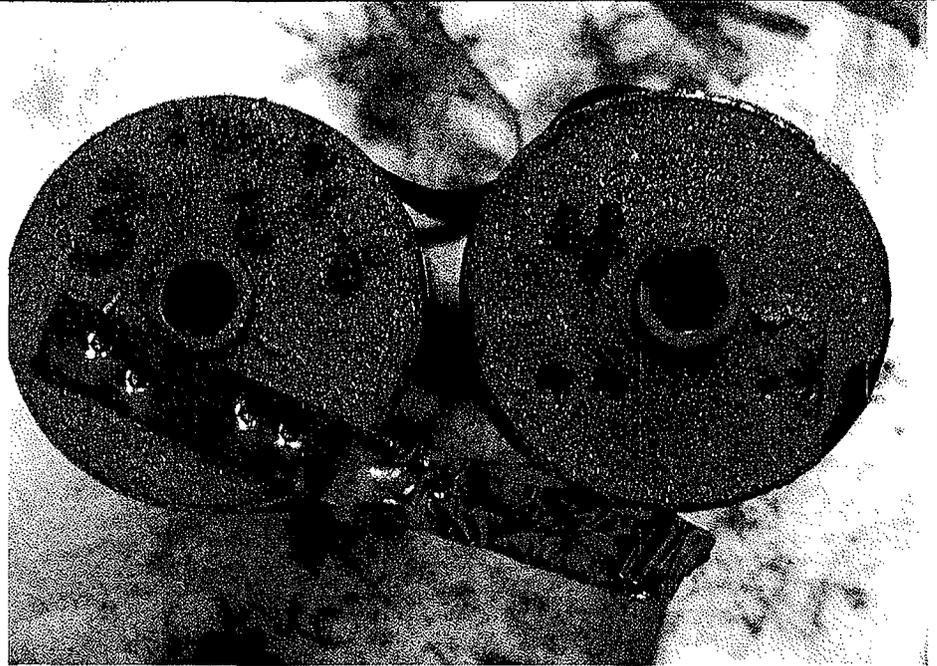
**Photograph 10:  
Nature of  
Connections**

The ribbon conductor is connected to each capacitor via (4) spot-welded points.

What was discovered was that many of the spot-welded connections were not bonded to the capacitor and were only making surface contact with the capacitor surface.

Note the non-uniformity of depth on the (4) connection points on #4.
