RE: Irigaray-Christensen Operations 2009 Annual Inspection Report, Permit No. 478

ANNUAL INSPECTION REPORT

Subject: Cogema Mining Inc.'s (now Uranium One, USA) Irigaray and Christensen In Situ Uranium Operations

Permit No.: 478

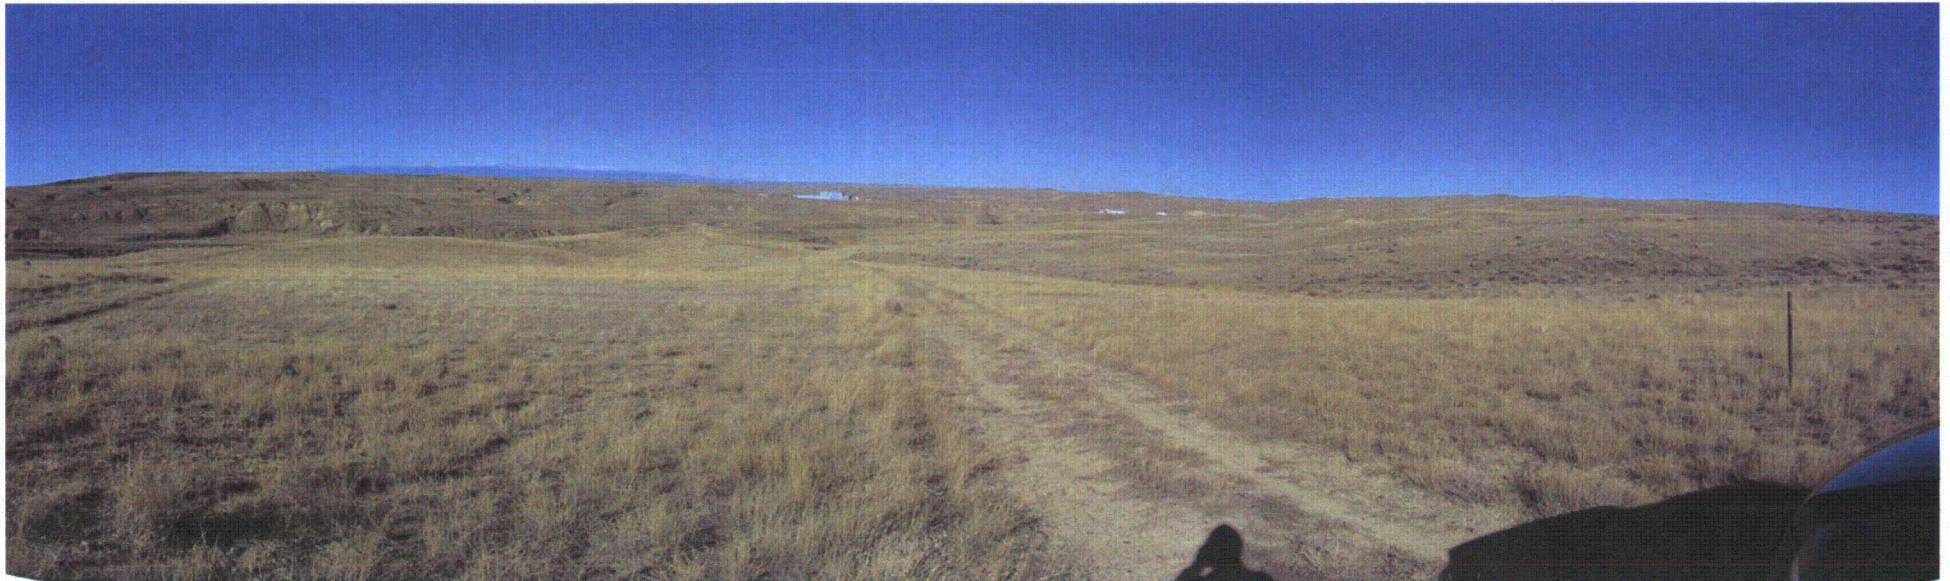
In Units 7, 8 and 9, the well field buildings, buried trunklines and manholes leading to the buried trunklines have been removed (Photo No. 1). The buried pipelines leading to each well in Unit 7 have now been removed as well. A few wellheads remain to mark the locations of the buried piping which still remains in the ground in Units 8 and 9. Some power poles remain, but others have been removed.

Photo No. 1 Looking west to north across Irigaray Wellfield Units 8 and 9. All of the wellfield buildings have been removed along with all underground piping and wiring. A few well heads remain for orientation purposes, but the well casings themselves have been cemented up. Topsoil was salvaged from these wellfields over 30 years ago and stockpiled. The Irigaray plant buildings are visible in the center distance.
