**RE: Irigaray-Christensen Operations 2009 Annual Inspection Report, Permit No. 478**

## ANNUAL INSPECTION REPORT

**Subject:** Cogema Mining Inc.'s (now Uranium One, USA) Irigaray and Christensen In Situ Uranium Operations

**Permit No.:** 478

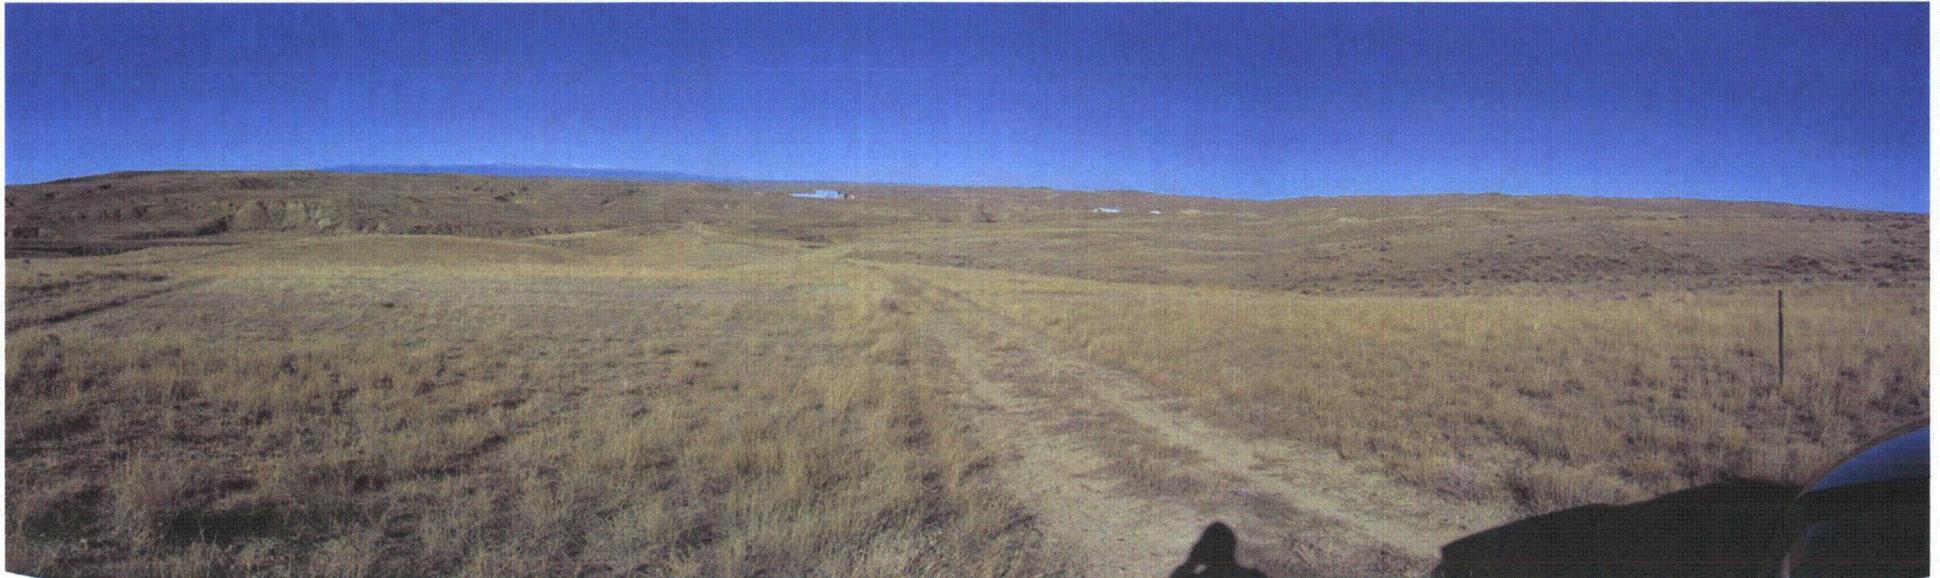
In Units 7, 8 and 9, the well field buildings, buried trunklines and manholes leading to the buried trunklines have been removed (Photo No. 1). The buried pipelines leading to each well in Unit 7 have now been removed as well. A few wellheads remain to mark the locations of the buried piping which still remains in the ground in Units 8 and 9. Some power poles remain, but others have been removed.

**Photo No. 1** Looking west to north across Irigaray Wellfield Units 8 and 9. All of the wellfield buildings have been removed along with all underground piping and wiring. A few well heads remain for orientation purposes, but the well casings themselves have been cemented up. Topsoil was salvaged from these wellfields over 30 years ago and stockpiled. The Irigaray plant buildings are visible in the center distance.
