Crystal River Unit #3 Containment Investigation and Repair

June 30, 2010

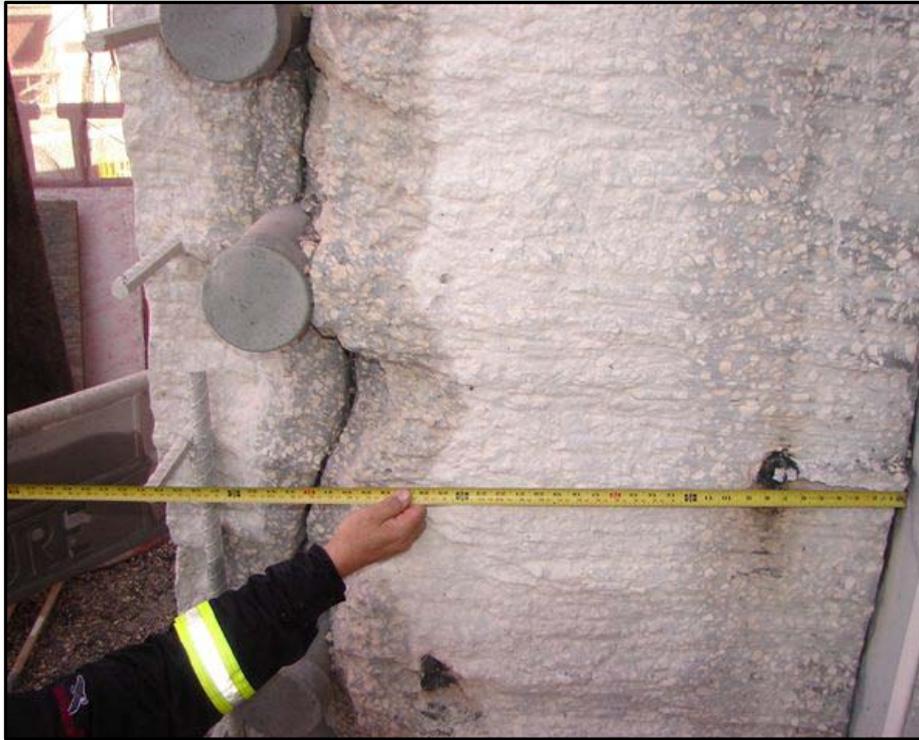
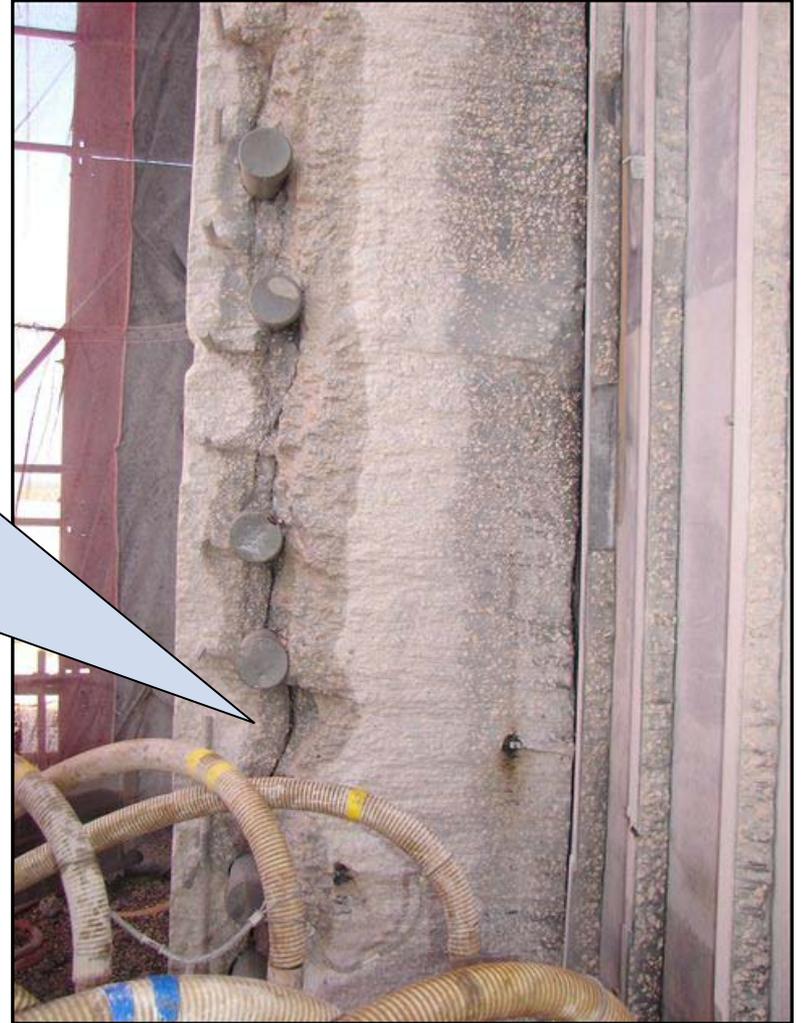
Delamination Close-up

- **Failure Modes 7.3 & 7.4 – De-tensioning Scope and Sequence** (*Root Cause*)
 - The number and order of de-tensioned tendons resulted in redistribution of stresses in the containment wall that exceeded tensile capacity, initiating the delamination
- **Failure Mode 7.5 – Added Stress Due to Removing Concrete at the Opening**
 - Removal of concrete increased the stress in the remaining concrete, contributing to the final extent of delamination

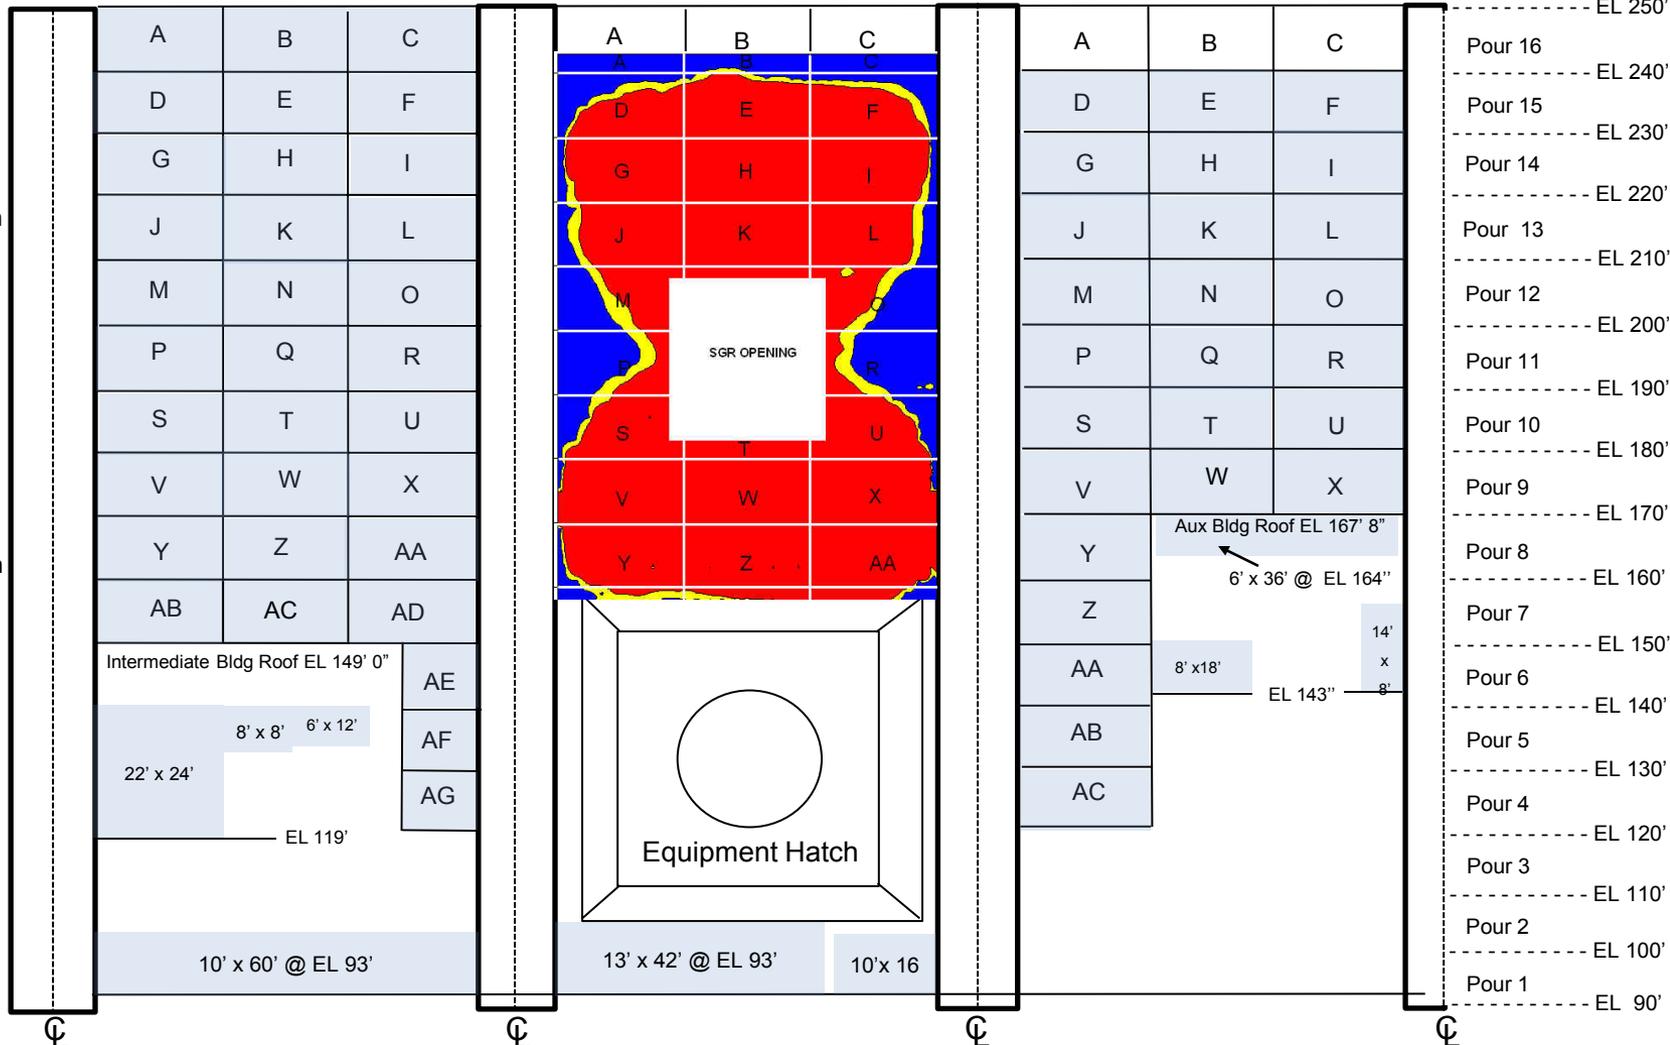
Containment "Unfolded" – Buttress 2 to 5

Conclusion – IR scans with confirmation core bores identified delamination only in the Buttress 3-4 span above the Equipment Hatch, as shown in red above

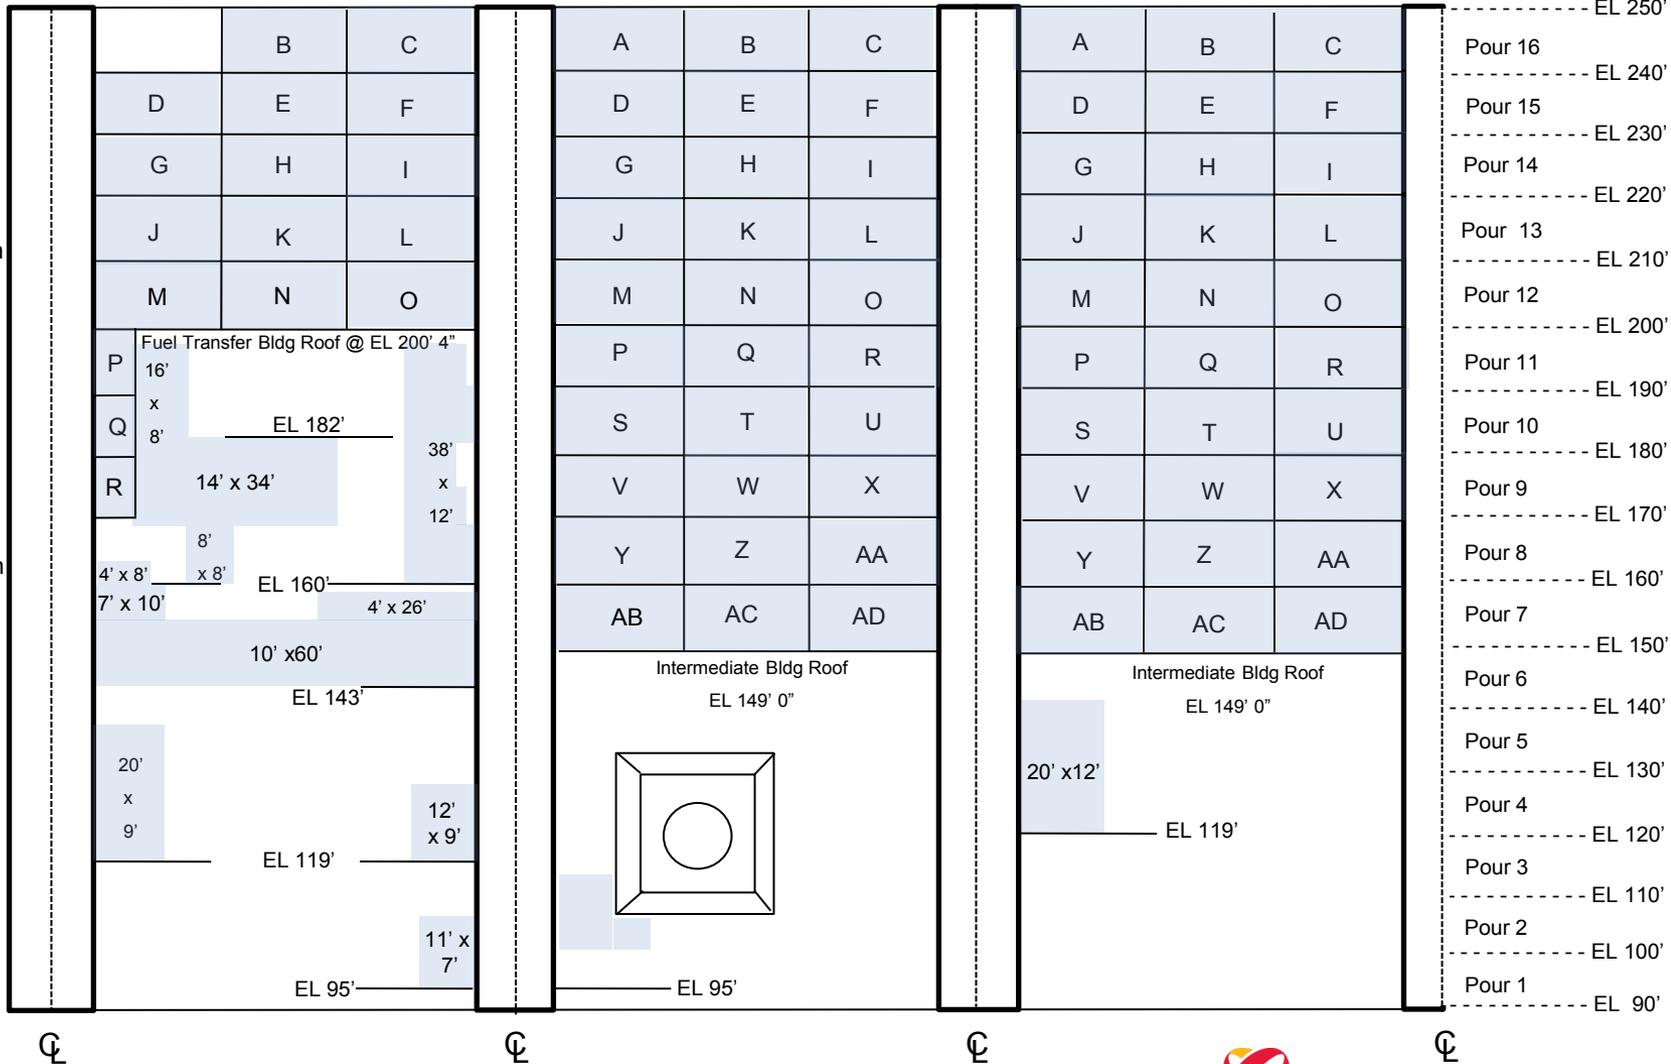
Containment "Unfolded" – Buttress 5 to 2

Conclusion – No delamination identified in these Buttress spans

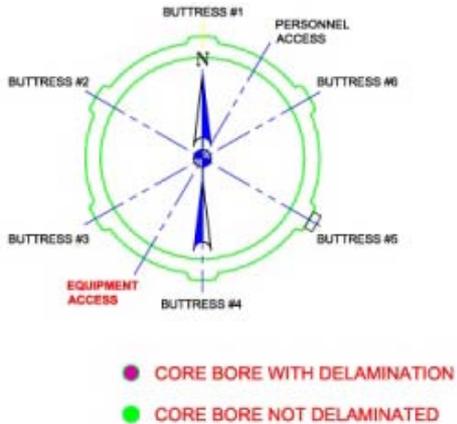
Core Borings

Conclusion – Physical observation of core boring has validated the delamination boundary, as accurately predicted by IR.

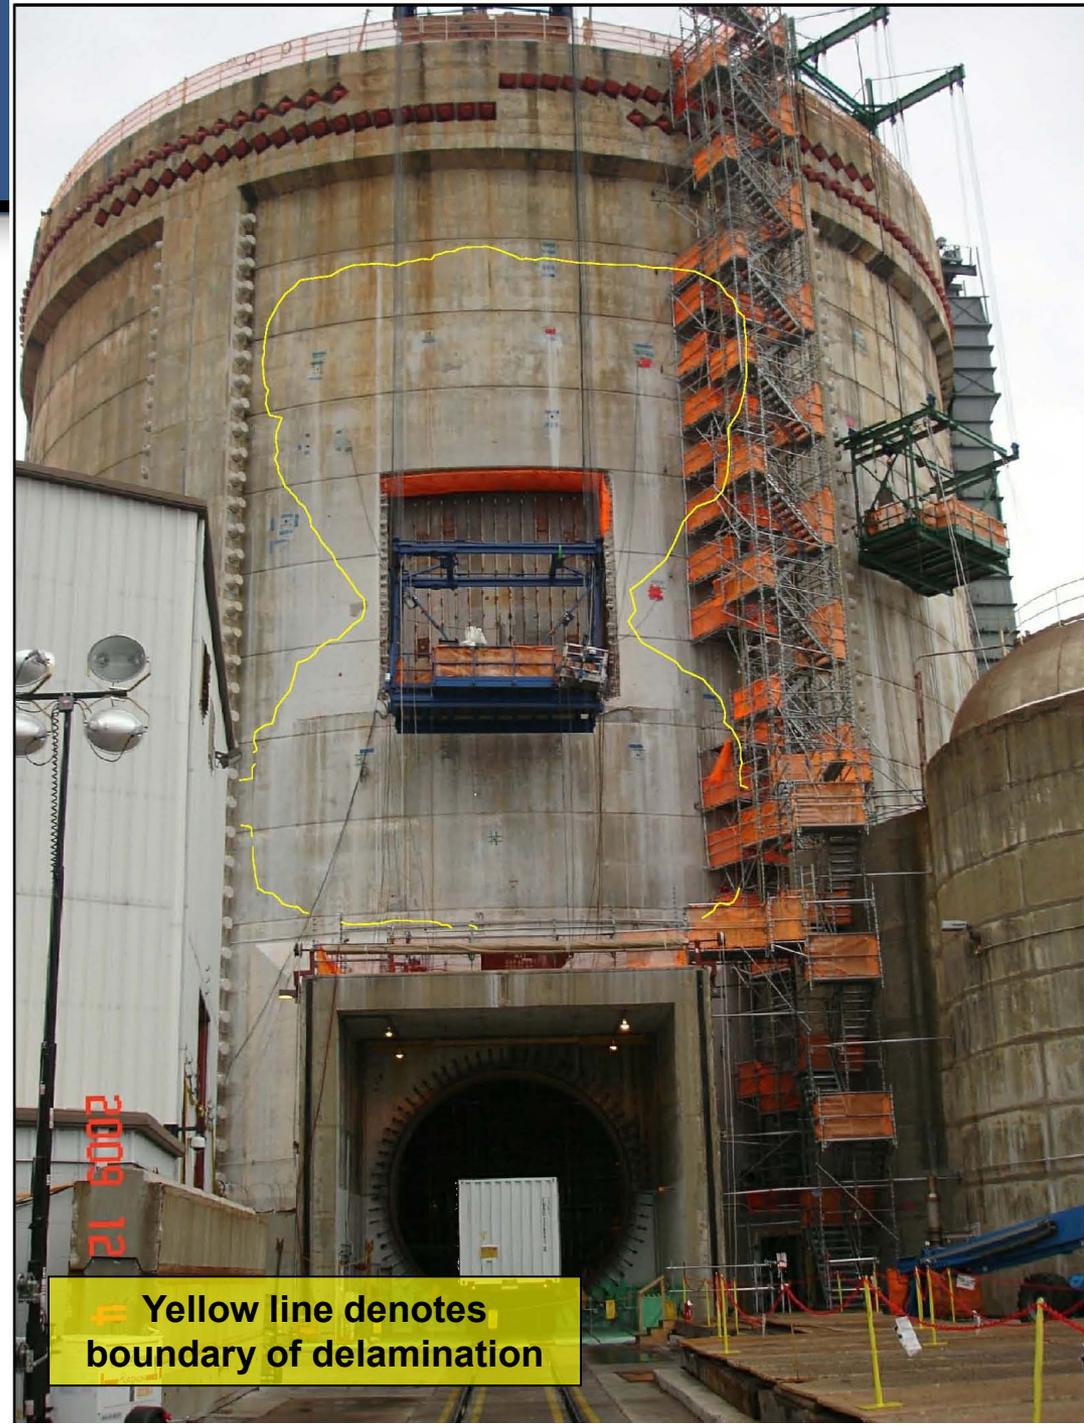
SGR Opening

Yellow line denotes
boundary of delamination

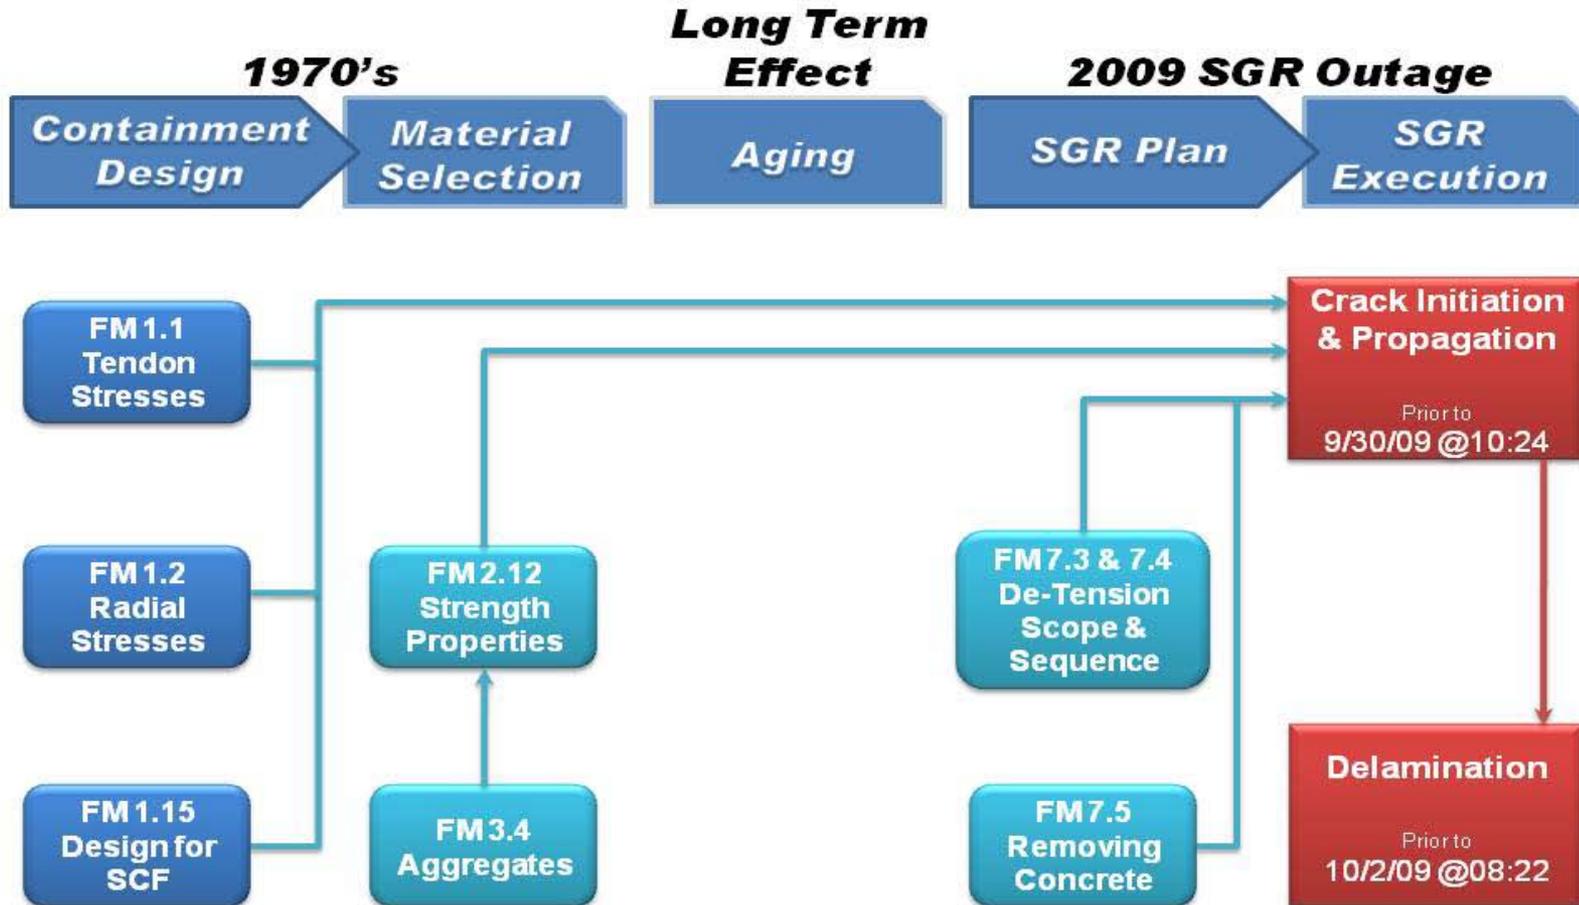
FAILURE MODES TIMELINE

- **Root cause:** De-tensioning scope and sequence resulted in redistribution of stresses that exceeded tensile capacity
 - Could not have been predicted based on existing information and models at that time
- **Conclusion:** Delamination occurred as a result of outage activities to create an opening for steam generator replacement

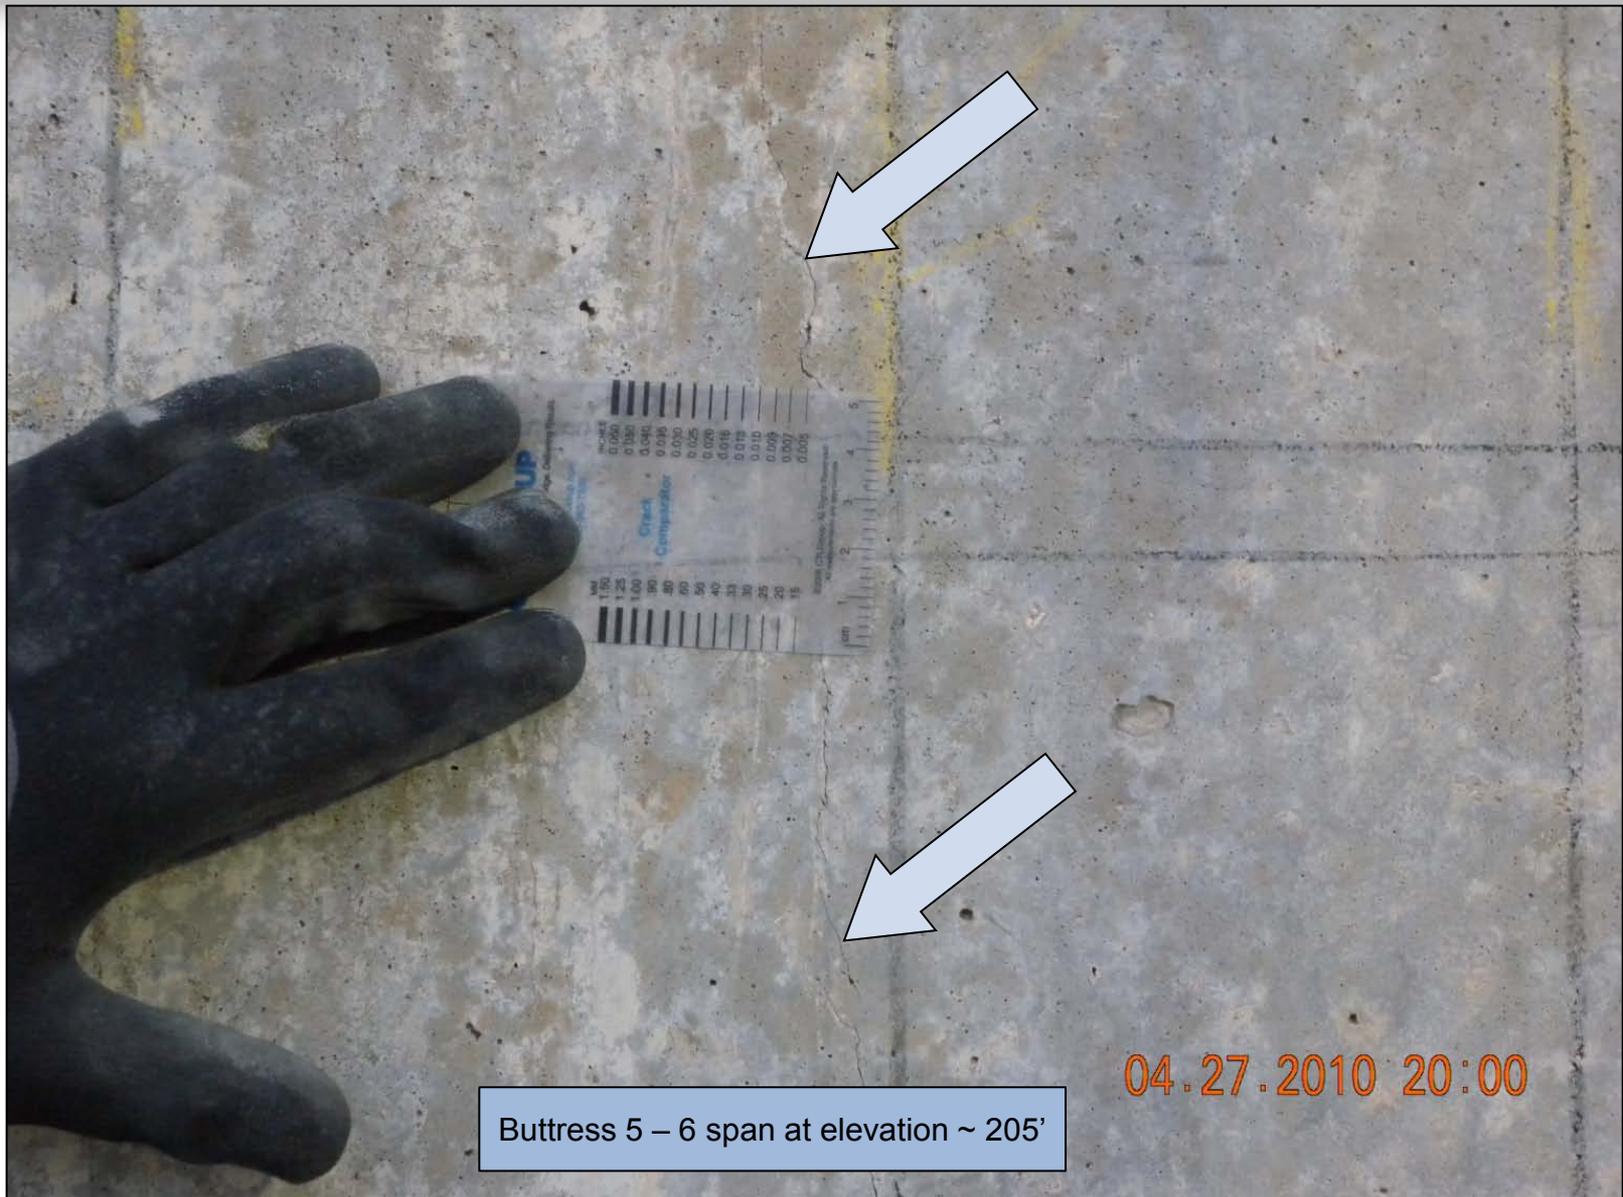
Hairline Cracking Outside of Restoration Area

- Vertical hairline cracking was identified in de-tensioned areas of the containment cylinder outside Bay 3 - 4
 - Observed after expanded de-tensioning
 - Located near some vertical tendon locations
 - Width < 0.010" (as measured at surface and within concrete core holes)
- In all areas of the containment cylinder still tensioned - no observations of vertical hairline cracking during detailed inspections

- Stress Reversal - Initial Tensioning to De-tensioning
 - After initial tensioning - the steel liner, reinforcement and tendon conduits increased in compressive elastic strain due to concrete creep
 - After de-tensioning - the steel liner, reinforcement and tendon conduit elastic strains reversed, but the concrete did not due to creep
 - Result was tensile stress in the concrete at the vertical tendons that exceeded tensile capacity
