Department of Environmental Quality

Subject: April 2010 Inspection Report, Cameco Resources, Permits 603 and 633

**APRIL 2010 INSPECTION REPORT
DISTRICT 1/LAND QUALITY DIVISION**

COMPANY: Cameco Resources (CR), Highland Ranch, Permit #603
& Smith Ranch, Permit 633

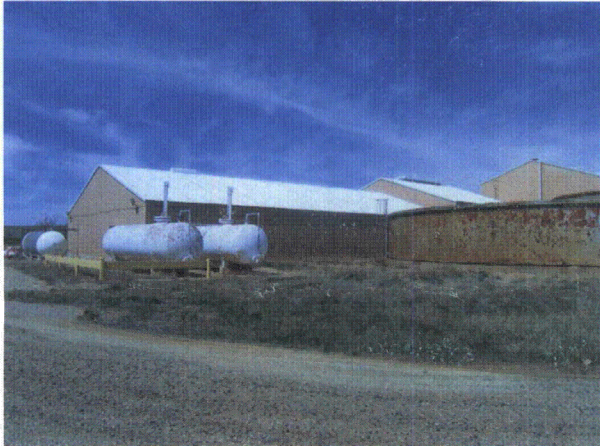
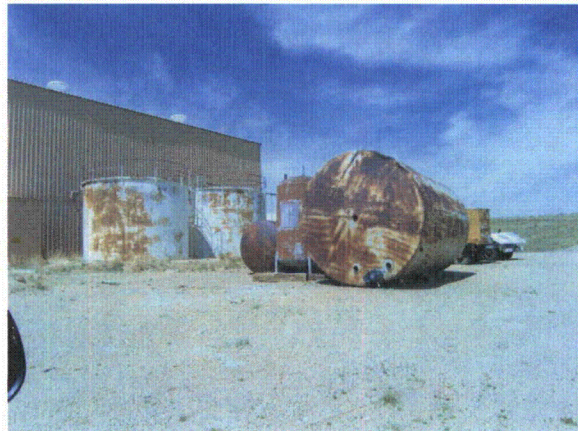
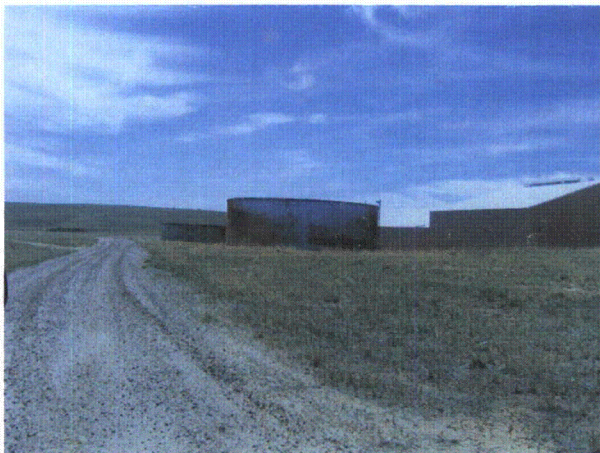
HUP Processing Plant and Offices - The facilities are abandoned, however, the office building is currently being used to house historic records for the mine. The processing plant was historically used for the open pit mine and at a later date for insitu mining. It was confirmed by CR that it has not been decontaminated. Used tanks and other old equipment are being stored on the east side of the plant including tanks that were used for ammonia, nitrogen, raffinate (product recovery solution), and reverse osmosis (**Figure 1**). The area is fenced with a locked gate at the entrance leading to the gravel parking area and facilities. It is apparent the facilities have been neglected for a long period of time and would require substantial structural inspection and most likely considerable renovation if they are to be used again. **Of greater concern is the need to decontaminate the tanks and processing plant. CR must submit a proposal to reclaim the processing plant and offices.**

Figure 1a Storage tanks at Highland Processing Plant

Figure 1b Storage tanks at Highland Processing Plant

Figure 1c Storage tanks at Highland Processing Plant

- 1 The LQD formally requested a plan to reclaim the HUP Processing Facilities through the 2008-2009 Annual Report Review. A deadline for the plan submittal was set for June 1, 2010. CR requested through a letter dated May 25, 2010, an extension until September 30, 2010 to submit the reclamation proposal. LQD grants this request and will expect a comprehensive proposal to address the entire facility. If CR intends to use the facility in the future a proposal for renovation will be required for LQD review and concurrence prior to re-opening the facility. CR also requests a meeting to discuss the proposal. Please contact the permit coordinator to schedule the meeting

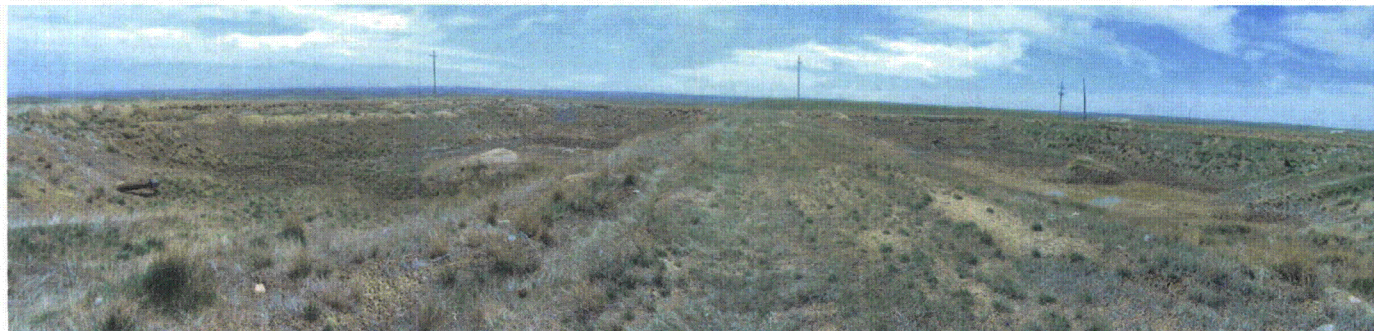
Radium Ponds – The ponds were observed and it was noted that one pond had a small pool of water in the bottom collected during recent precipitation; the other was dry (**Figure 2**); both ponds were well vegetated. No reclamation work has begun. CR is in the process of training new staff to operate the new spot scanner so that on-site sampling can be completed as excavation occurs. **CR must develop and submit a proposal to reclaim the ponds for LQD review prior to beginning reclamation.**

Figure 2 Radium Ponds

- 2 Radium pond reclamation was also addressed in the May 25, 2010 letter to LQD. The letter states a schedule for the reclamation will be sent to LQD by July 30, 2010. NOTE: LQD requests a reclamation proposal for the selenium pond addressing the volume of contaminated material to be excavated, disposal plans for the material, proposal for re-grading the topography, replacement of contaminated soils (source and volume) and a seeding schedule. This proposal will need to be reviewed and approved prior to initiating reclamation of the ponds so that LQD can provide concurrence with a future request to remove the pond reclamation from liability in the surety.

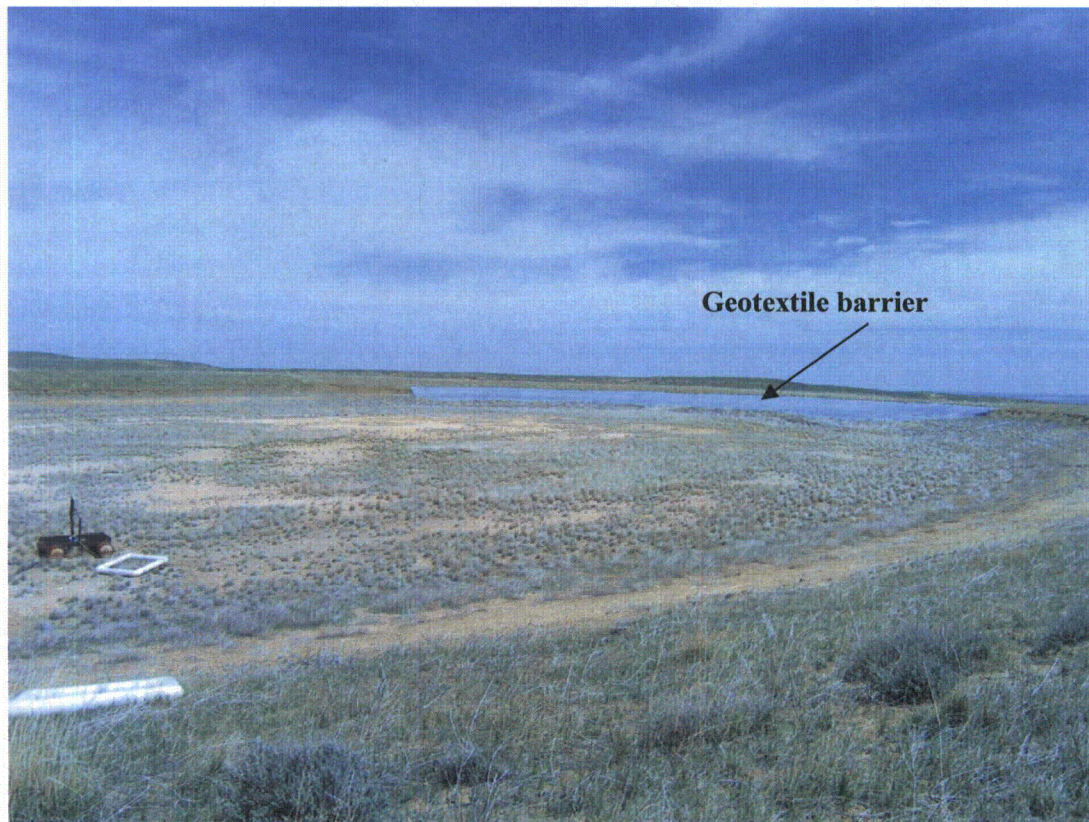
PSR-1 and Irrigator 1 – The pond was dry with limited vegetation. No erosion was observed on the side slopes of the pond. A French drain was installed to mitigate a leak at some time during the use of the pond. The geotextile is still secured to the slope (**Figure 3**). It was installed to help control the leak. Several shallow wells are located down gradient of the leak (**Figure 4**). The irrigator was observed from a distance on the irrigation site and was not in use.

Figure 3 View of PSR-1, dry. limited vegetation

- 3 PSR-1 Irrigator and Pond. These facilities also require a formal proposal for reclamation and should be addressed in the HUP Facilities proposal. If CR intends to use the irrigator or pond in the future a proposal for renovation will be required for LQD review. Please ensure the shallow wells are included in the surety estimate for the 2010-2011 Annual Report.

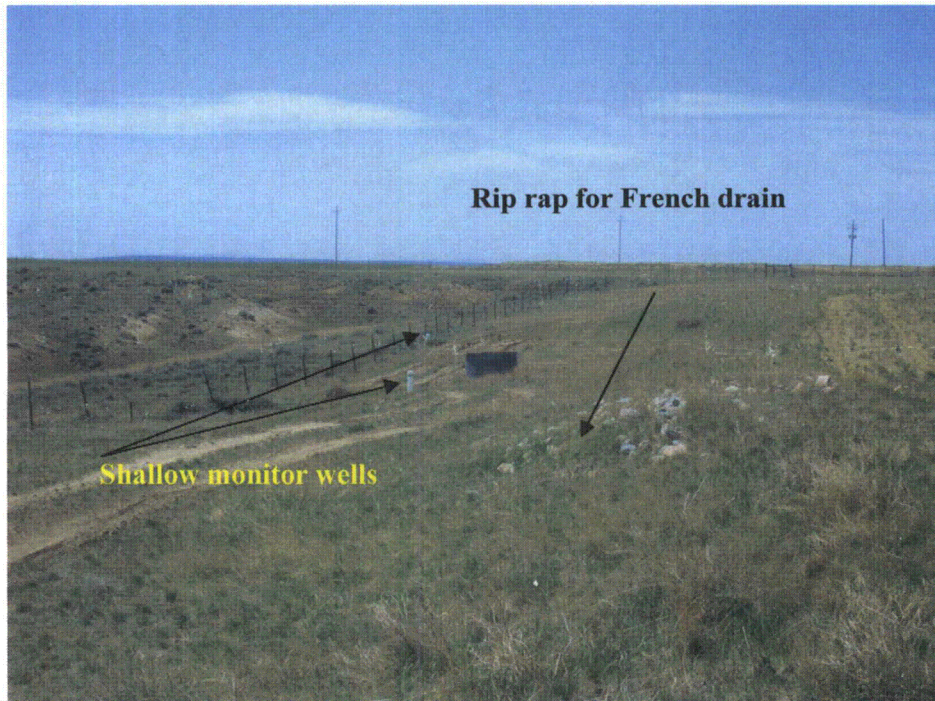
Figure 4 View of French drain rip rap and shallow wells.

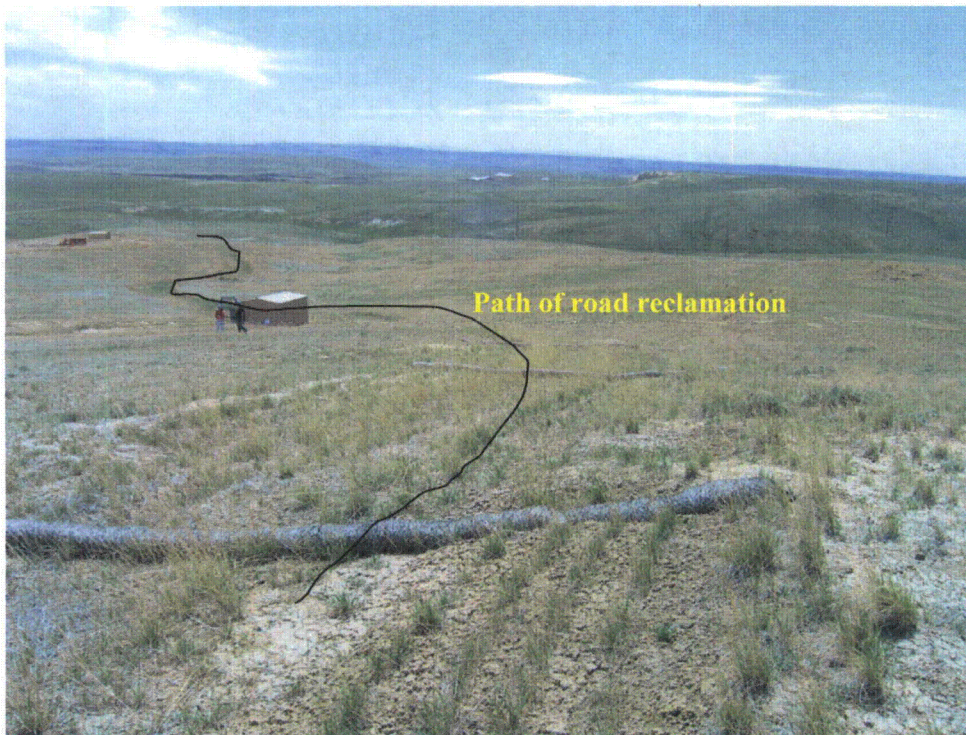
Mine Units A & B – The reclamation of the repaired road identified during inspection in 2008 was observed. The re-vegetation has been successful and has stabilized the slope. No erosion was found along the reclaimed road. Straw waddles remain along the slope to aid stabilization until the vegetation is well established (**Figure 5**).

Figure 5 Revegetated road disturbance, A/B Wellfield

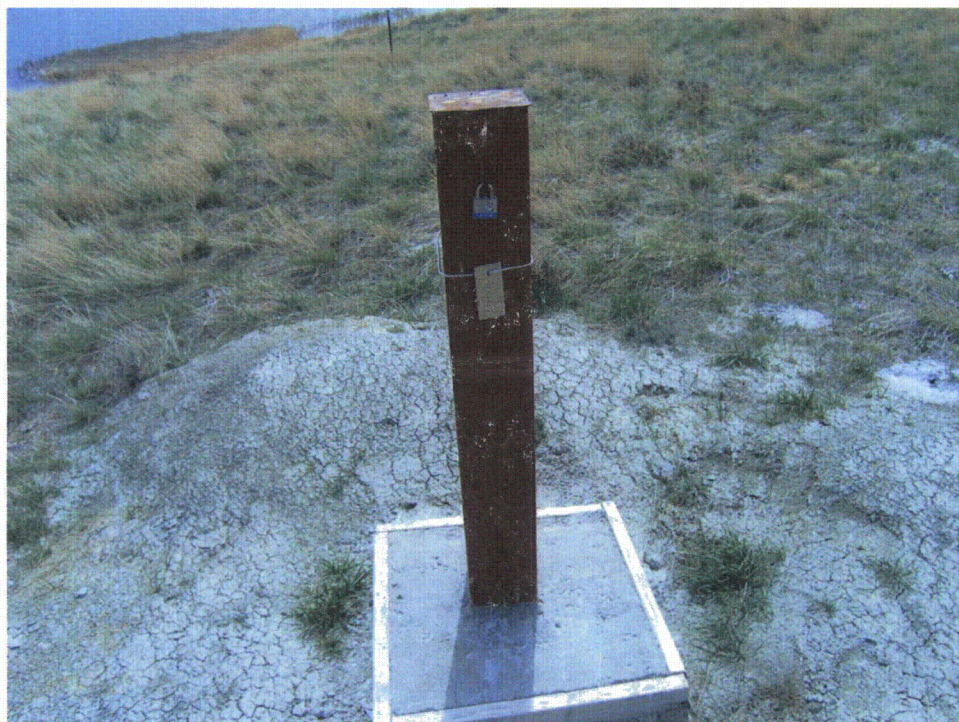
PSR-2 and Irrigator 2 – The irrigator was noted to be located on the south end of the irrigation circle and was not in use at the time of the inspection. CR intends to begin using the irrigator within the next few weeks. CR was required by the NRC to install additional monitoring wells to evaluate the potential leak of the pond. CR did not propose the wells to the LQD for review prior to installation. The locations were inspected and verified (**Figure 6**). **CR must ensure these wells are included in the next annual report with a detailed discussion explaining their purpose and include in a revised surety if not already included.**

Figure 6 New monitor well at PSR-2

- 5 PSR-2 Irrigator and Pond. The irrigator was not in use during the inspection. Discharge from the selenium plant was going to the pond. There are four new wells installed around the pond that were not reviewed by the LQD. These wells must be explained in the next annual report and included in the surety estimate.

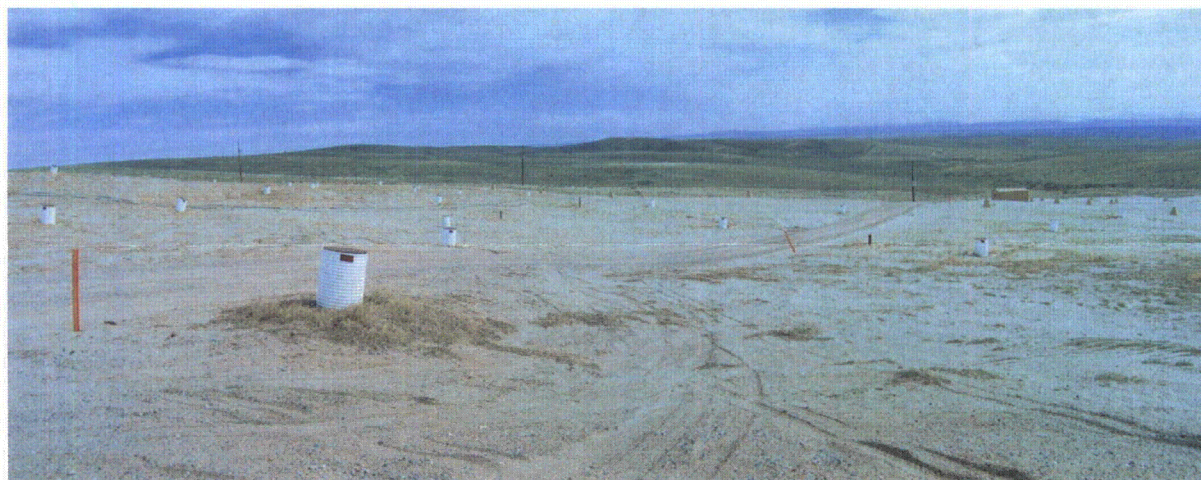
Mine Unit K – The surface disturbance around Header House 8 remains un-vegetated. The soil conditions in the wellfield are very sandy which is inhibiting the revegetation (**Figure 7**). The reclamation staff is continuing to work on K-Wellfield. Header Houses K-8 and K-6 were inspected and found to be operating as evidenced by the flow gauges. The inspection sign-in sheet were current with complete documentation. **It was stressed that sediment controls should be installed prior to spring/summer storm events that could lead to erosion on the sandy slopes. The culvert at the entrance to MU-K remains on a schedule to be cleaned out.**

Figure 7 MU-K; poor revegetation due to sandy conditions

- 6 Please remove the outdated tags on the flow meters in Header Houses in Mine Unit I.
- 7 LQD continues to wait for the final report responses for the Mine Unit C Bioremediation Project which was due in mid-June. There are concerns with wellfield restoration that need addressed. LQD requests that the NaS treatment be delayed until LQD is confident with the proposed treatment.
- 8 Mine Unit K, Header House 8 area re-vegetation efforts have been unsuccessful. The soils are very sandy and will require sediment controls be installed to protect the surface from erosion until revegetation can be established.

The culvert at the entrance to MU-K is near full and will need to be cleaned out.
