PROMPT INVESTIGATION REPORT

1. **IR Number:** 465719
2. **IR Title:** Braidwood Prompt Investigation of the loss of water from FRAC farm berm area number one
3. **Chairperson and Team Members:**
 - Chairpersons: Patrick Daly, Rick Leasure
 - Team Member: Jim Smit
 - Team Member: Craig Sprainhower
3. **Event Date:** 03/13/06
4. **Event Time:** 1145
5. **Summary of the Event:**

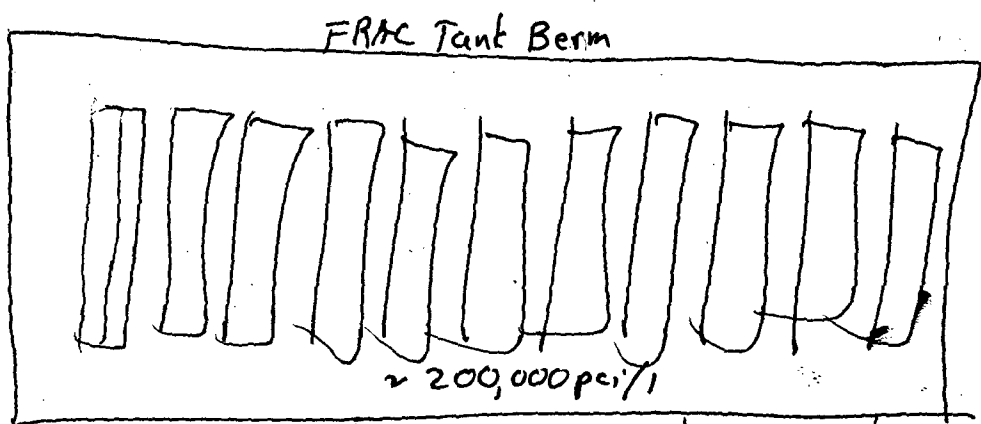
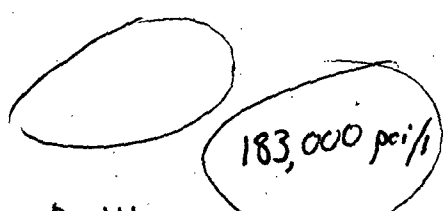
↑ Samples here show less than MDA (MDA is 17700 pci/l)

Puddles from leak last night - pumped back to berm AR 00465719

Leak this morning (sample in progress) AR 00465946

Plans are to pump some FRAC tanks to new tank berm (in progress) to make room in tanks so water in berm can be pumped to tanks. Then they will try to discover source of new leak.
