**PROMPT INVESTIGATION REPORT**

- 1. **IR Number:** 442540
- 2. **IR Title:** Leak at Circ Water Blowdown Vacuum Breaker
- 3. **Chairperson and Team Members:**
  - Chairperson: Gary Dudek (Ops)
  - Investigator: David Gustafson (Plant Eng.)  
Jason Eggart (Chemistry)
  - Contributor: John Kijowski (Plant Eng.)
- 3. **Event Date:** 01/16/2006
- 4. **Event Time:** ~0900

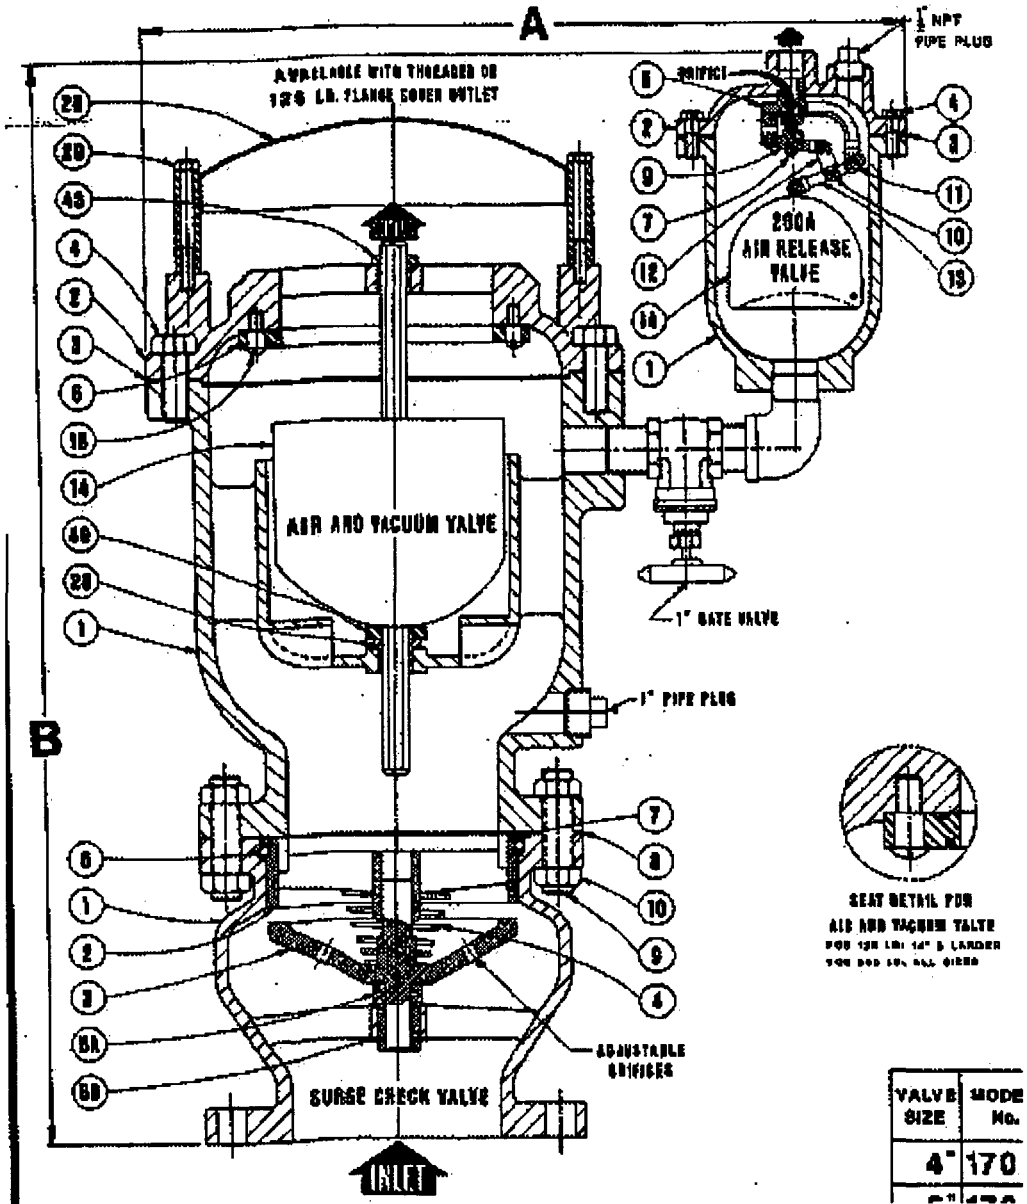
Diagram 1, Typical Vacuum Breaker Arrangement

The Circulating Water (CW) Blowdown system allows lake water to be pumped to the Kankakee River at a normal rate of approximately 25,000 gallons per minute as a means to maintain lake chemistry. The CW Blowdown system is also designed to accept liquid radioactive and sewage treatment releases. The CW Blowdown piping, which runs from the station to the Kankakee River, is buried underground and contains a series of vacuum breaker components placed along the piping run. The vacuum breaker assembly consists of a butterfly isolation valve, surge protection valve, vacuum breaker valve, and an air

release valve (see attached diagram). The vacuum breakers allow air to enter the piping during system shutdown in order to prevent a vacuum condition from damaging the concrete piping and air to exit and water fill the piping during system start up.

The vacuum breaker is a float type design, which seals against an elastomer seat as water fills the pipe and opens when water level lowers. The function of the air release valve is to allow small amounts of air in the piping to be released without unseating the main vacuum breaker float/seal. The isolation, surge protection, and vacuum breaker valves all have flanged joints that bolt in series to the blowdown piping. The air release valve has a threaded joint and is connected to the vacuum breaker via pipe nipples and a local isolation valve. The most probable leakage locations are the vacuum breaker float/elastomer seat either from degradation or debris trapped in seating area, air release valve internal elastomer seat, and flanged/threaded joints. A review of maintenance history on the

leaking vacuum breaker valve assembly, OCW066, determined the vacuum breaker was recently replaced in November 2001. Therefore, as a minimum, a new vacuum breaker elastomer seat and gasket between the vacuum breaker and surge protection valve were installed. It is unclear from the WO documentation if the air release valve was replaced at that time. A more detailed review of the recently performed Work Order is needed to determine if the air release valve assembly was also replaced. This should be addressed in the suggested work group eval associated with IR# 442540.
