**Title:** ELEVATED TRITIUM VALUES IDENTIFIED IN 2 STORM DRAINS DUE TO THROUGH-WALL LEAKS IN UNDERGROUND PIPING

**Unit(s):** Dresden Station Units 2/3

**Event Date:** 06/05/09

**Action Tracking Item Number:** 00928304

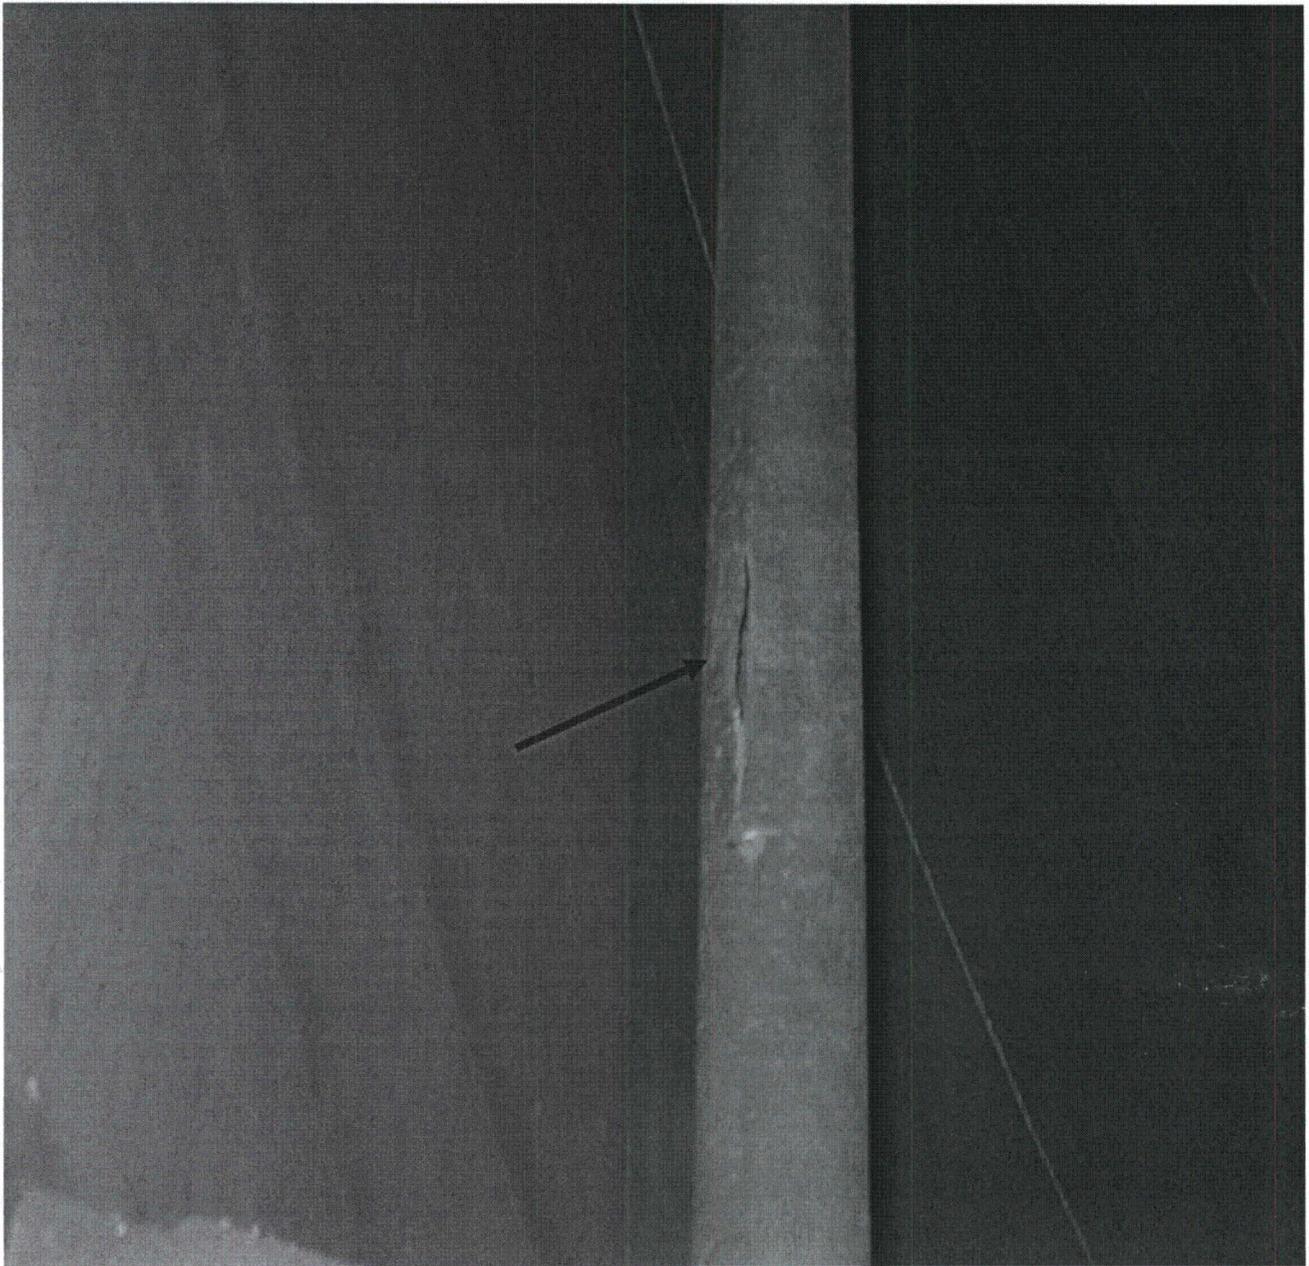
The visual inspection completed on 6/17/09 of the Unit 1 Condensate Storage Tank (CST) standpipe revealed two areas with fish mouth ruptures as well as another area with a through-wall crack. It has been determined that the most probable root cause of these is the freezing of the standpipe during historical operating methods.

It is suspected that the tank was left empty with no heating during weather conditions that were cold enough to freeze the residual water in the pipe causing the indications noted when the pipe was inspected. The reason that this evolution was used was to have the available inventory to allow the drain down to commence in a faster manner. This method of water management hasn't been used in the last seven years and it is believed that the damage to the standpipe is historic in nature.

Lowest Standpipe Failure, ~10 ft off the bottom

Root Cause Being Addressed (Include TapRoot Codes)	Corrective Action to Prevent Recurrence (CAPR) (Include AT Assignment #)	Owner	Due Date
Degraded Standpipe due to freezing	Remove standpipe and install blind flange <b>Work Order: 01241421-43</b>	Maintenance	Complete

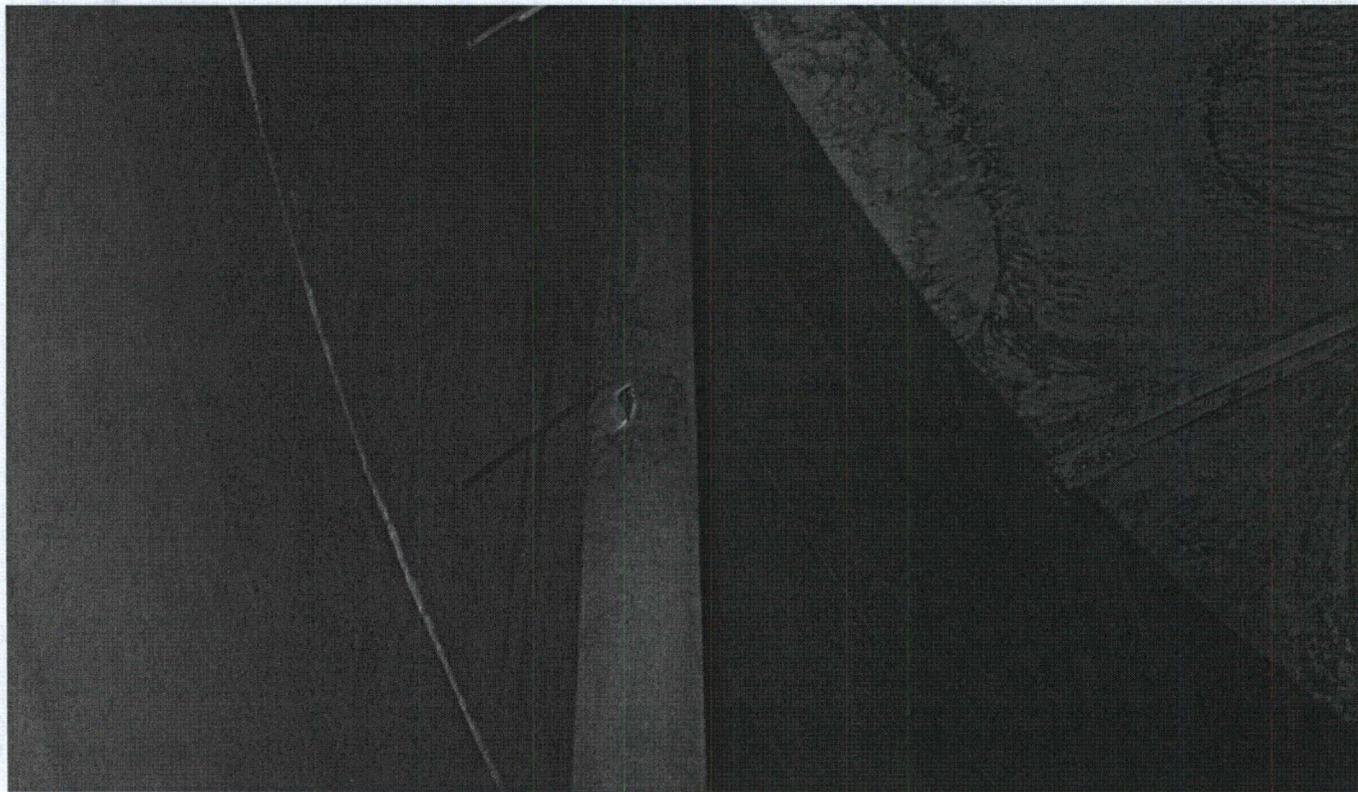
Middle Standpipe Failure.

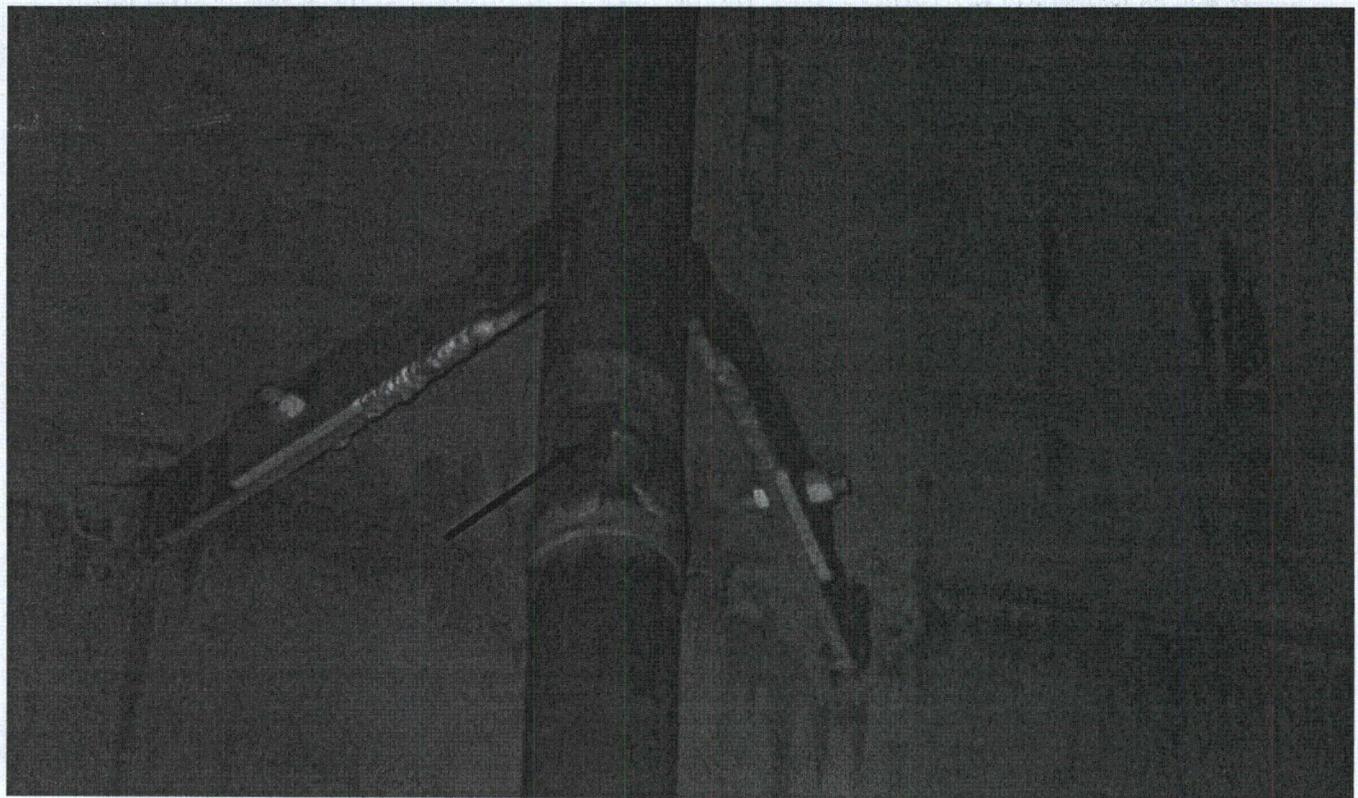
Upper Standpipe Failure

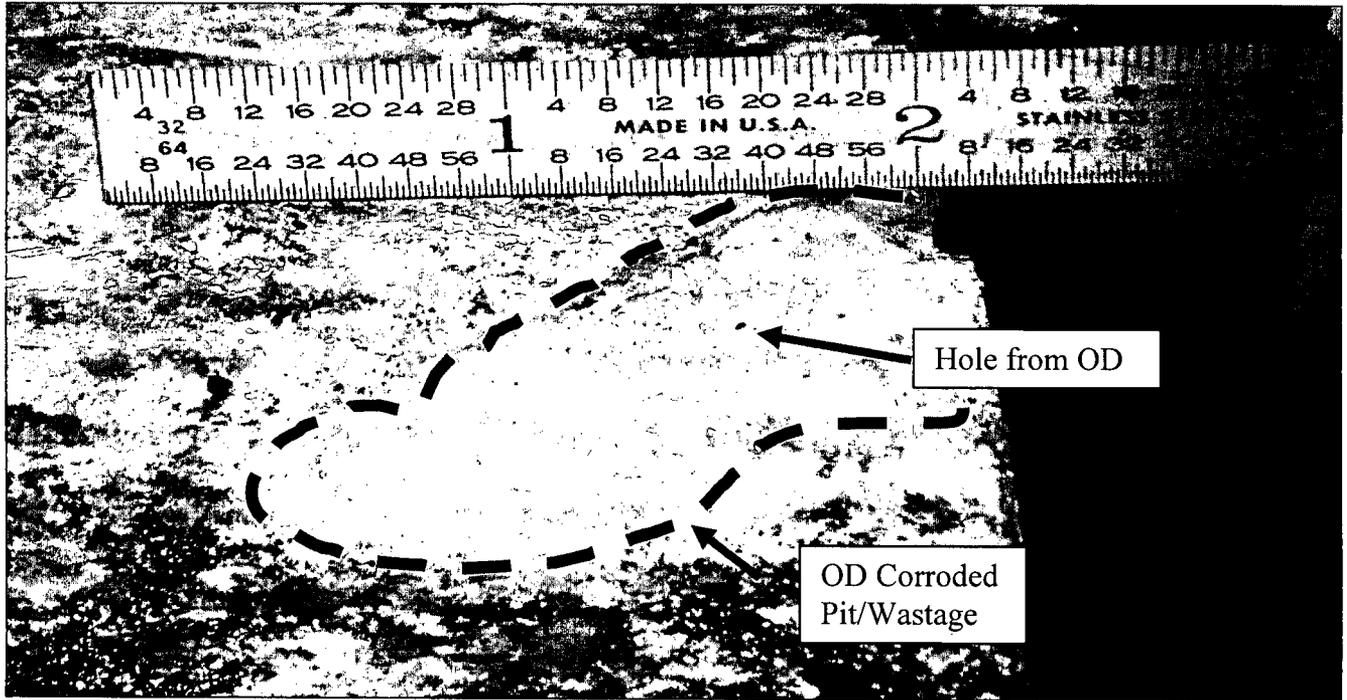
The through-wall leaks identified on lines 2/3-4324-4" and 2/3-3346-24" were the result of external corrosion caused by the degraded protective moisture barrier wrap. The leak on line 2/3-4324-4" was approximately 1/16" in size and was located within a 2" area of external corrosion. The moisture barrier wrap installed on this line was a bituminous coating. Initial inspection of the leak location identified that the protective moisture barrier wrap was degraded to the extent that a section of the wrap was missing from this specific area. The leak on line 2/3-3346-24" was approximately .2" in size and was located within a 1" area of external corrosion. This area was not identified by G-scan due to the limitations of the technology, specifically the distance this indication was from a circumferential weld. Corporate engineering is addressing the limitations identified with this technology and have also published letter VPE090609 titled "Oyster Creek Guided Wave Inspection Root Cause which provides a status of lessons learned with guided wave and the implementation plan in support of the buried piping program at Exelon plants. The moisture barrier wrap installed on this line was a thin form of tape coating. This coating had degraded and fallen off the pipe in certain areas and had numerous areas where the taped had curled edges. Neither Design Engineering nor Sergeant & Lundy Engineers could find the pipe coating specifications for either coating. Moisture barrier wrap degradation can be attributed to various causes, soil stresses, loss of electrical resistance, improper application, improper backfill procedures, contaminants in soil, biodegradation of the adhesive and age. Although the cause of the degradation could not be determined it is believed that the most probable cause of the degradation can be attributed to biodegradation of the adhesive and age. This was determined by the brittleness of the bituminous coating, which resulted in cracking of the coating. Per previous conversations with an industry coatings expert, the life

Through-wall leak from OD
