UNITED STATES  
NUCLEAR REGULATORY COMMISSION

SUBJECT: FORT CALHOUN STATION - NRC FOLLOWUP INSPECTION - INSPECTION  
REPORT 05000285/2010007; PRELIMINARY SUBSTANTIAL FINDING

Failure to Maintain External Flood Procedures

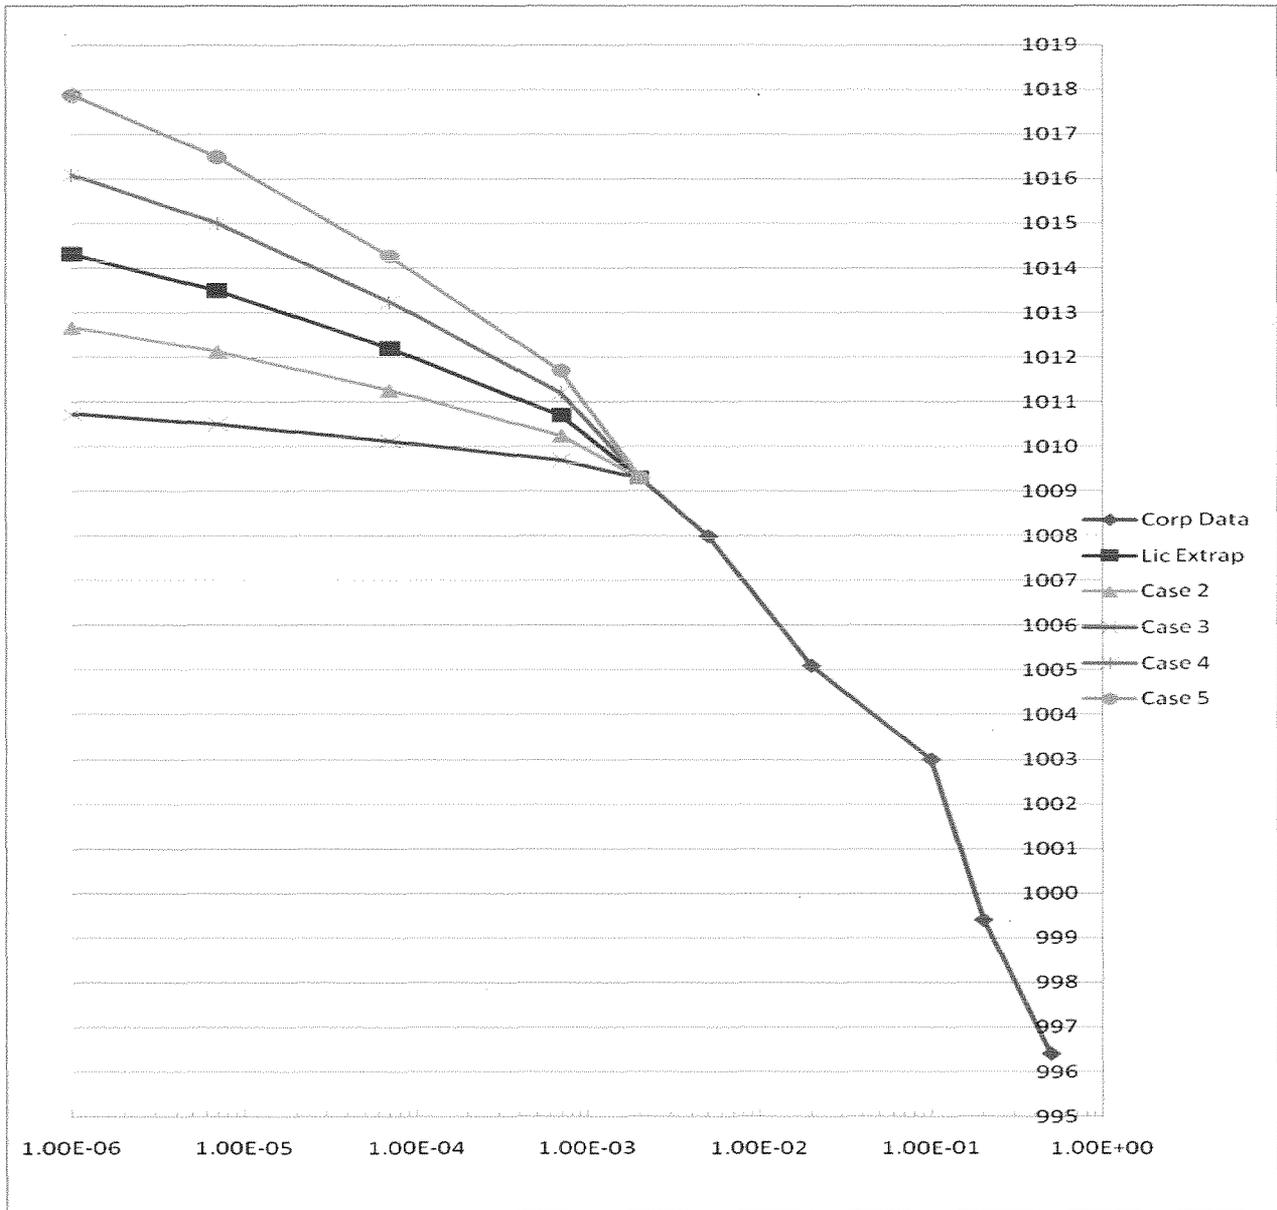
### Frequency Extrapolations – Height versus Logarithm of Flood Frequency Excedance

It's important to note that Case 1 may be unrealistically low. After almost 100,000 years of additional exposure, the flood elevation at the 1 E-5/year point was a little over 1 foot above that predicted by the Army Corps of Engineers at the 1/500 year point. Likewise, Case 5 may be unrealistically high. The plotted line deviated from the Army Corps of Engineers' estimates at a sharper angle.

Case 3 was the best estimate case specified by the licensee.

Cases 1 and 2 were sensitivity cases that assumed that the licensee’s best estimate was overly conservative.

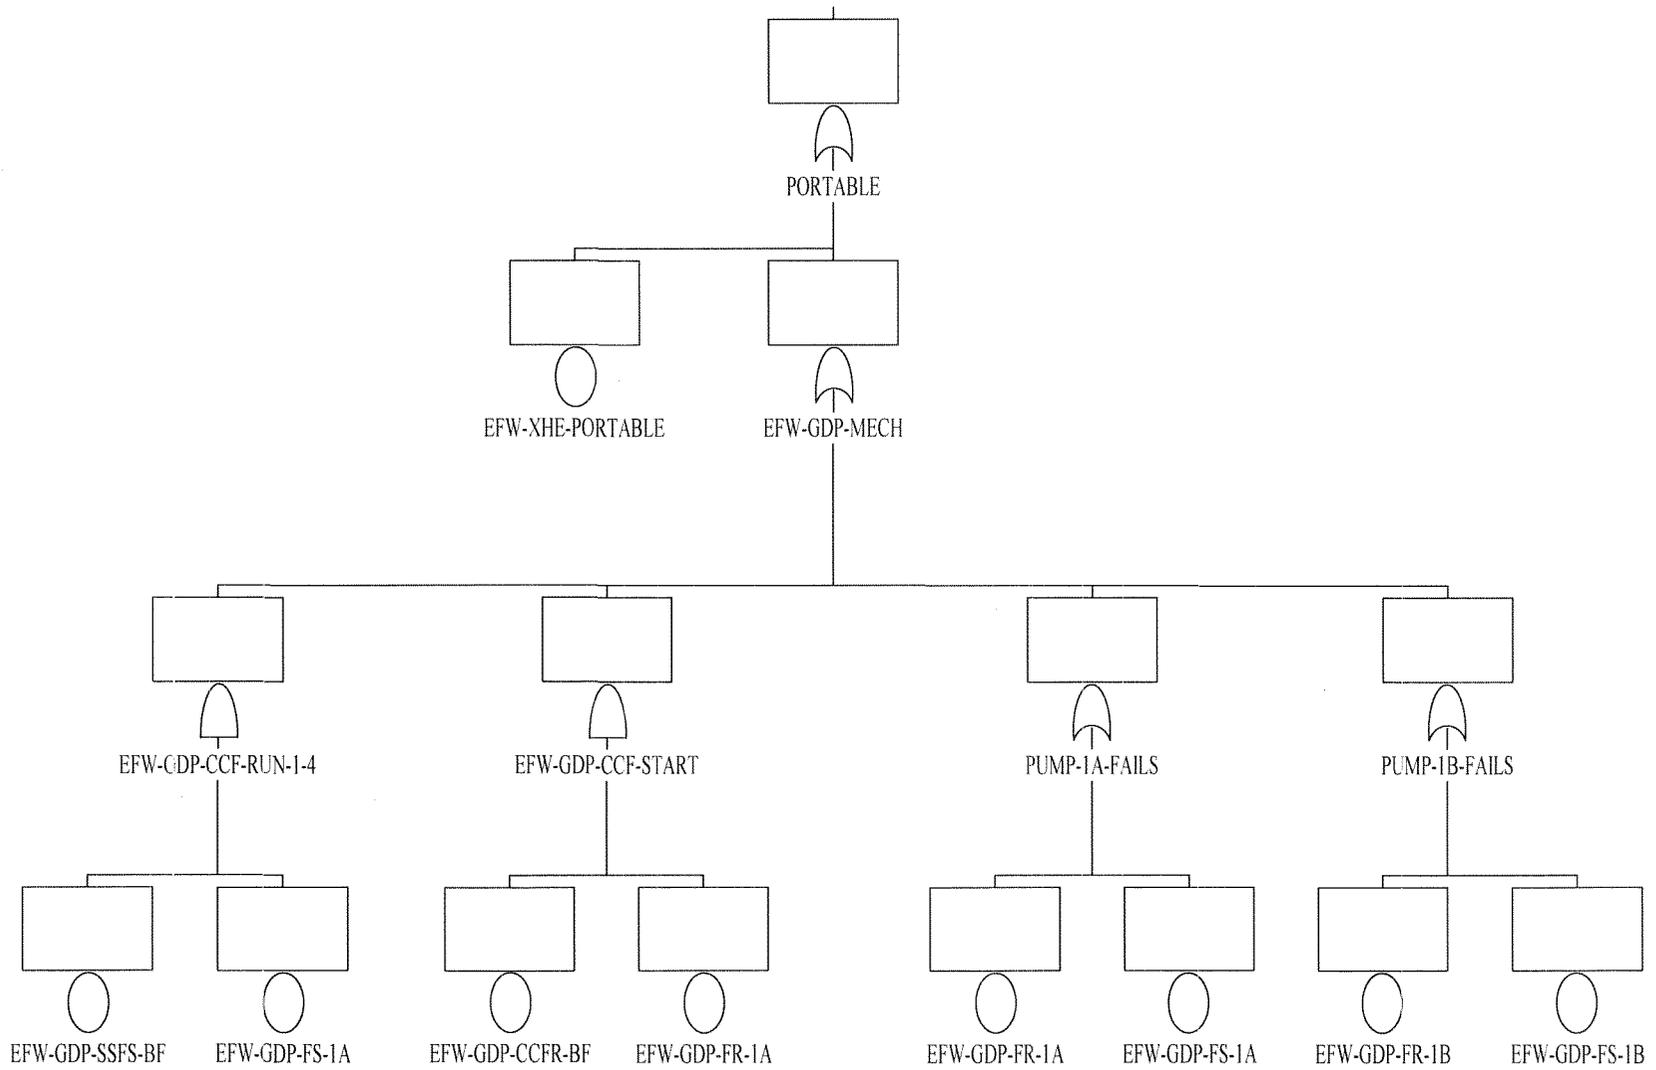
## Fault Tree 1 Gasoline Powered Pump System

- g. A fault tree to estimate the failure probability for the gasoline-powered pumps was constructed and solved using the simplified plant analysis risk (SPAR) model. After flooding greater than 1010 feet MSL, the gasoline powered pumps would be the only equipment available to provide makeup water to the steam generators. The fault tree assumed:

- Both pumps must function for the action to be successful.
  - Human error probabilities associated with installing the gasoline powered pump system were evaluated using NUREG/CR 6883, "The SPAR-H Human Reliability Analysis Method," August 2005 (Attachment 3). From this evaluation, the analyst inserted a human error probability basic event into the system fault tree. The SPAR-H worksheets were broken up into two sections, a "diagnosis" section and an "action" section. The diagnosis section evaluated the probability that operators would fail to diagnose the problem, such that mitigating actions would not be taken. The action section estimated the probability that operators (or craftsmen) would fail to successfully install and operate the system.

- The analyst assumed that operators would properly diagnose the flood.
    - The "action" portion of the SPAR-H worksheet was much more difficult to perform and the probability of failure was over-riding (when compared to the diagnosis portion).

- The analyst used the licensee's estimates for gasoline pump failure probability.
  - Other basic components that would have very low failure probabilities, such as manual isolation valves, were not included in the fault tree.

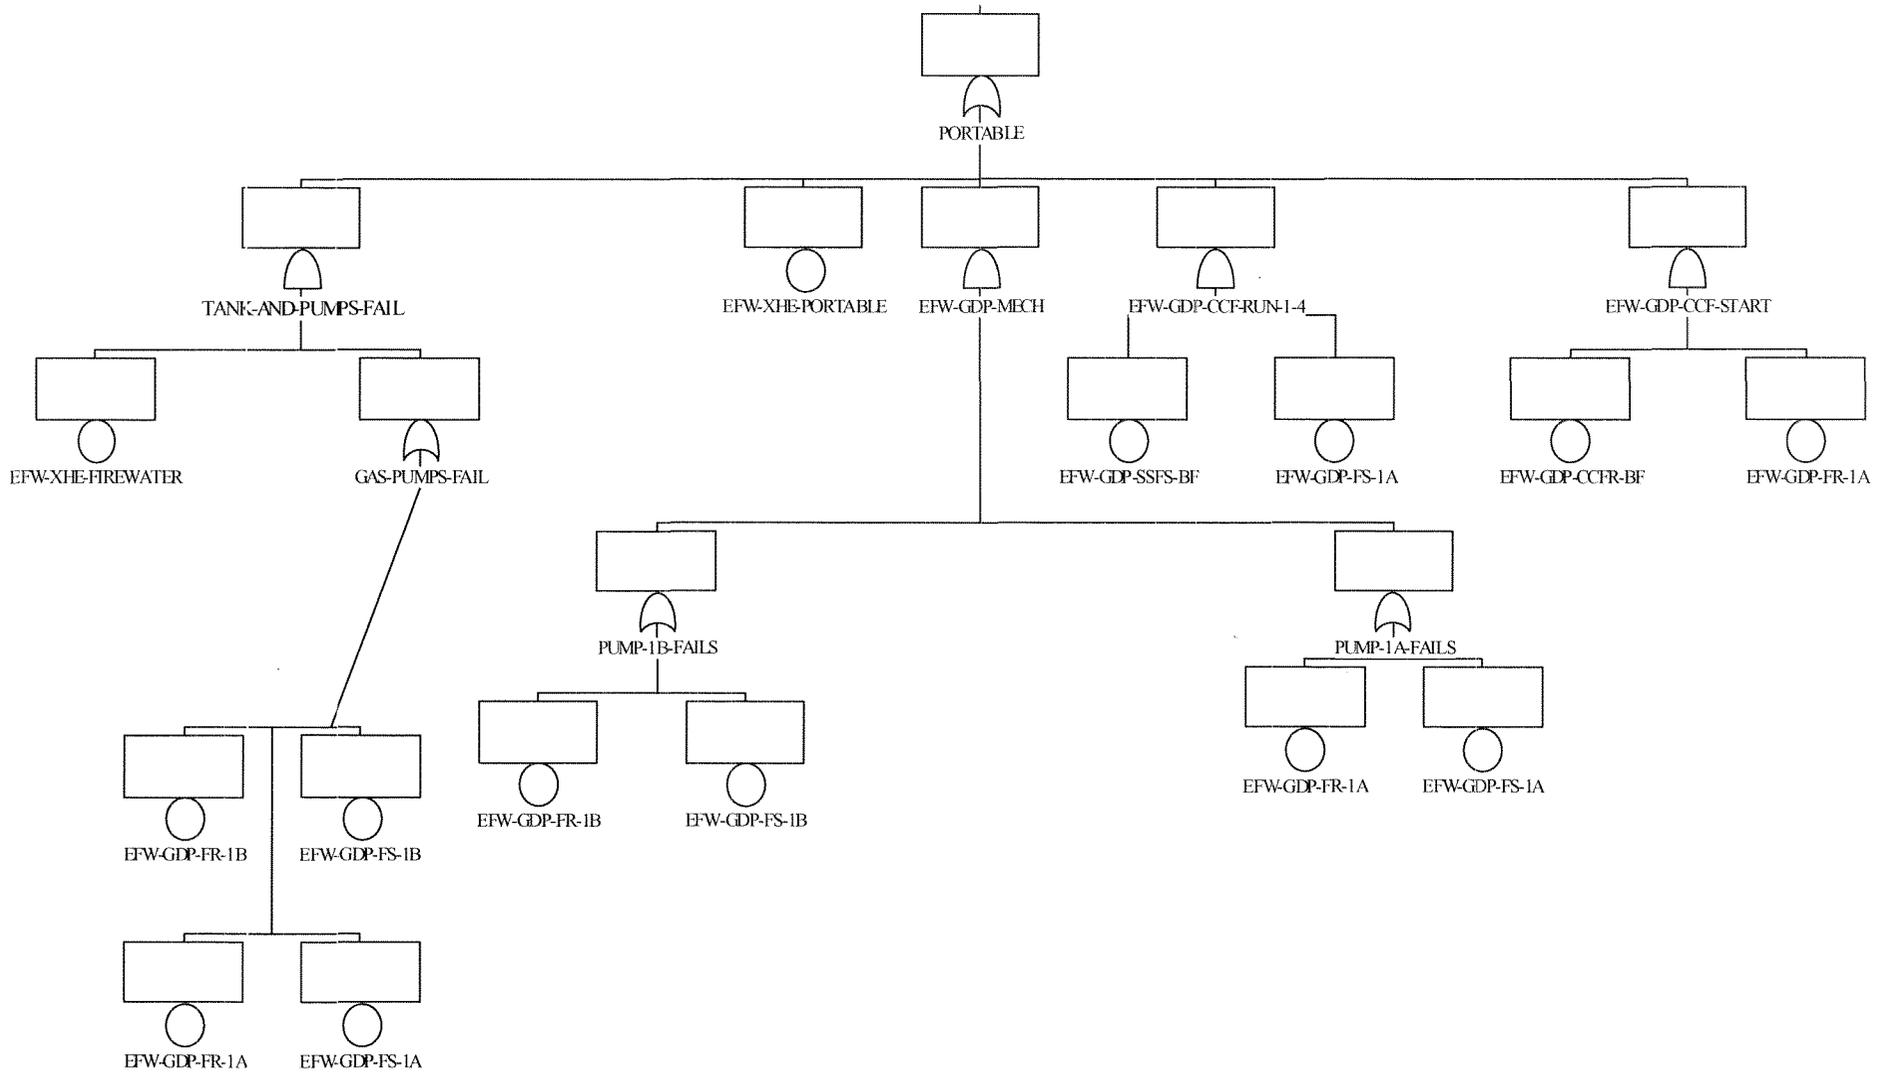
**Fault Tree 2**  
**Gasoline Powered Pump System**  
**with Essential Feedwater Storage Tank Refill from Firewater Tank**

- c. Alternate Method of Refilling Essential Feedwater Tank (SPAR-H 2, Attachment 3): The licensee proposed an alternate method for refilling the essential feedwater tank. The offsite fire water tank (at a higher elevation across the highway) could be used to refill the essential feedwater tank. The advantage of using this tank was that the reliance on the gasoline-powered pumps would be reduced. Instead of requiring that both gasoline powered pumps remain functional (one to fill the steam generators and one to refill the essential feedwater storage tank), the licensee could have one pump fail and still satisfy the steam generator makeup function.

To evaluate the scenario, the analyst adjusted the gasoline power pumps system fault tree so that a failure of both fire pumps would be needed to fail the system (not just one pump). The analyst added a new basic event to account for the human error probability for the new manual actions. The analyst also made other adjustments to model use of the firewater tank. The adjusted fault tree is shown in Attachment 6, second fault tree.
