Edwin I. Hatch Nuclear Plant-Unit 1  
HNP-ISI-ALT-10, Version 1  
Temporary Non-Code Repair of Service Water Piping

**Hatch Nuclear Plant – Unit 1**

**Alternative HNP-ISI-ALT-10**

**Temporary Non-Code Repair of Service Water Piping**

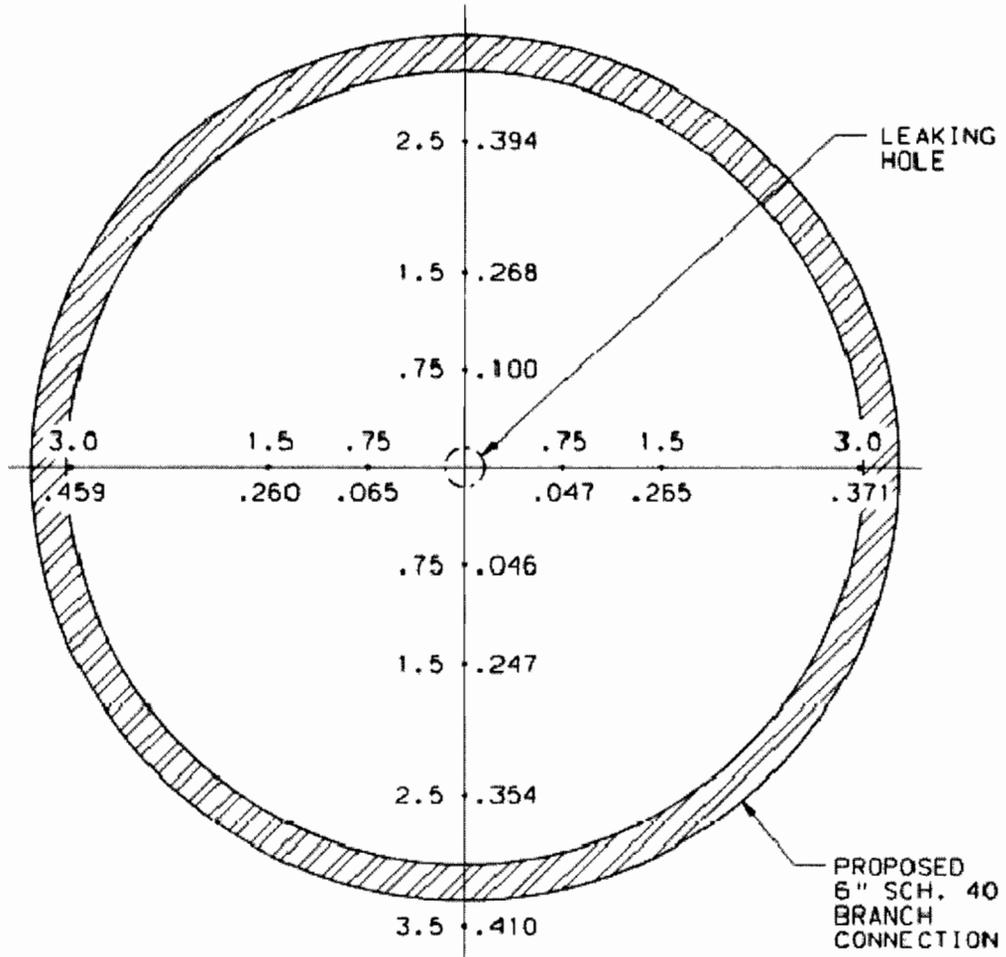
**Figure 1**

The cause of the leak is postulated to be localized pitting, possibly due to Microbiologically Influenced Corrosion (MIC) attack. MIC is the prime suspect due to the stagnant conditions in this section of piping. MIC indications have previously occurred in other stagnant lines at Hatch throughout the plant life.

Detailed UT measurements were obtained around the area of the leak to better understand the scope of the degradation (See Figure 1). The measurements were taken in approximately 3/4" radial intervals from the center of the leak. The measurements showed that at 3/4" away from the leak, the wall thickness was found to average 0.06" thick. At 1.5" from the center of the hole, the wall thickness was found to average 0.26" thick, which is above the allowable minimum wall thickness of 0.179 (calculated based on the design pressure). The diameter of the hole is approximately 1/4".

The wall thickness returned to a nominal wall thickness of 0.375" (or greater) at a radial distance of approximately 3" from the center of the leak. The measurements showed that the degraded area appeared to extend uniformly in a radial pattern from the center of the leak, resulting in a cone shaped defect.

**Thicknesses Around the Leaking Hole**

SNC intends to encapsulate the leak by welding a 6" Nominal Pipe Size (NPS) branch connection over the hole, as shown in Figures 1 and 2, using the design and examination requirements of ANSI B31.1, 2007 Edition. A 6" NPS branch connection was selected because as shown in Figure 1, it will be welded over material with a remaining thickness well above the minimum wall thickness of 0.179". The degraded material around the hole cannot be removed with the system in operation; therefore, the "defect" will be left in place. As a result, this cannot be considered as a Section XI Code repair.

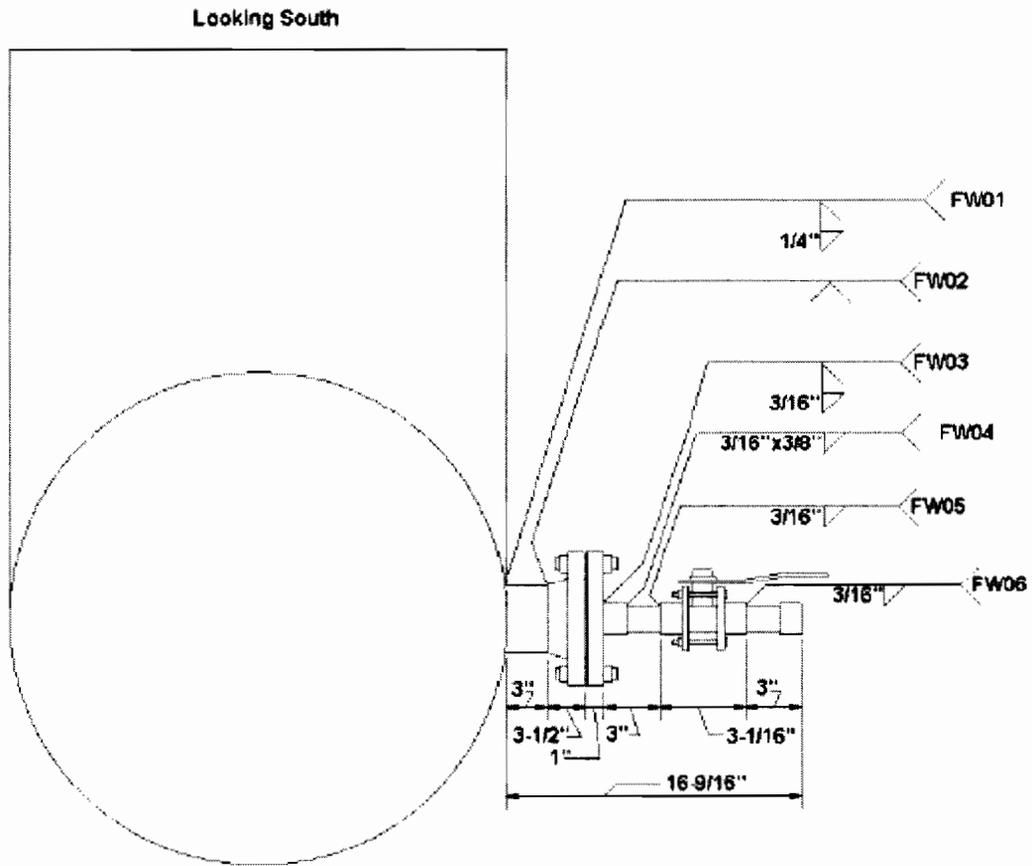
**Figure 2**

**Proposed Non-Code Temporary Repair**

The welding of the branch connection to the 30" pipe will utilize a full-penetration weld. With a leak in the elbow, SNC is aware of issues with keeping the weld dry. However, engineering judgment indicates that with the 6" branch connection roughly centered over the leak, the leakage should pass through the branch connection in a stream without wetting the weld area. If water spray at the weld is determined to be a problem, compensatory actions (e.g., plugs, temporarily installed flow diverters) will be evaluated and used as necessary in order to produce a satisfactory weld.
