CR Title: Root Cause Evaluation for Tritium Leak

# **Root Cause Evaluation Report**

### Attachment E: Condensate Lines As-Found Condition

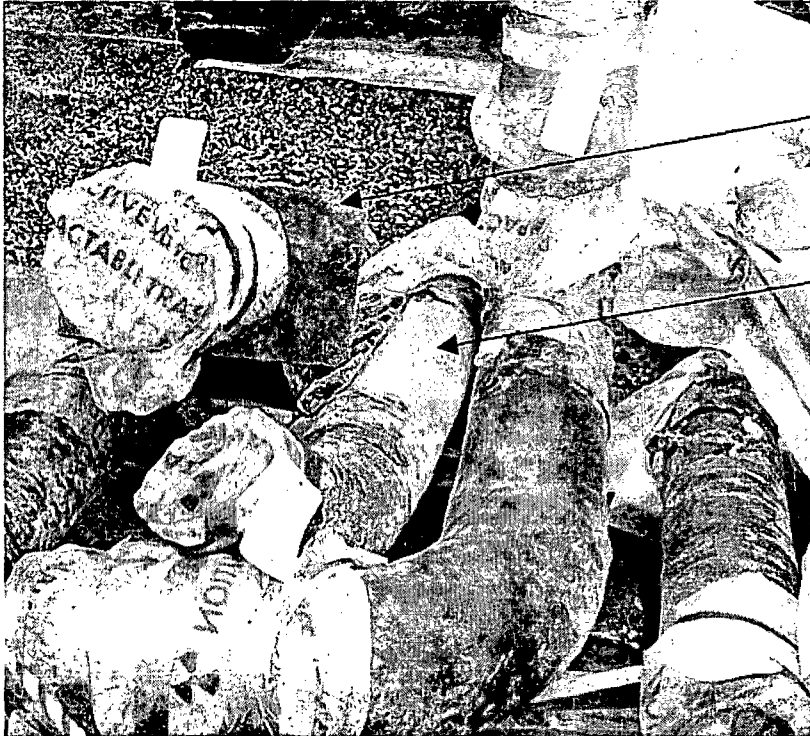
Figure 1

½" CS plate of unknown origin or purpose

SS clamp of unknown origin or purpose on 8" the line; one was removed after excavation

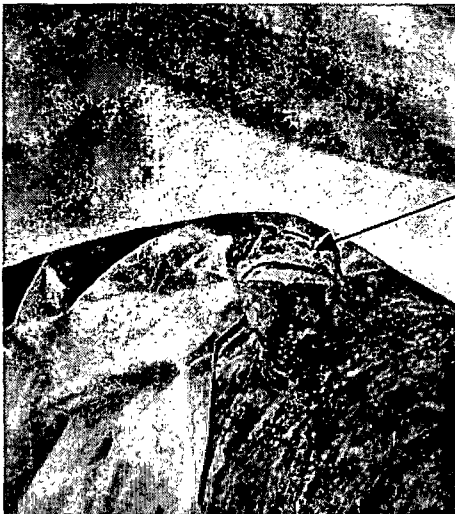
Figure 2

Temporary repair plug installed in August 2001 per Work Order C0032859

As seen in Figure 2, multiple temporary and partial repairs were implemented following the July 1991 pipe failure. Work Order C0032859 was initiated to clean, inspect, and repair the 1991 hole in the 8-inch Condensate line. The

repair installed a temporary seal-welded plug. This temporary plug was evident when the 8-inch line was excavated in April 2009.

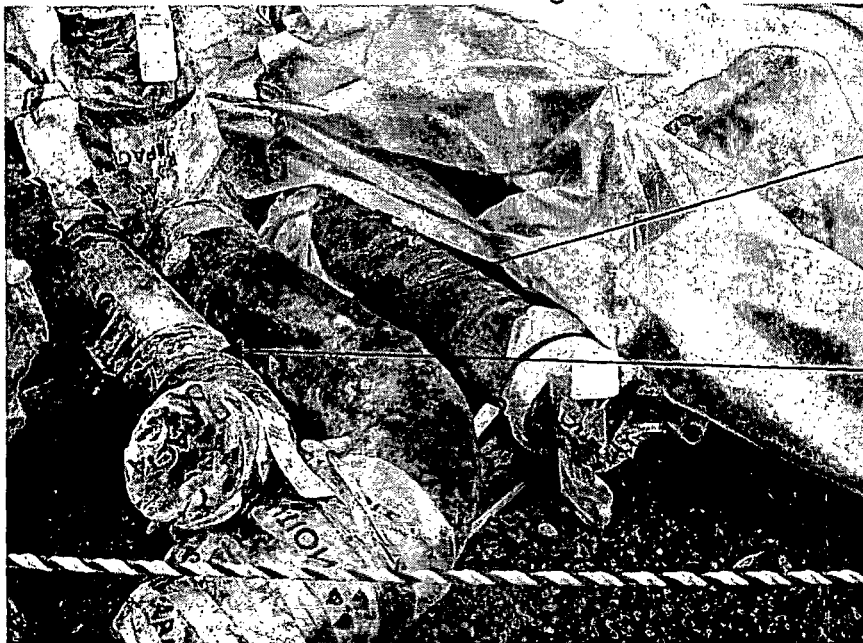
Figure 3

10" Condensate Transfer line elbow was not wrapped; wrapped area did not have Polyken™ epoxy coating applied.

8" CST to Hotwell line section that was not wrapped; SS clamp applied

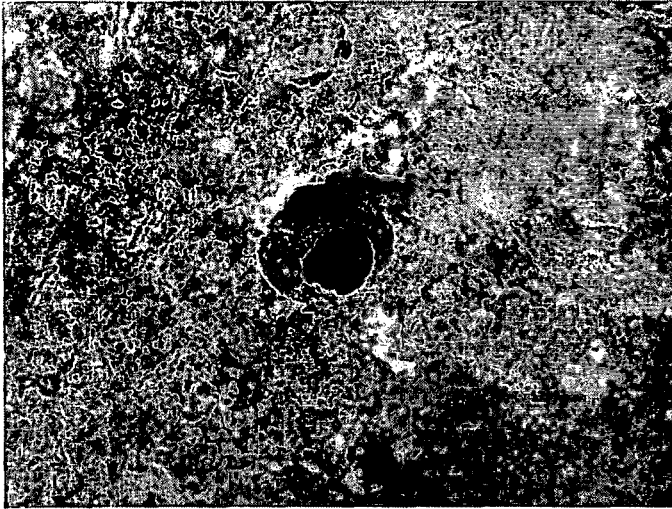
This figure is an example of pure Anodic Dissolution. A large cathode and a small anode produce focused corrosion at the location of the metal exposure to a ground source. This is typical when buried pipe coatings degrade. This line is a fire service pipe defect from TMI.

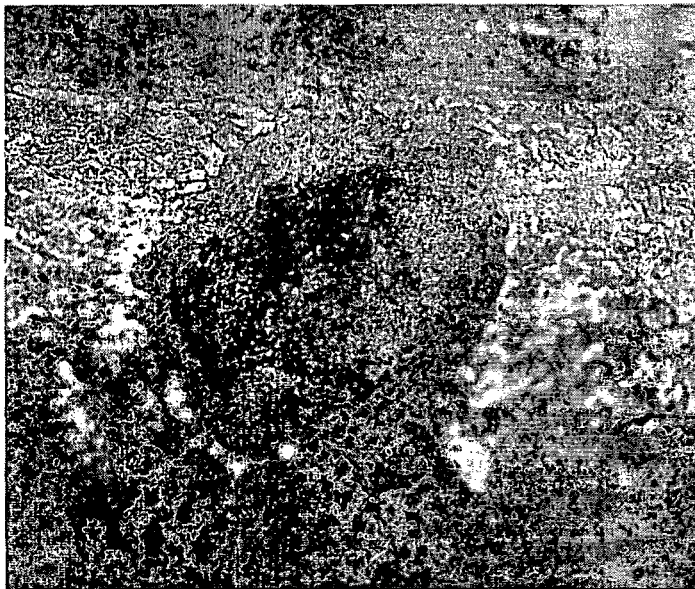
Figure indicates the effect of Anodic Dissolution due to poor coating. The shear cliff like walls and the smooth bottom are features of AD. This figure is a defect found in the TMI A Deice Line.

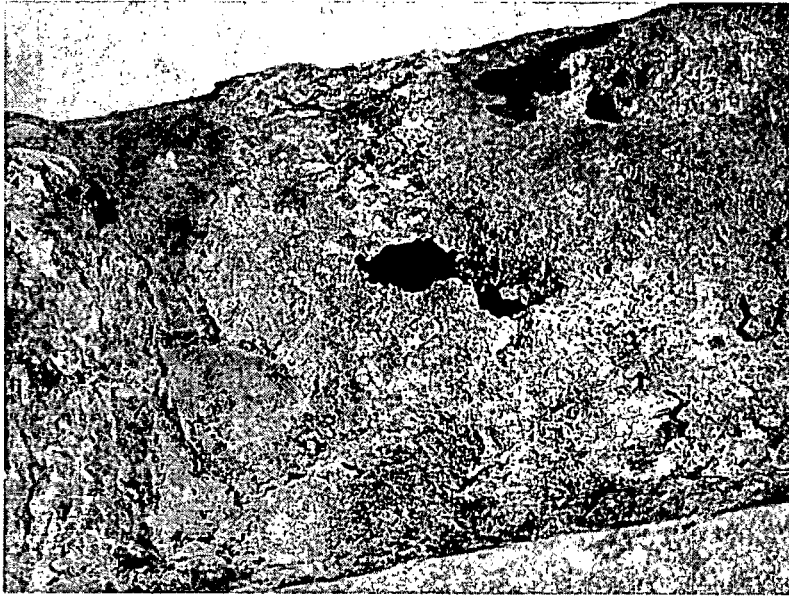
Figure shows the general “wastage” of pipe wall over a greater area when large areas of coating are lost or degraded. The corrosion mechanism is Anodic Dissolution and is distributed over a larger area. Typically, wastage takes longer to produce a through wall pit than focused Anodic dissolution. This photo is of a service air buried pipe leak at TMI.

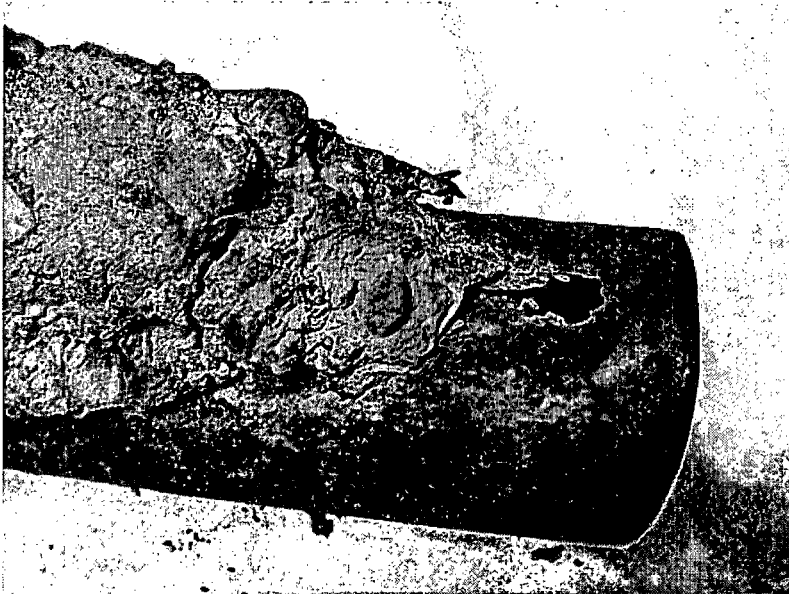
Figure shows a wastage defect and the extremely poor quality of coating on the pipe. Also note the rocks attachment in what coating is present. Clear indication that the coating was not protected and its degradation resulted in a wastage defect in the domestic water pipe. This pipe is a buried domestic water pipe at TMI.
