ATTACHMENT 16
Sheet 1 of 3
Significant Adverse Condition Investigation Report
Form CAP-NGGC-0205-16-6

Action Request Number: 00268357

Summary of Event: Increasing trends of tritium concentration have been observed in Wells ESS-2C and ESS-16, located on the east side of the point where the Discharge Cooling Water Tunnels pass under the plant's security fence. The increasing trend of tritium concentration in these wells is dated back to the 2004 and 2005 timeframe. These wells had previously showed declining trends during 2003 following the implementation of corrective actions from NCR 26566, Degradation Observed in Storm Drain Piping. These wells have been monitored for tritium since their installation in 1995. These wells were installed based on hydrologist recommendations during the 1995 D'Appolonia review following a failed leak test of the RadWaste Effluent Line. This effluent line was repaired by lining the pipe in 1994 with subsequent Preventative Maintenance leak tests performed during each unit's refueling outage passing inspection. The Unit 2 Storm Drain piping that is routed to the Storm Drain Collector Basin (SDCB) passes close by to Wells ESS-2C and ESS-16. This piping

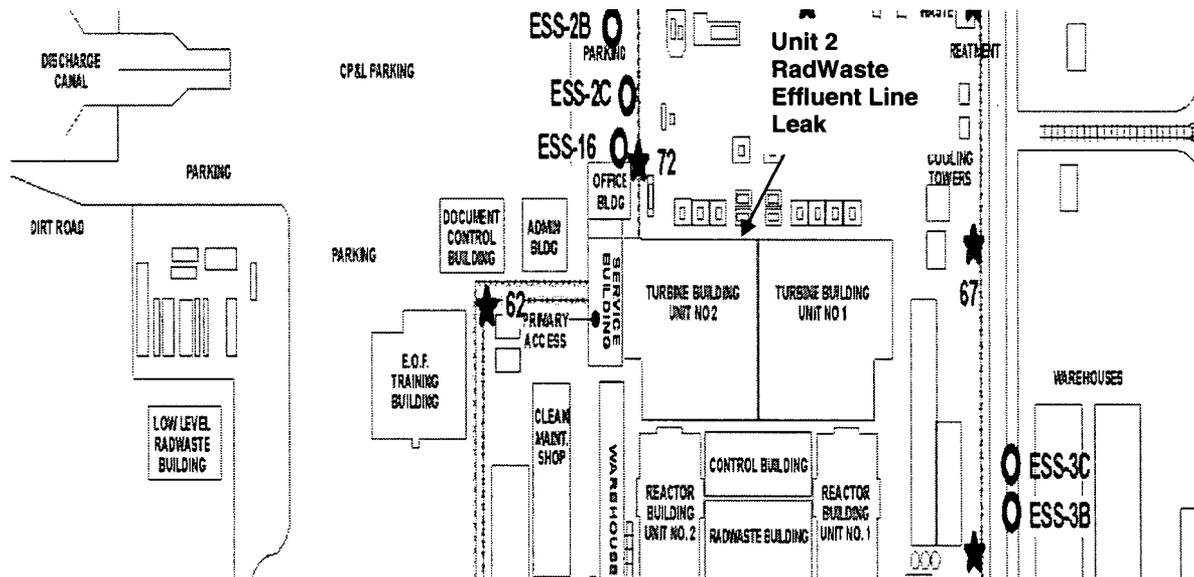
Figure 1
Locations of Wells ESS-2C and ESS-16

interviews with the Progress Energy Geologist who participated in the hydrology study and well installations following the RadWaste Effluent Line leak, other wells were not permitted to be installed at that time because of Site Management decisions as the locations of these wells would have been within the Transformer and Switchyard areas of the site. Wells ESS-2C and ESS-16 are located just outside this area and are east of the point where the Discharge Cooling Water Tunnels pass under the plant's security fence before heading towards the Discharge Weir (see Figure 1).

Wells ESS-2C and ESS-16 were sampled following their initial installation in 1995 and showed tritium concentrations of 46,000 pCi/L and 35,000 pCi/L, respectively. Neither of the wells showed any detectable gamma emitting radionuclides, which was expected. Tritium is a highly mobile radioactive isotope. Being an isotope of hydrogen that is part of the molecular structure of water, tritium flows in response to potential gradient in a manner identical to that of groundwater. It is typically not affected by adsorption, dispersion, chemical reaction with the aquifer matrix or other retarding forces.

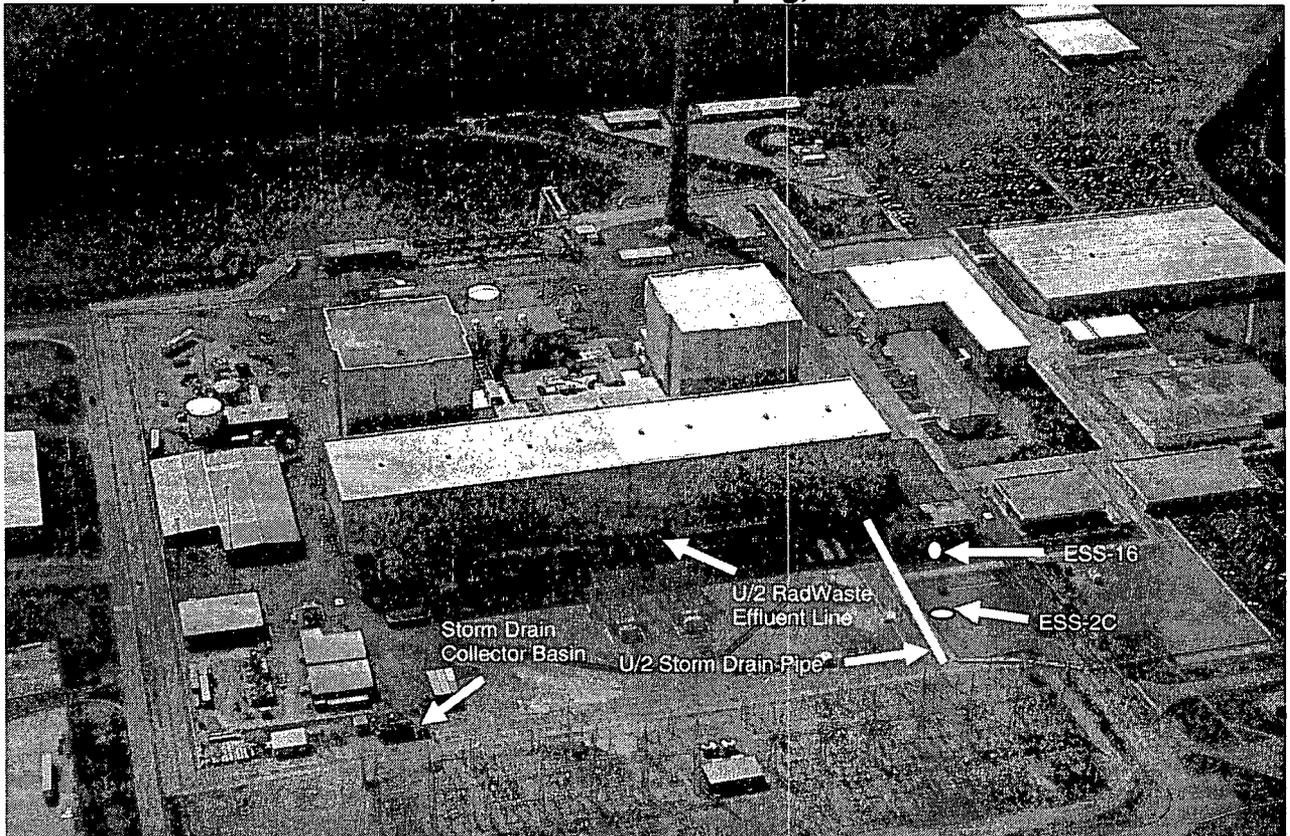
Figure 3
Locations of ESS-2C, ESS-16, Storm Drain Piping, and RadWaste Effluent Line

To account for this increasing trend, a multi-discipline team was assembled to determine causes for the increase. Potential input sources in the area were identified that could help determine root cause for the increase. As a result of team discovery, the high potential input sources located in the area are the Storm Drain System piping that runs parallel to Wells ESS-2C and ESS-16 and the historical 1994 U/2 RadWaste

Line leak. Assumptions of other input sources were also made. Examples included potential turbine building leakage or other unidentified leakage. The Storm Drain Piping is located approximately twenty feet east of Well ESS-2C. The location of the 1994 RadWaste Line leak is approximately 240 feet away from ESS-2C. Other monitoring wells in nearby areas, such as ESS-2B and ESS-2D, have not shown an increase of tritium concentrations. This validates statements from the 1995 D'Appolonia report that tritium would be contained in the backfill location, where Wells ESS-2C and ESS-16 were installed based on D'Appolonia suggestions. However, some inconsistencies have been noted within the D'Appolonia report during this investigation that questions its validity and conclusions drawn during the 2006 NEI responses. To further address this concern, Priority 1 NCR 233865 Assignment 30 was initiated to update hydro-geological studies of the plant backfill to ensure that previous assumptions of tritium migration remain valid as related to the 1995 D'Appolonia Study. Actions to evaluate responses to like those given during the 2006 NEI Initiative will be reviewed ensure appropriate measure are in place to prevent inadvertent radiological releases.

With the location of the Storm Drain System piping approximately twenty to thirty feet away from Wells ESS-2C and ESS-16, as seen in Figure 3, and the known mobility of tritium, it would be assumed that the tritium trends for these wells would mimic that of the major input source of tritium into the Storm Drain System piping, if the Storm System Piping was the cause. Figure 4 below is a graph of tritium concentrations measured in the Unit 2 Turbine Building AirWash basin, Well ESS-2C, and Well ESS-16.

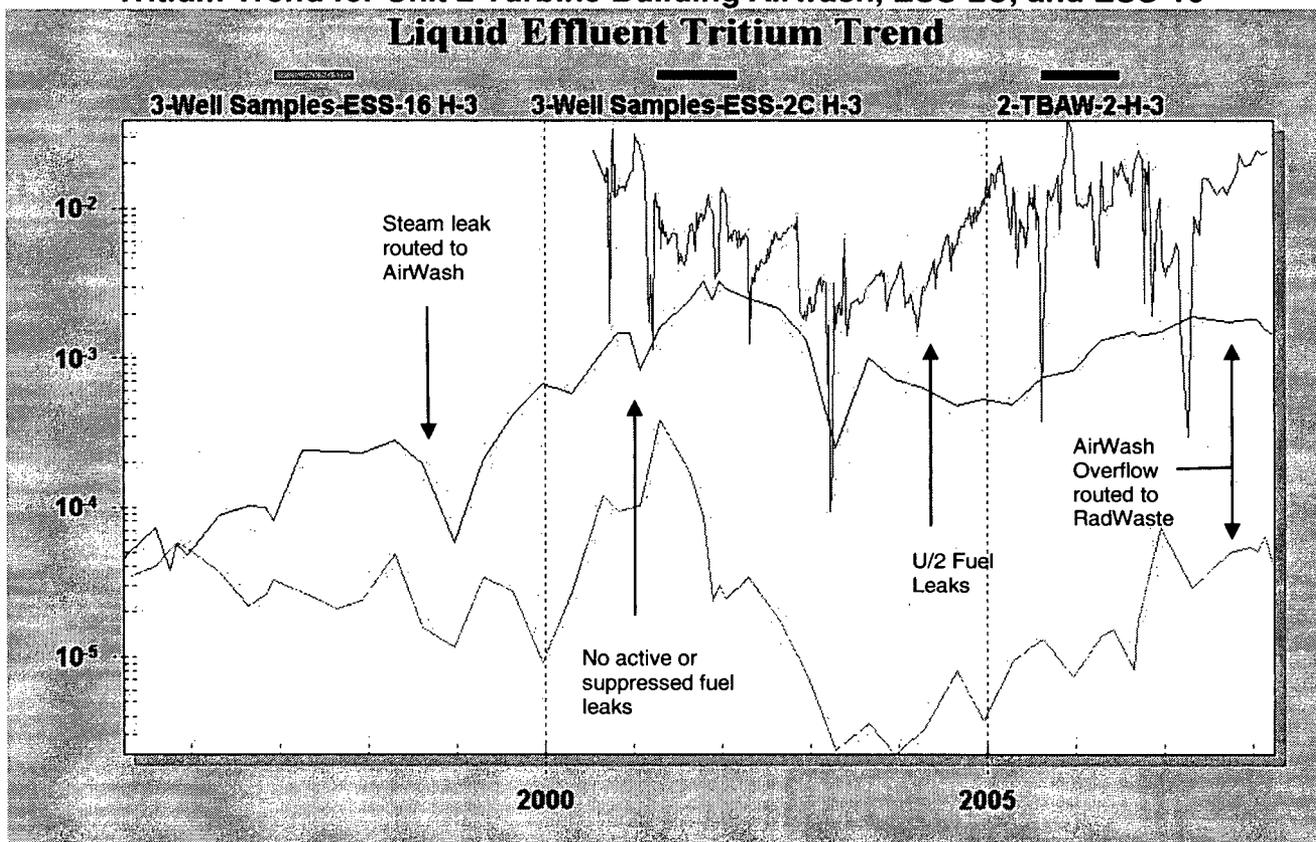
Figure 4
Tritium Trend for Unit 2 Turbine Building Airwash, ESS-2C, and ESS-16
Liquid Effluent Tritium Trend

Tritium analysis for the AirWash system did not begin until late 2000. However, examining the trends shows that Wells ESS-2C and ESS-16 closely follow the trend seen in the Unit 2 Turbine Building AirWash tritium. The rise and falls are also closely related to the fuel leaks faced by the plants. Although the concentration of tritium is much higher in the Unit 2 Turbine Building Airwash, it would be diluted once it reaches non-radioactive liquids transported in the Storm Drain system piping. In June 2007, the AirWash overflow was rerouted to RadWaste. Looking at the annotation on Figure 4 where the overflow lines were rerouted, it does appear that the short term trends have decreased very slightly.

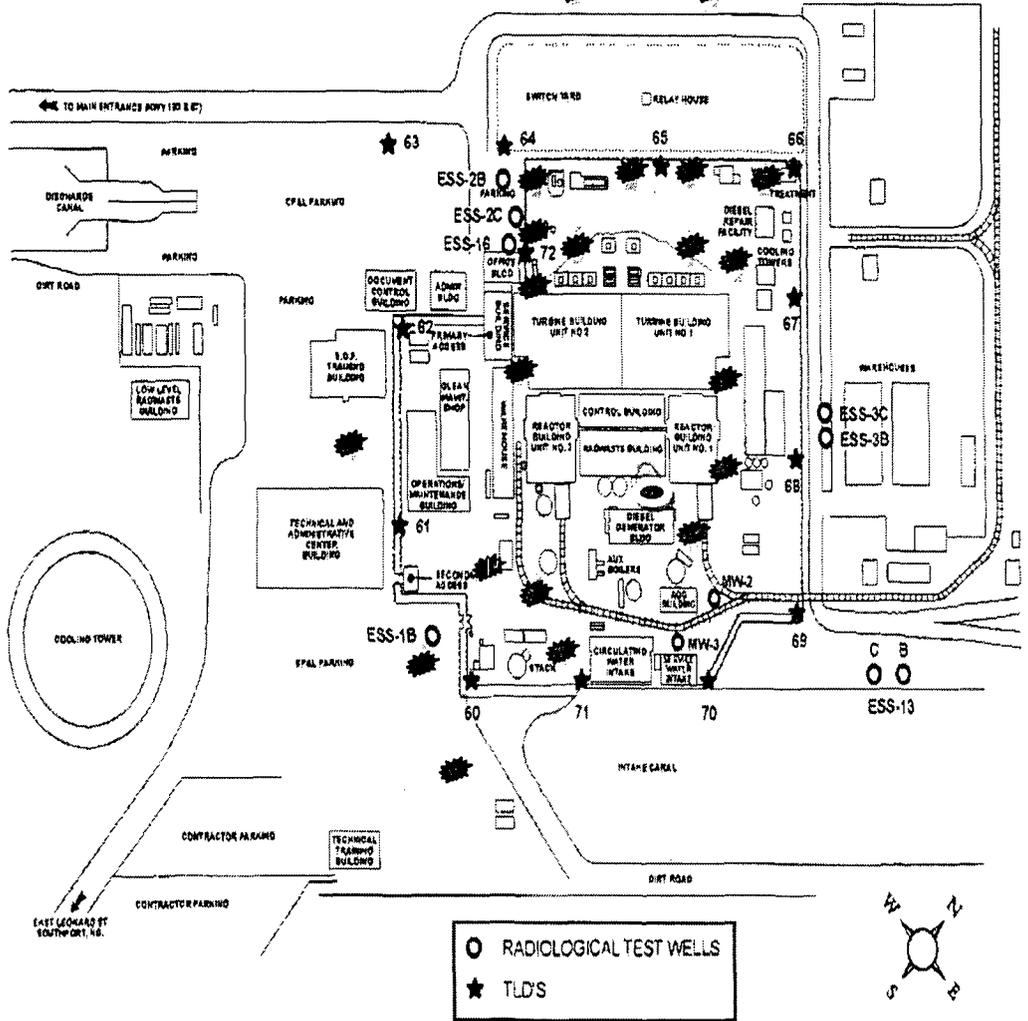
DIAGRAM 7
Page 1 of 1
Location of Radiological Test Wells

- Shallow and deeper screening / well installation up to 50ft depth
- Shallow, first water only due to deeper infrastructure conflicts (~15-20ft depth)

After installation of new wells, a site-wide modeling will be completed to map tritium inputs and migration to help mitigate future impacts. Corrective actions will be assigned to sample and analyze any manhole, basin, and well on site that is readily accessible to assess the magnitude and severity of the plant's tritium impact.
