SAND2010-4936
Unlimited Release
Printed July 2010

A Preliminary Look at the Fire-Induced Electrical Failure Behavior of Kerite® FR Insulated Electrical Cables

A Letter Report to the U.S. NRC/RES

Steven P. Nowlen and Jason Brown

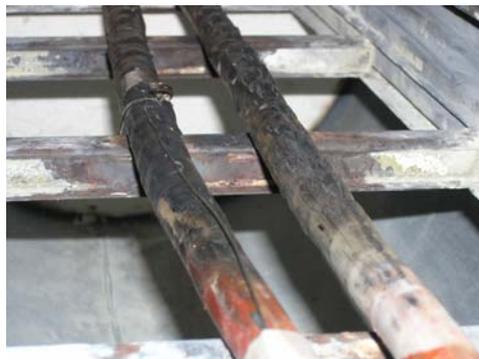
Figure 12: Post-test photos of the Kerite cable in the initial experiment.

Figure 12 shows the paired test cables after completion of the test. The left-hand cable is the temperature response cable and the right-hand cable is the electrical performance cable. During this test, the cables did not ignite which allowed for a post-test examination to be performed.

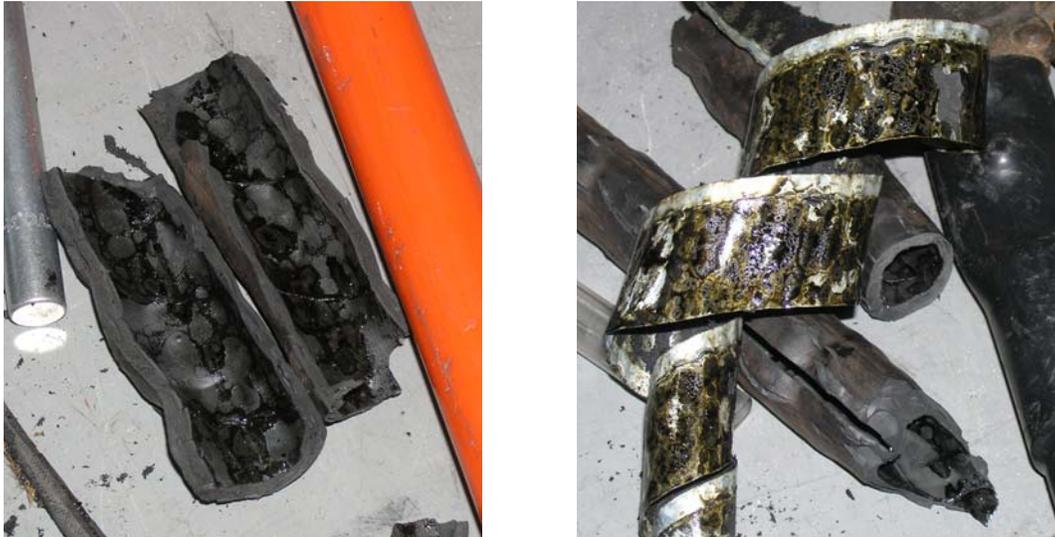
Figure 13: Oily residue found between the jacketing material and zinc wrap

As a first step, the jacket was separated from the cable. An oily residue was observed between the jacketing material and zinc wrap and again between the zinc wrap and the insulated conductor bundle. This is illustrated in Figure 13. Once the zinc wrap was removed, the cloth material over the conductor bundle was also removed. Throughout the heated portion of cable, conductors were observed to have both circumferential (Figure 14) and axial (Figure 15) cracking. In two conductors in particular, circumferential cracks through the insulation of both conductors were exactly aligned. The right-hand photo in Figure 14 shows these two adjacent conductors each with a circumferential crack at the same point along their length (visible below the edge of the razor knife in the center of the photograph). As discussed in Section 6, this alignment of insulation cracks in two adjacent conductors is thought to be an important aspect of the Kerite failure behavior.

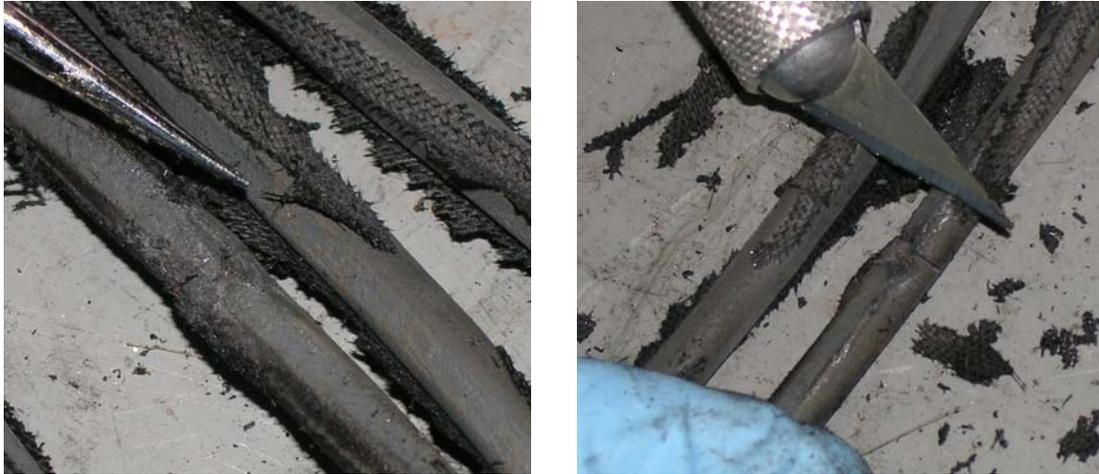
Figure 14: Circumferential cracking discovered during post-test analysis

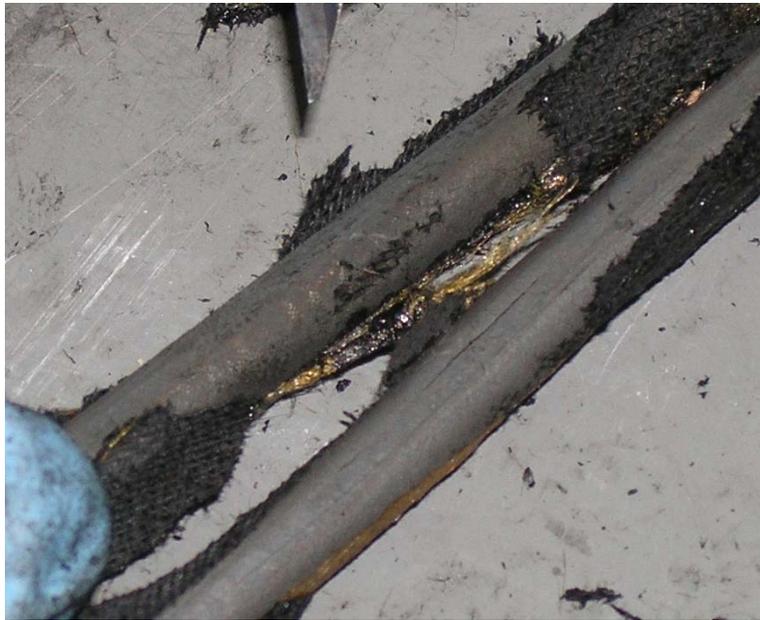
Figure 15: Axial cracking observed during post-test analysis is visible as a dark line running along the right hand conductor near the center of the photo.

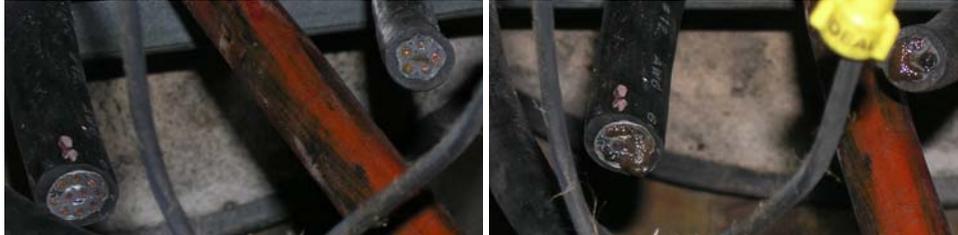
Figure 20 illustrates this liquid which can be seen as a yellow-green in color and transitioning to dark brown or black over the course of the test.

Figure 20: A pre-test view of the test cables (left) and a photo taken during the Test 15 (right) showing liquid leaking from the cut ends of the both of the thermal response cables (the 5/C and 10/C cables).

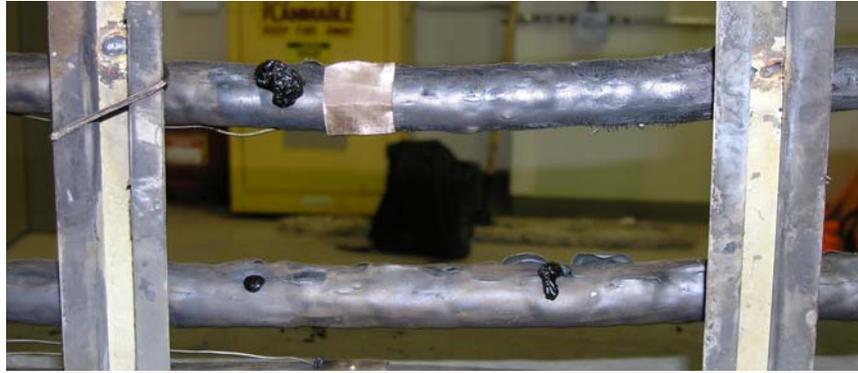
Figure 23: Hardened residue on the jacketing material.

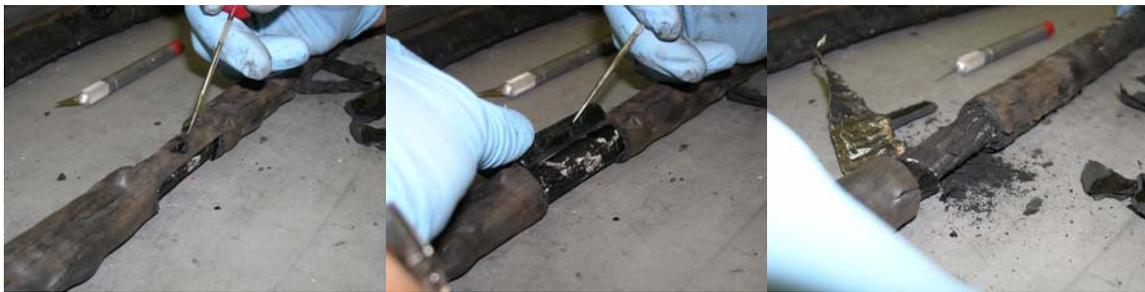
Figure 24: Post-test examination of the 10/C Kerite cable from Test 15.

Post-test examination initially focused on, but was not solely limited to, the areas where the liquid residue had seeped from the jacket as pictured in Figure 24. As was the case for the cable from Test 13-qual, an oily residue was observed beneath the jacketing material. The investigation also identified circumferential and axial cracking of the conductor insulation similar to that noted in Test 13-qual. This is illustrated in Figure 25. In this particular case, no areas were noted where the cracks in one conductor were in direct alignment with cracks in an adjacent conductor.

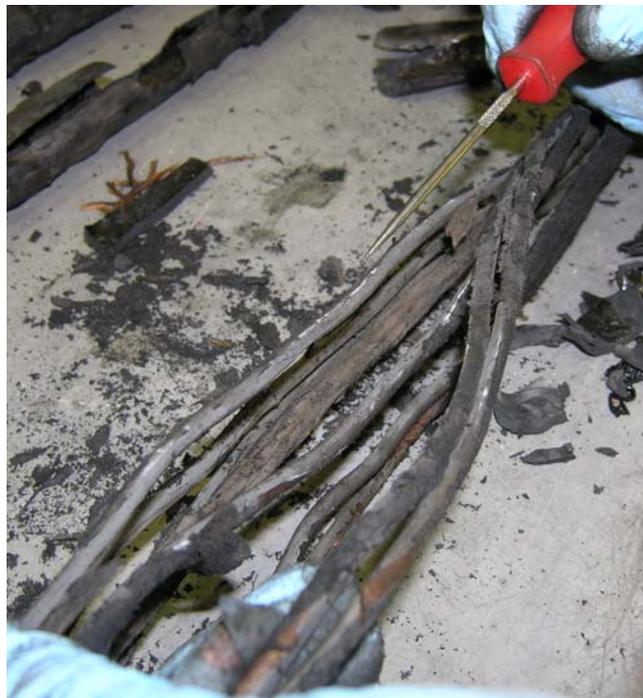
Overall, test 15 and the post-test inspection revealed very similar levels of physical damage (cracking) as had been observed in the case of Test 13-qual. Inspection of the 5/C cable also revealed similar cracks in the conductor insulation. When inspecting these cracks, it was also common that the actual copper conductor was visible indicating that the cracks were not limited to the insulation surface, but rather, went all the way through the insulation. These observations will be discussed further in Section 6.

Figure 25: Insulation cracking observed in Test 15.

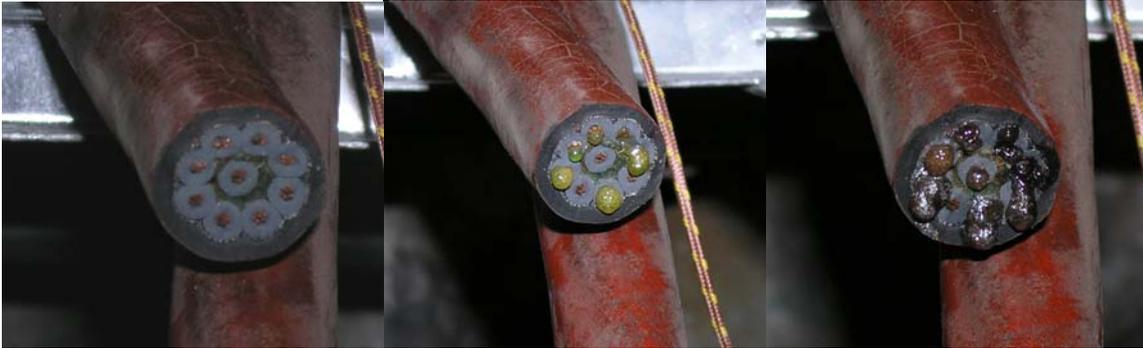
One observation made during testing was that the Progress Energy cables also displayed a liquid material leaking from the cut ends of the cables during testing. Figure 30 shows the end of the thermal response cable in Test 44 pre-test (left), at the initial onset of the leaking material (center) and later in the test (right). Note that the material darkens as the test progresses and the cable temperature increases.

Figure 30: Progression of the liquid residue leaking from the cut end of the thermocouple cable: pre-test on the left, and then progressively later in the test for the center and right photos.
