RCE REPORT

Northern States Power Company, a Minnesota corporation (NSPM), d/b/a Xcel Energy
Prairie Island Nuclear Generating Plant

Refueling Cavity Leakage
Event Date: 1988-2008

RCE 01160372-01 Revision 01(CAP 01201071)

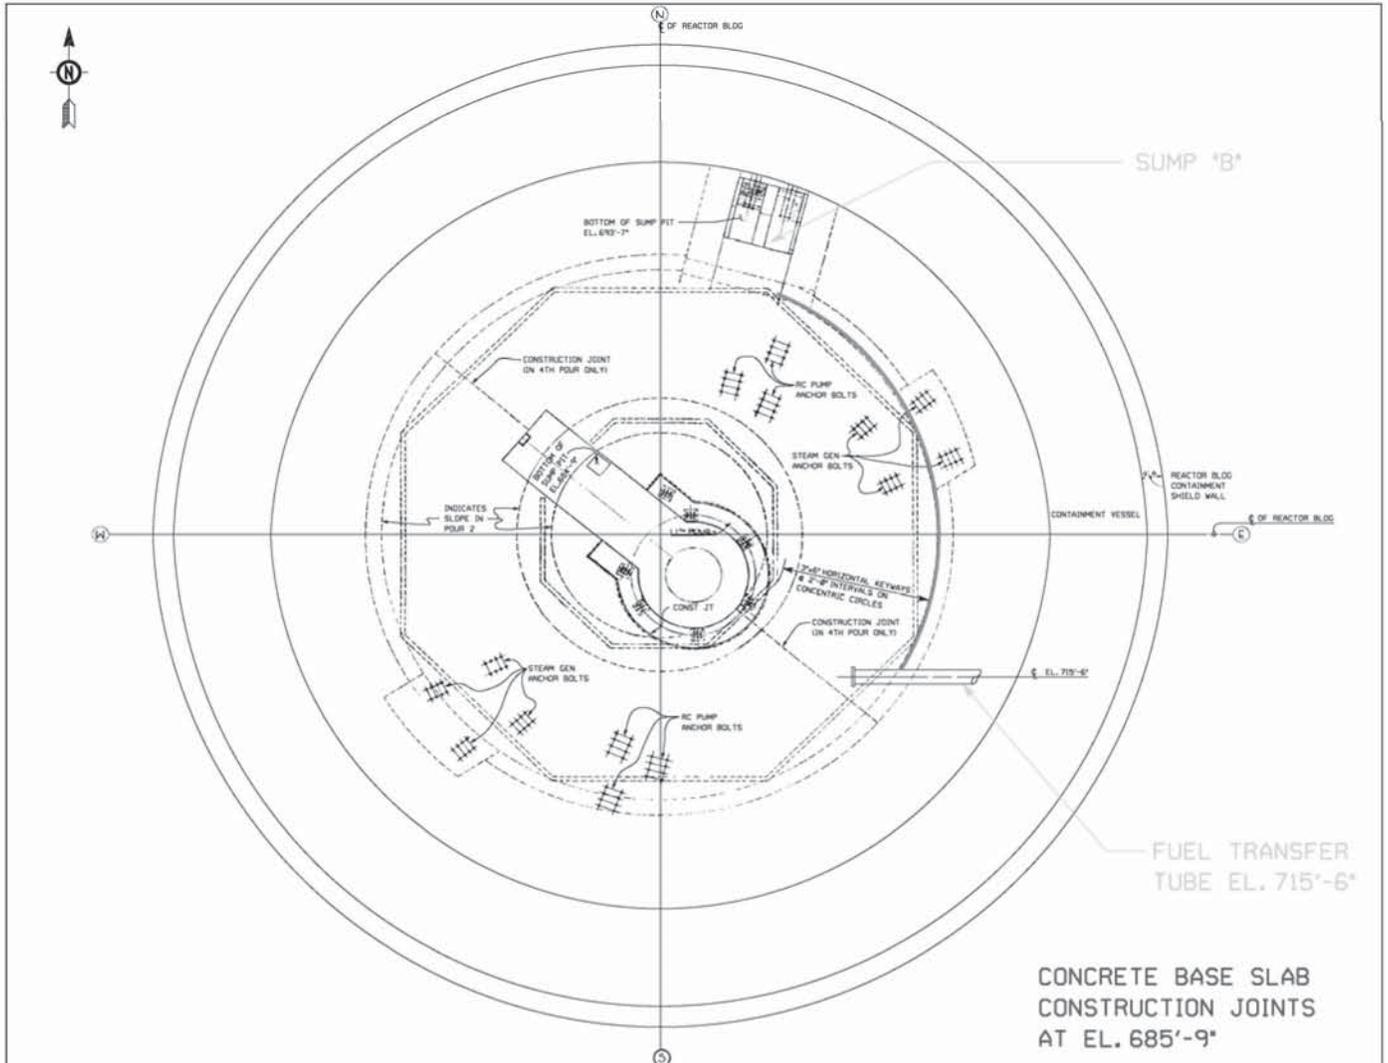
Figure 3.

Shows the horizontal leak path from the transfer pit to Sump B.
