RCE REPORT

Northern States Power Company, a Minnesota corporation (NSPM), d/b/a Xcel Energy
Prairie Island Nuclear Generating Plant

Refueling Cavity Leakage
Event Date: 1988-2008

RCE 01160372-01 Revision 01(CAP 01201071)

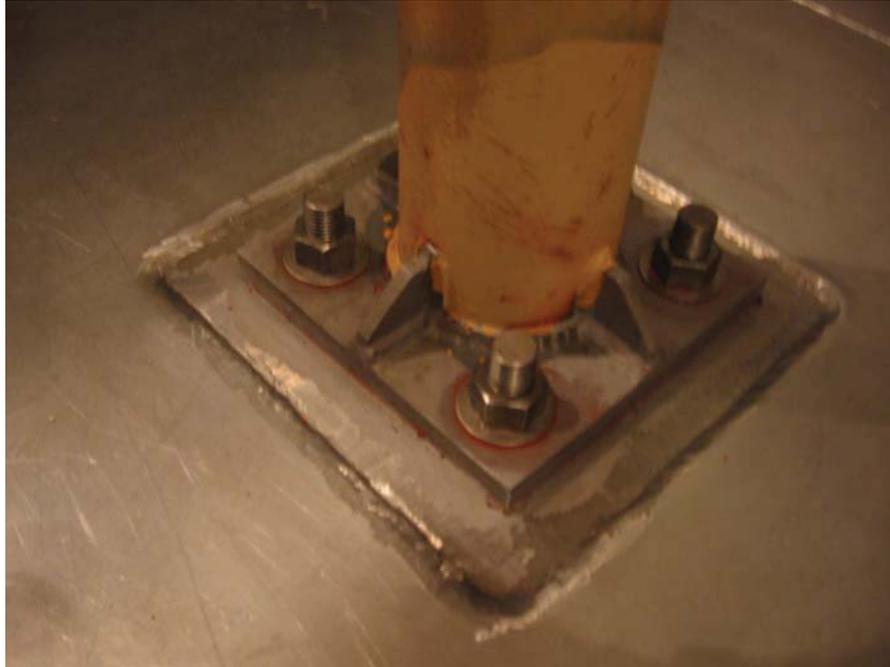
All evidence suggests that the leakage which is seen coming out of the grout in Sump B, beneath the refueling cavity in the Regen Heat Exchanger Room and elsewhere, originates from flaws in the refueling cavity liner. Due to the efforts over the last several years to mitigate the leakage, the likely leak locations have been narrowed down considerably. In 1998 and 1999, extensive examinations were conducted of the seam welds between the liner plates and the embedment strips. NDE consisted of dye penetrant examinations and vacuum box testing of the accessible welds, and these exams ruled out the seam welds as the source of the leakage. The next step that was taken was to apply the polyurea strippable spray-on coating (brand name InstaCote) onto the cavity liner to attempt to mitigate the leaks. The first application was in the Unit 2 upper cavity and fuel transfer pit, including the bottom 6 feet of the vertical walls. The lower cavity was not coated. It was successful in stopping the leakage that outage. InstaCote was applied a second time during the following Unit 2 outage coating the lower cavity and transfer pit (the upper cavity was not coated). Again, the result was no leakage into Sump B or the Regen HX Room. Taken in combination, these results strongly indicate the leak is in the transfer pit for Unit 2. Based on this information, and following two consecutive failures of InstaCote application to effectively stop the leakage (attributed to insufficient coverage of the key locations), engineering made a decision to change methods and instead use a sealant (caulk) around only the suspect locations. This decision reflected the understanding that the liner plates and seam welds had already been shown to be sound, and therefore were not benefited by the application of the cavity coating. Over the last several outages on each unit, caulking has been applied to the anchor bolts of the upper and lower internals storage stands in the lower cavity and the RCC change fixture in the transfer pit. These locations were chosen as the leakage points because, unlike most of the embedment plates in the refueling cavity, the studs in these embedment plates are set into through-holes in the plates, creating a natural leak path along the threads (see following photographs and figures).

(Typical Internals Stand Support)

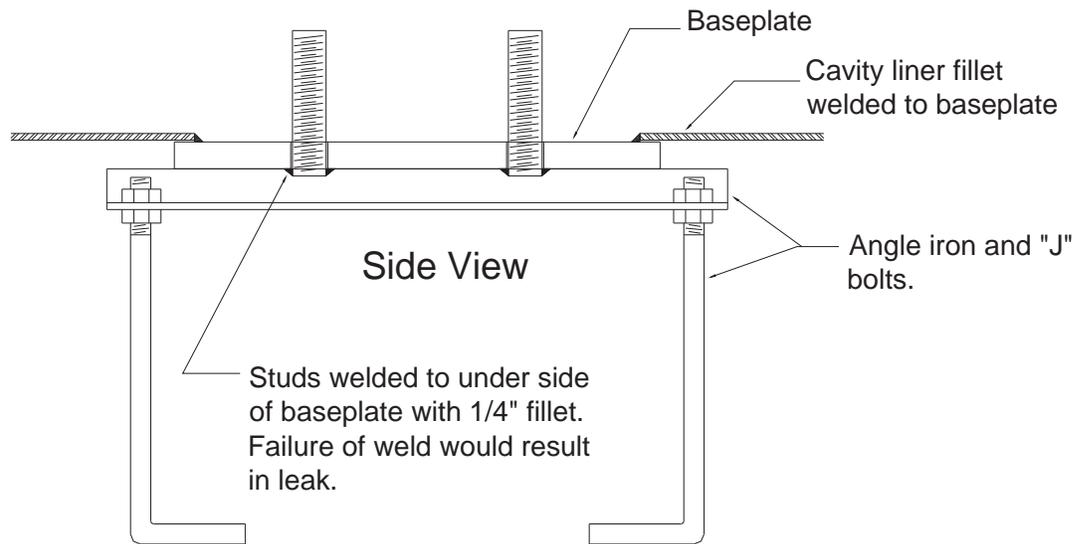
General Arrangement of Internals Stands Supports

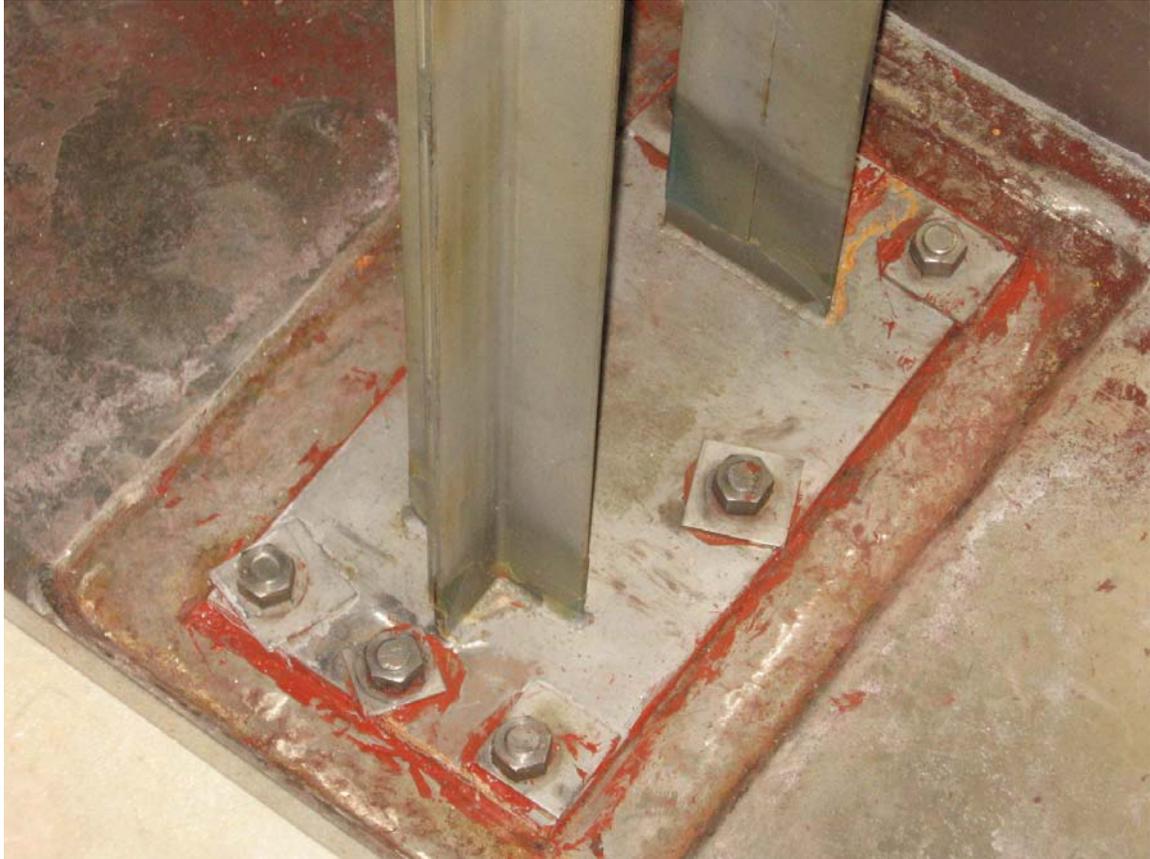
(Typical RCC Change Fixture Support)

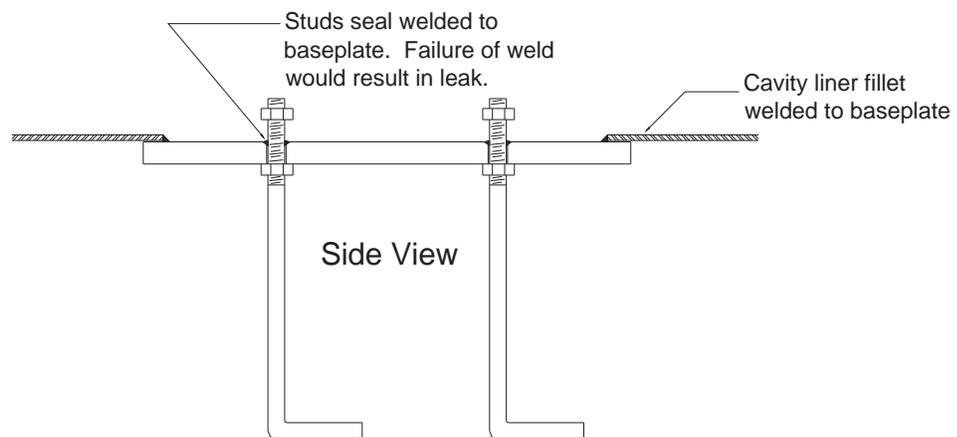
General Arrangement of Change Fixture Supports

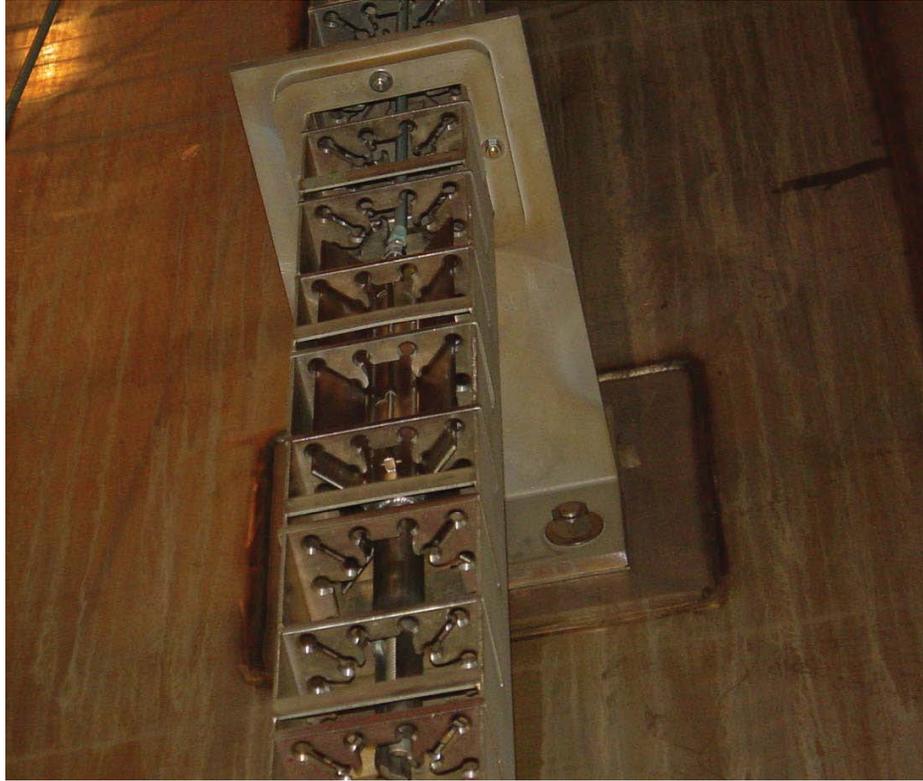
Revision 1 – Continued leakage in 1R26 indicates leakage of the Guide Tube supports.

(Typical Guide Tube Support) Revision 1

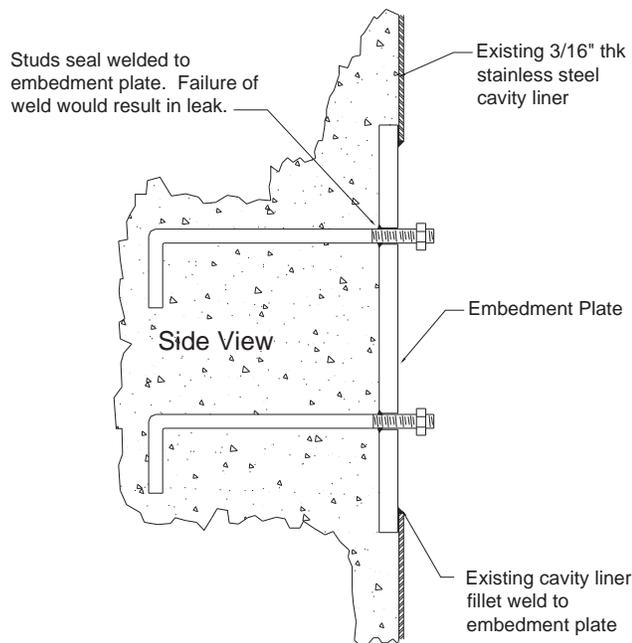
General Arrangement of Guide Tube Supports Revision 1

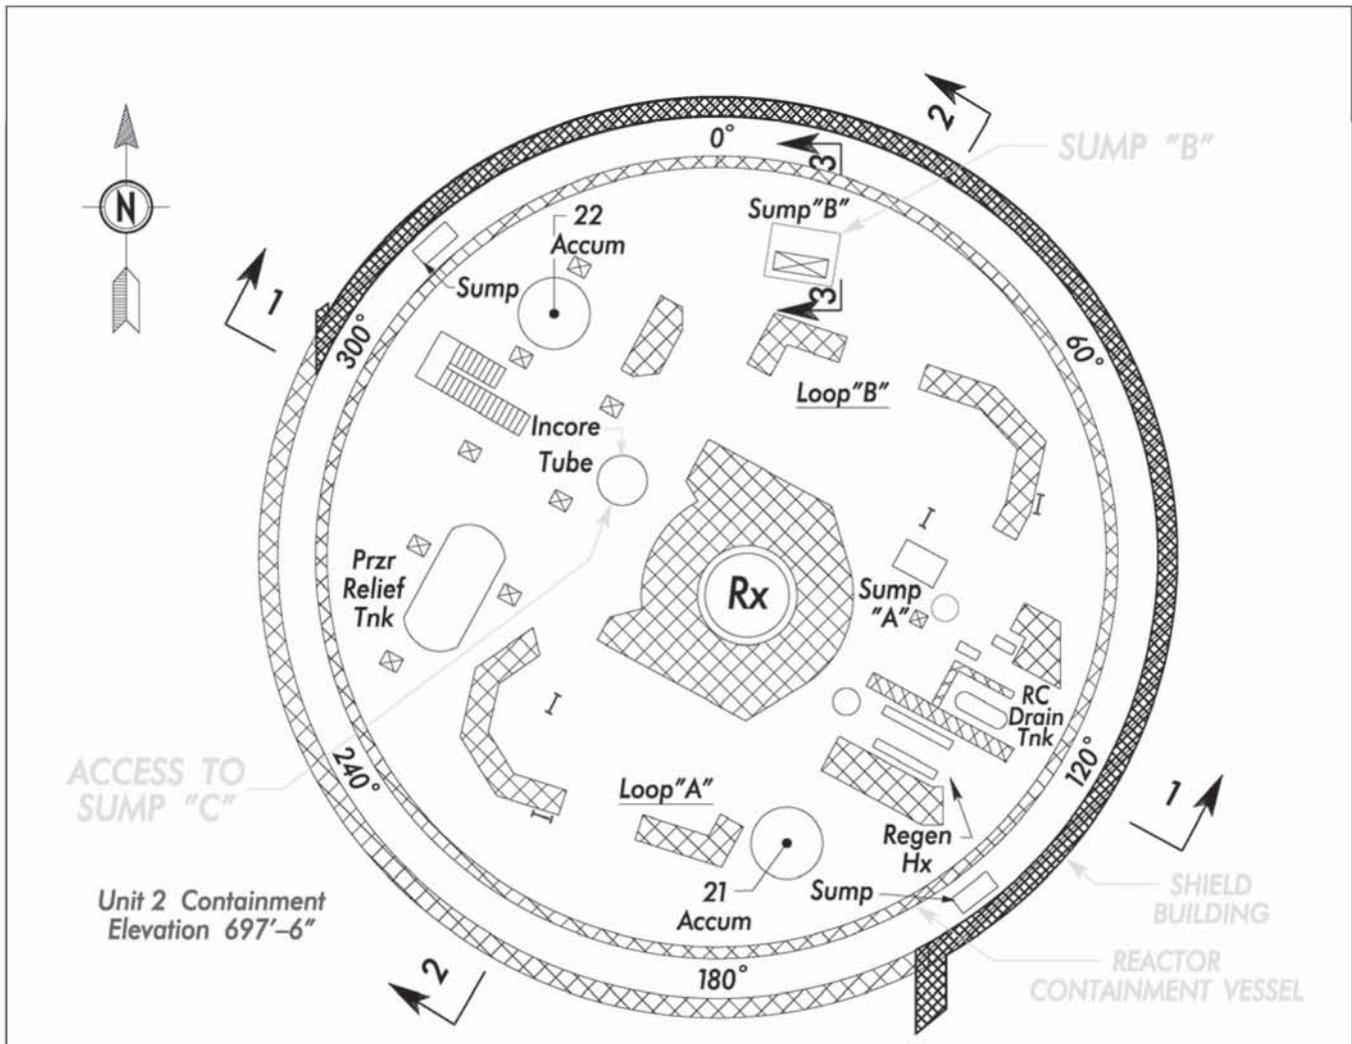
Figure 1.

Shows the location of Sump B on the North side of containment and Regen Heat Exchangers directly below the lower cavity.

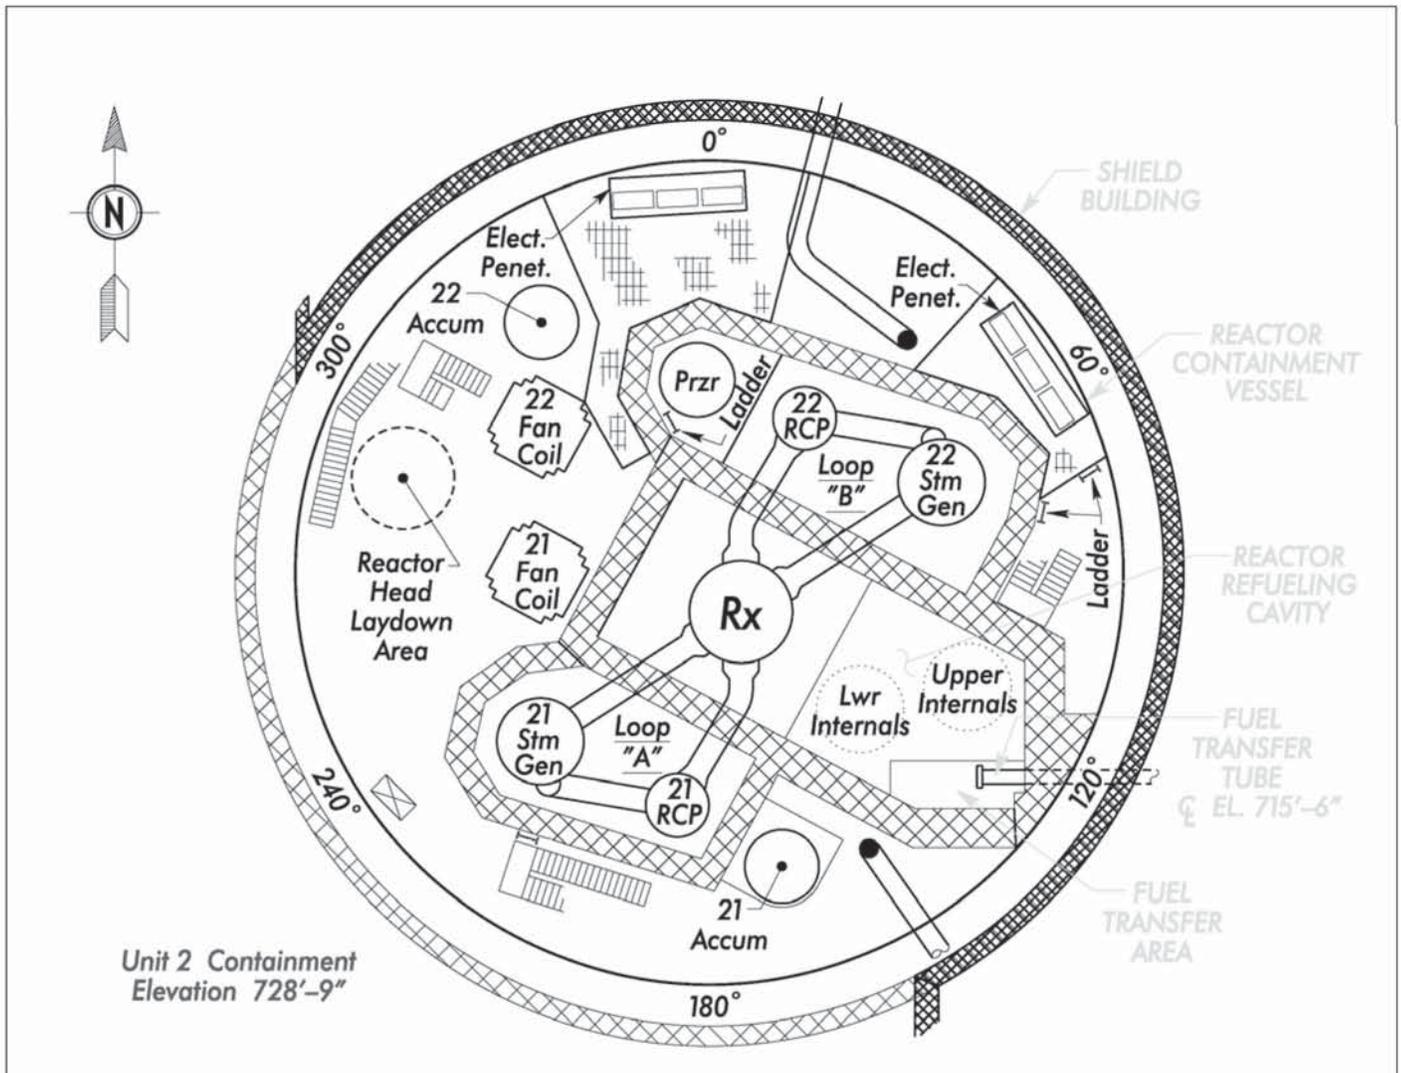
Figure 2.

Shows the location of the upper and lower internals stands, and transfer pit.

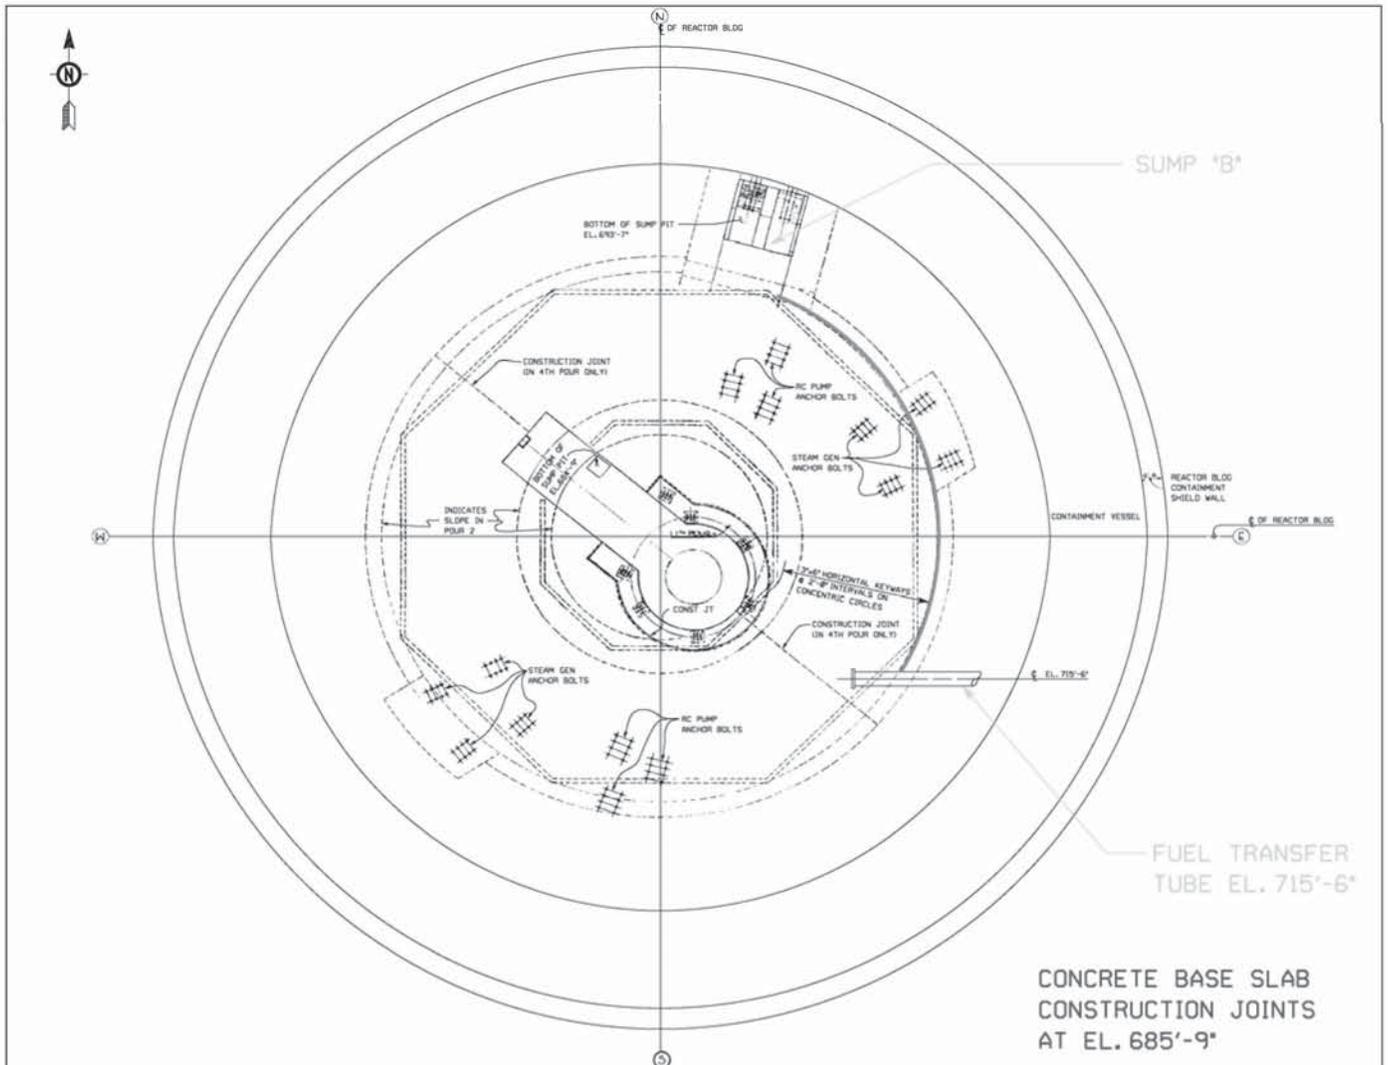
Figure 3.

Shows the horizontal leak path from the transfer pit to Sump B.

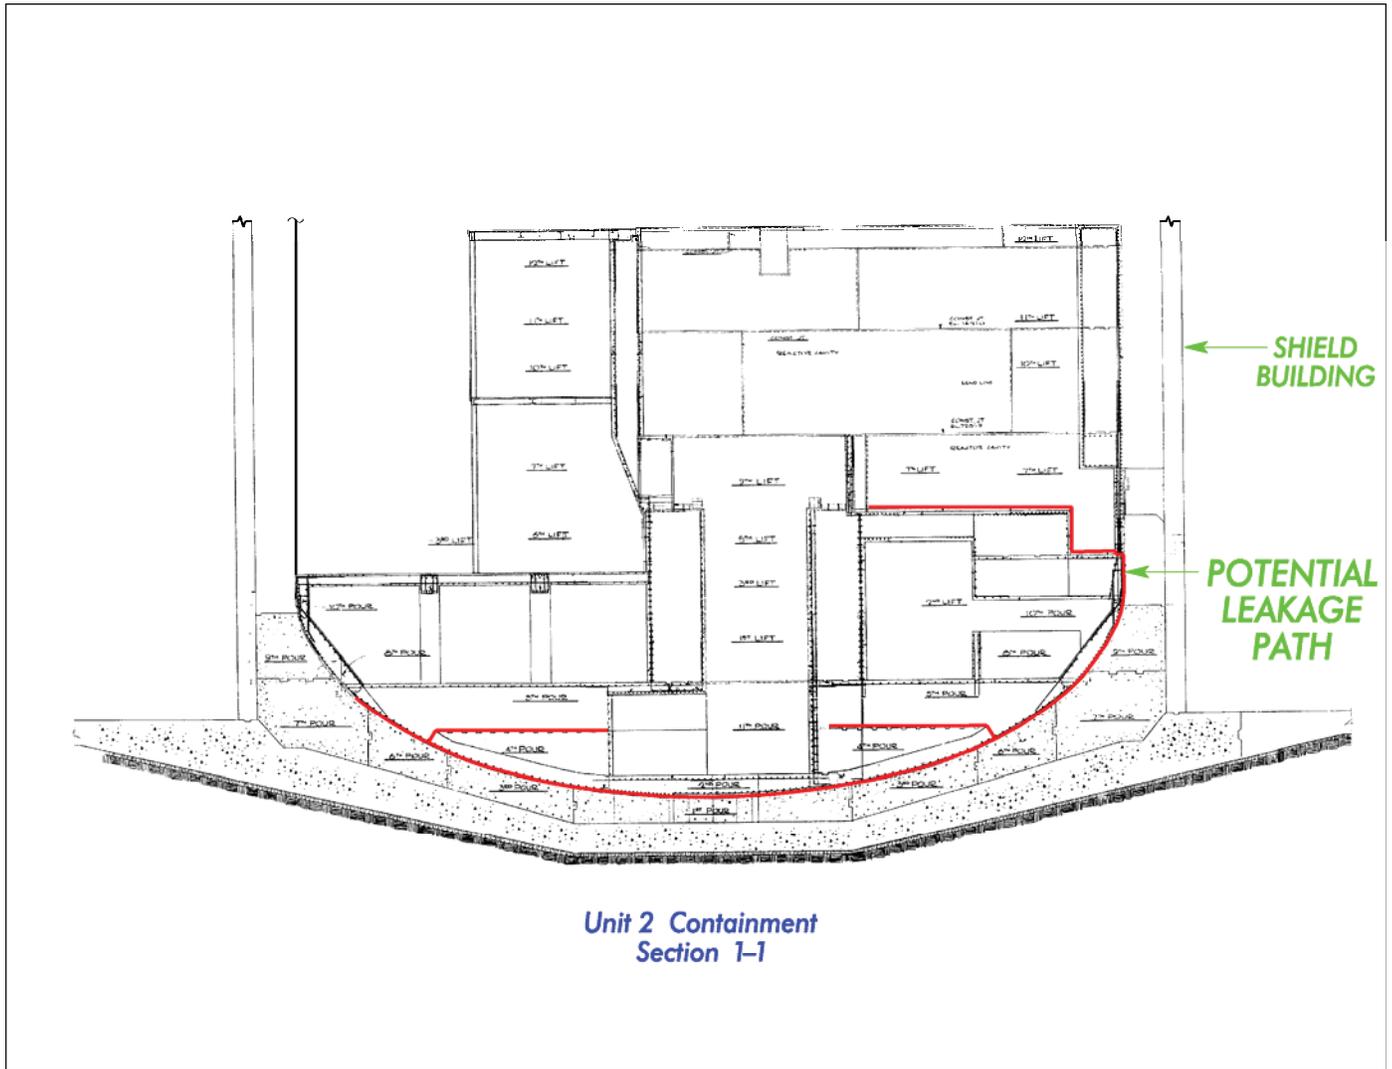
Figure 4.

Shows the vertical leak path with potential leakage between the concrete and containment vessel to the low point of the bottom head.

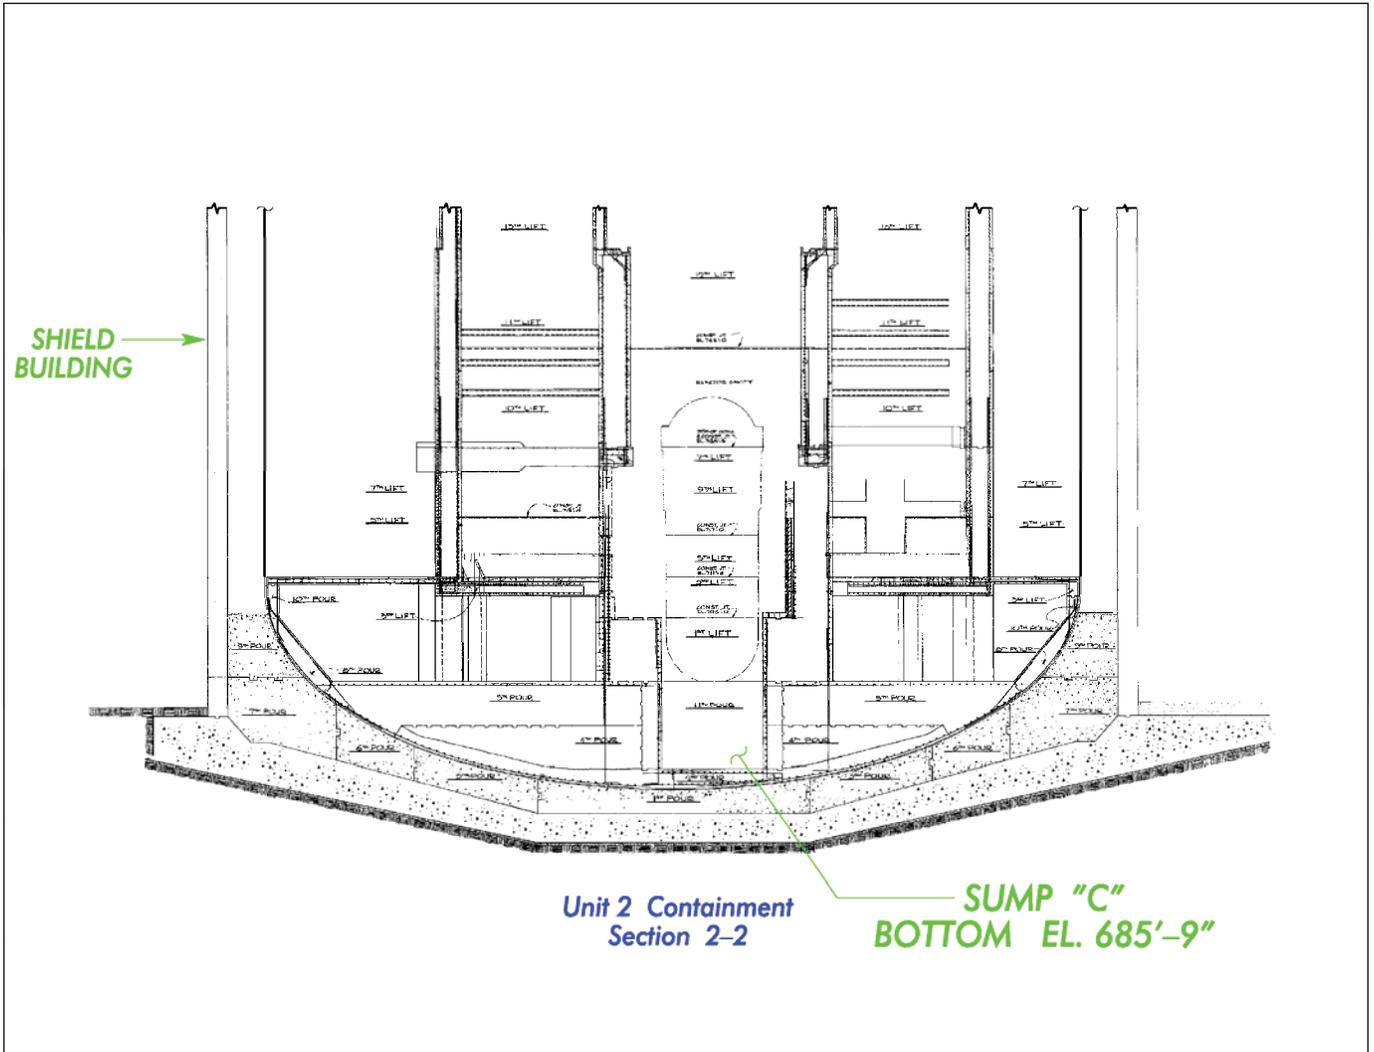
Figure 5.

Shows the location of Sump C around and under the reactor vessel.
