Title: Evaluation of Effect of Borated Water Leaks on Concrete, Reinforcing Bars, and Carbon Steel Plate of the Containment Vessels at Prairie Island Units 1 and 2

Number: R-4448-00-01 Rev: 0 Date: 3/2009

Organization Name: Dominion Engineering, Inc PO or DIA Reference: 00026901

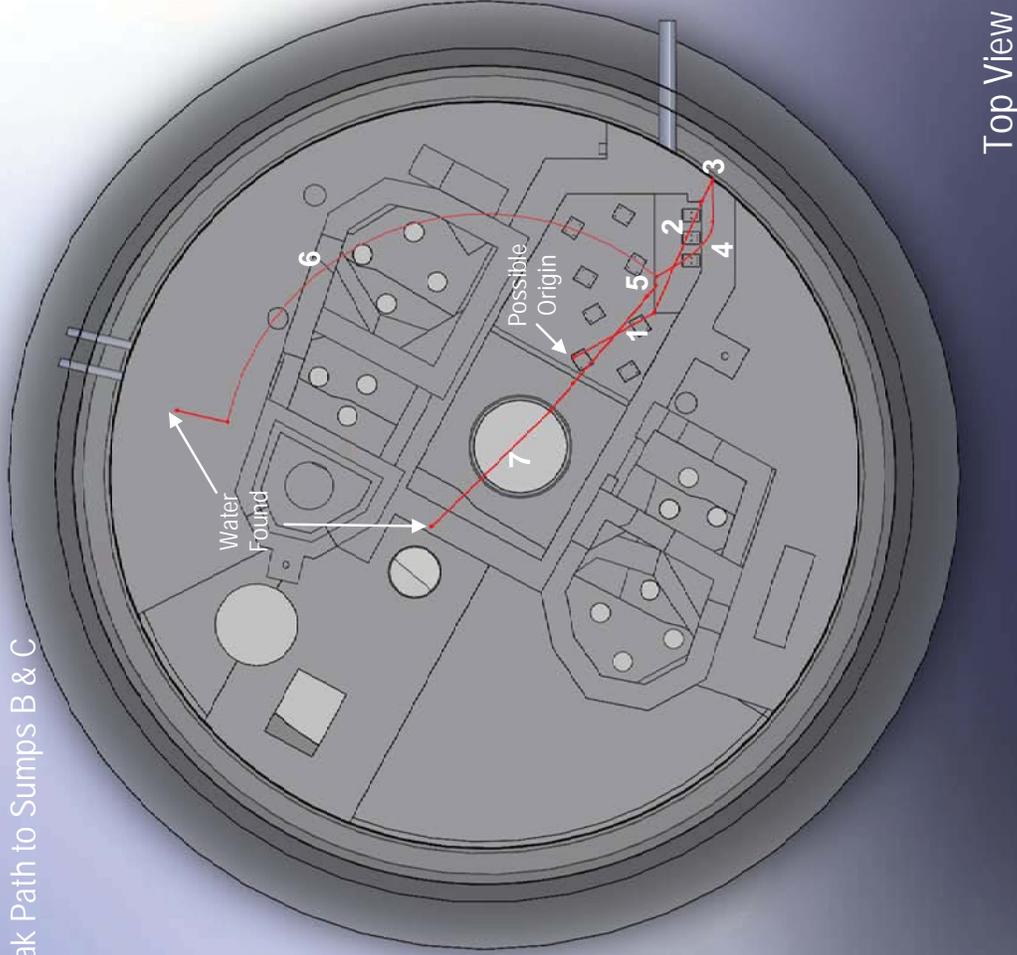
Figure A-2 Possible Borated Water Leak Paths to Sumps B & C in Unit 2 – Top View

Possible Borated Water Leak Path to Sumps B & C

- 1) Borated water from refueling pool possibly seeps through bolts at Internals Supports Stands on bottom of Reactor Refueling Cavity to the concrete floor underneath SS liner
- 2) Water seeps under SS liner to bottom of fuel transfer area and joins postulated leaks through bolts at Changing Fixture Supports
- 3) Water seeps at corner of fuel transfer area to the CS Containment Vessel
- 4) Water travels between Containment Vessel and concrete down to intersection of concrete Pours 2, 4, and 5
- 5) Path branches to two known destinations: Sumps B and C
- 6) Water follows arcing path between concrete Pours 2 and 5 to Sump B where it was found when grout was removed around the suction lines
- 7) Water follows along intersection of concrete Pours 2, 4a, and 4b where it then enters Sump C

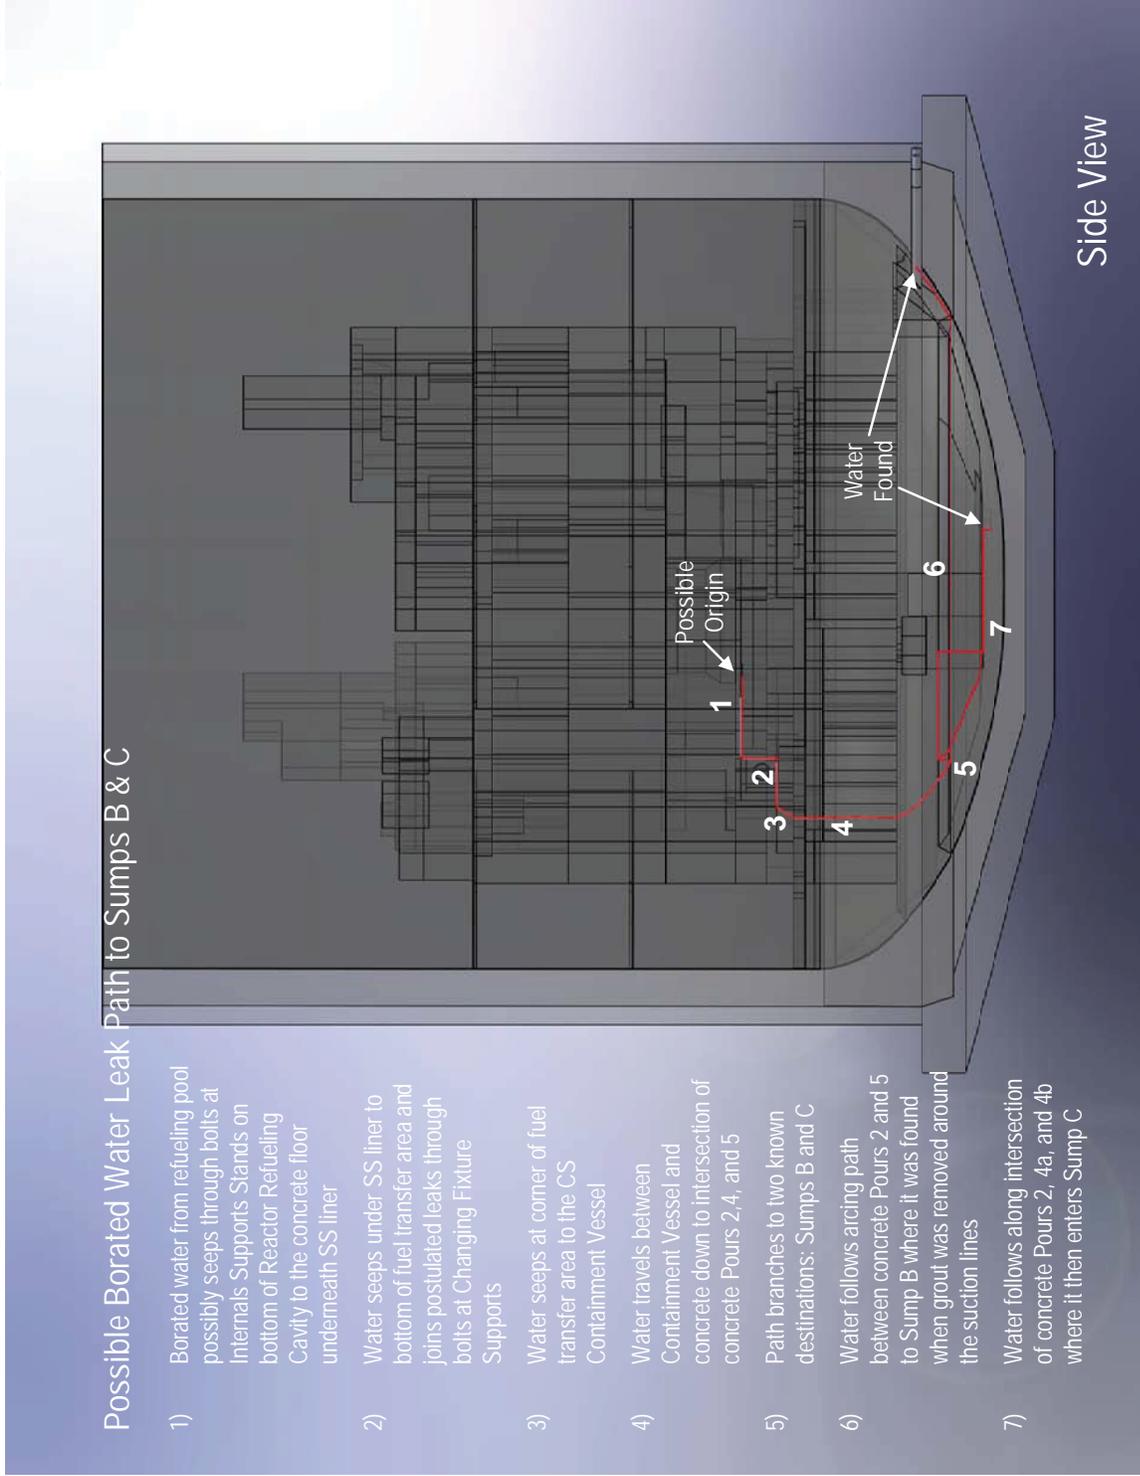
Figure A-4 Possible Borated Water Leak Paths to Sumps B & C in Unit 2 – Transparent Side View

Possible Borated Water Leak Path to Sumps B & C

- 1) Borated water from refueling pool possibly seeps through bolts at Internals Supports Stands on bottom of Reactor Refueling Cavity to the concrete floor underneath SS liner
- 2) Water seeps under SS liner to bottom of fuel transfer area and joins, postulated leaks through bolts at Changing Fixture Supports
- 3) Water seeps at corner of fuel transfer area to the CS Containment Vessel
- 4) Water travels between Containment Vessel and concrete down to intersection of concrete Pours 2, 4, and 5
- 5) Path branches to two known destinations: Sumps B and C
- 6) Water follows arcing path between concrete Pours 2 and 5 to Sump B where it was found when grout was removed around the suction lines
- 7) Water follows along intersection of concrete Pours 2, 4a, and 4b where it then enters Sump C

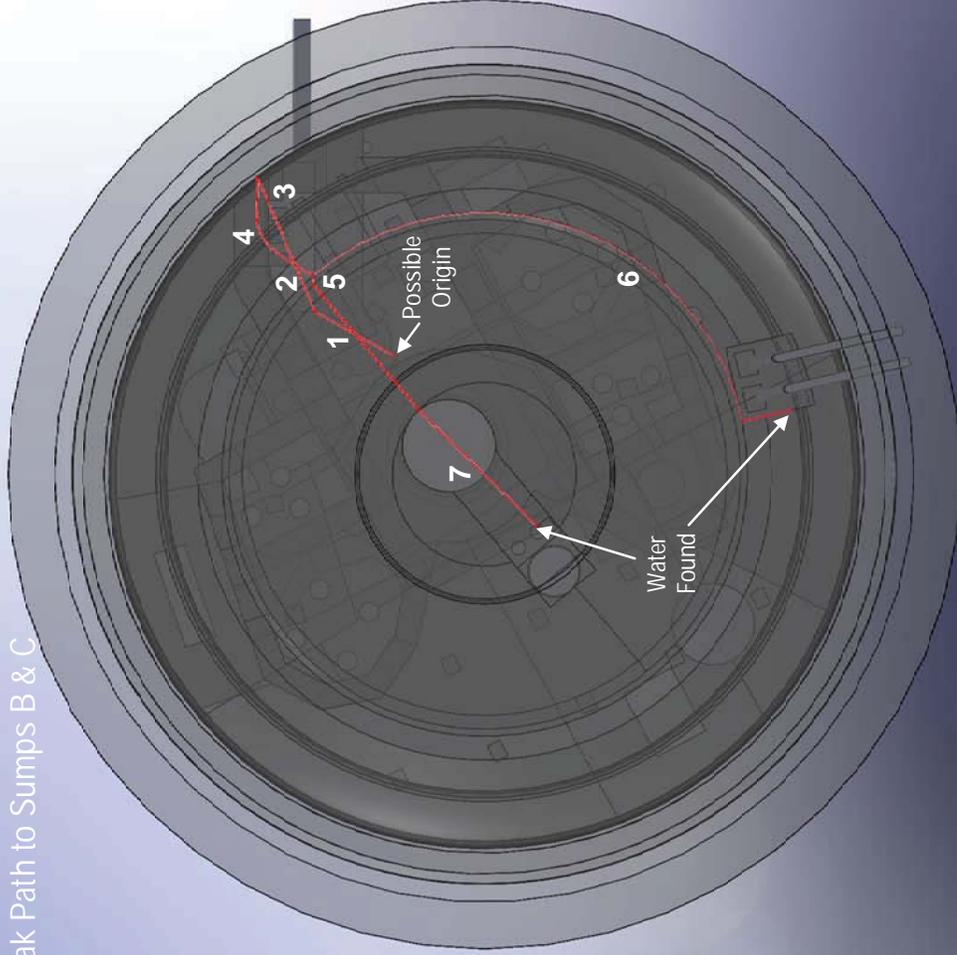
Figure A-5 Possible Borated Water Leak Paths to Sumps B & C in Unit 2 – Transparent Bottom View

Possible Borated Water Leak Path to Sumps B & C

- 1) Borated water from refueling pool possibly seeps through bolts at Internals Supports Stands on bottom of Reactor Refueling Cavity to the concrete floor underneath SS liner
- 2) Water seeps under SS liner to bottom of fuel transfer area and joins postulated leaks through bolts at Changing Fixture Supports
- 3) Water seeps at corner of fuel transfer area to the CS Containment Vessel
- 4) Water travels between Containment Vessel and concrete down to intersection of concrete Pours 2, 4, and 5
- 5) Path branches to two known destinations: Sumps B and C
- 6) Water follows arcing path between concrete Pours 2 and 5 to Sump B where it was found when grout was removed around the suction lines
- 7) Water follows along intersection of concrete Pours 2, 4a, and 4b where it then enters Sump C

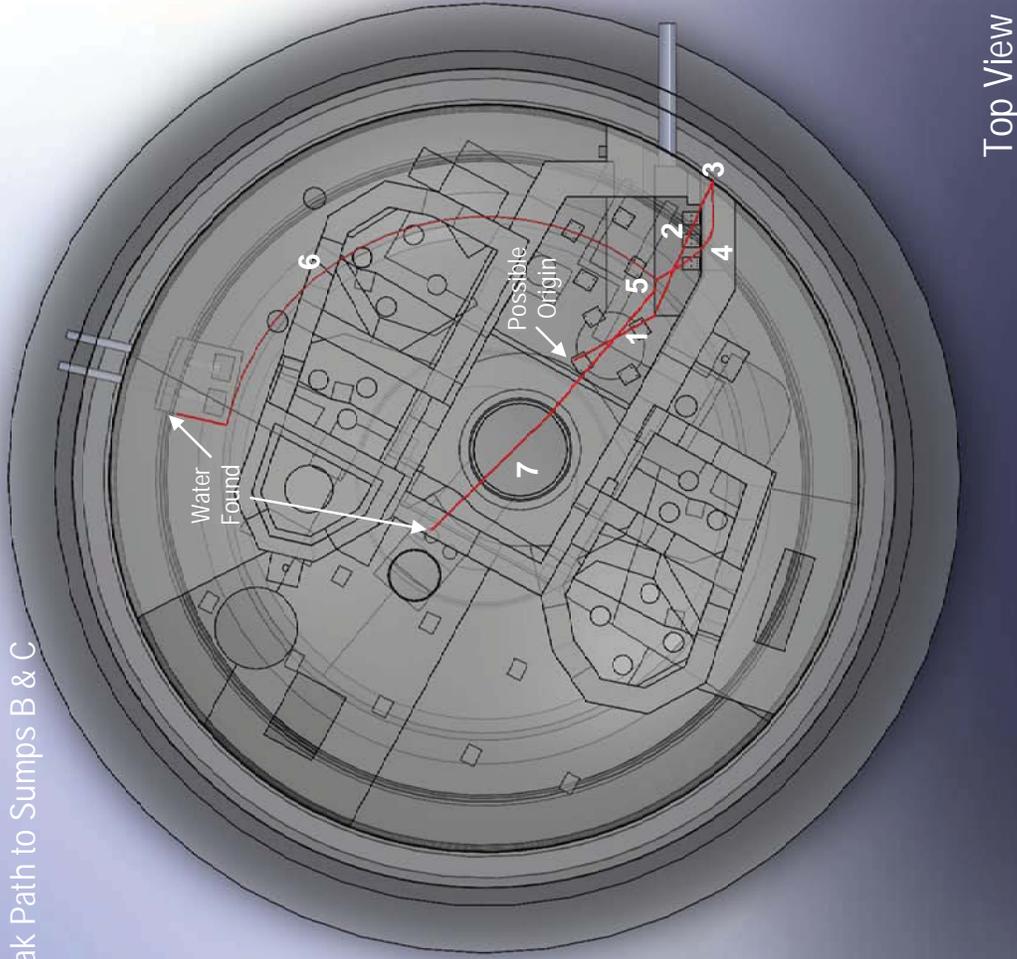
Figure A-6 Possible Borated Water Leak Paths to Sumps B & C in Unit 2 – Transparent Top View

Possible Borated Water Leak Path to Sumps B & C

- 1) Borated water from refueling pool possibly seeps through bolts at Internals Supports Stands on bottom of Reactor Refueling Cavity to the concrete floor underneath SS liner
- 2) Water seeps under SS liner to bottom of fuel transfer area and joins postulated leaks through bolts at Changing Fixture Supports
- 3) Water seeps at corner of fuel transfer area to the CS Containment Vessel
- 4) Water travels between Containment Vessel and concrete down to intersection of concrete Pours 2, 4, and 5
- 5) Path branches to two known destinations: Sumps B and C
- 6) Water follows arcing path between concrete Pours 2 and 5 to Sump B where it was found when grout was removed around the suction lines
- 7) Water follows along intersection of concrete Pours 2, 4a, and 4b where it then enters Sump C

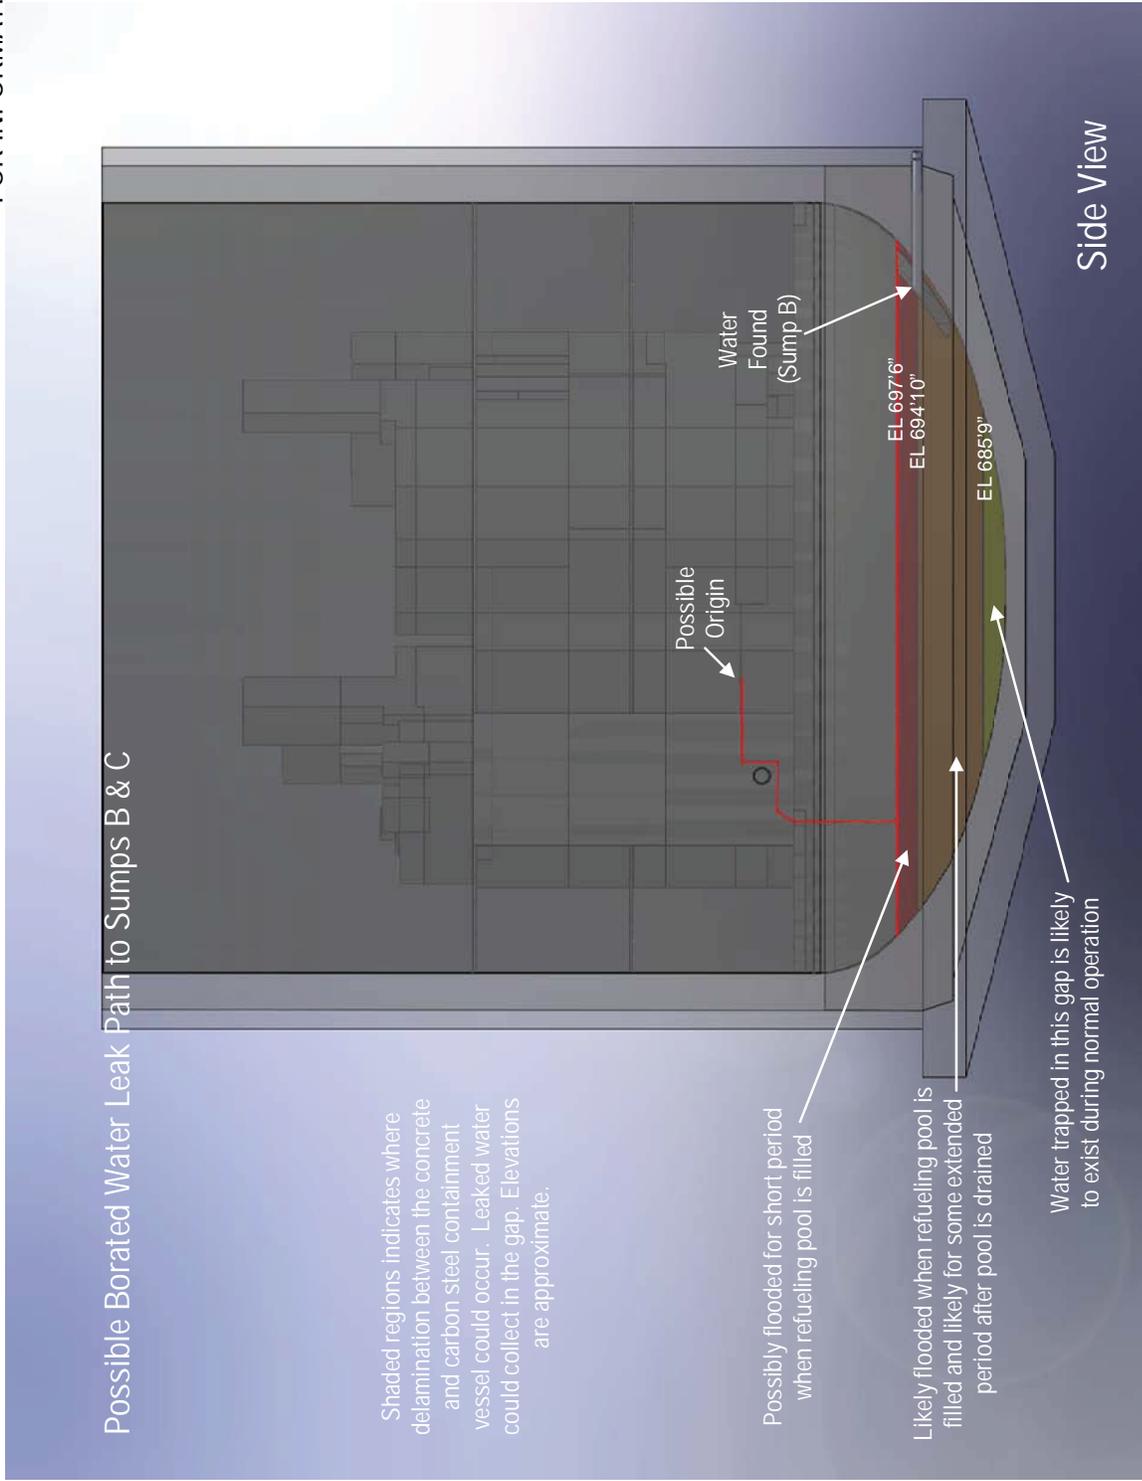
Figure A-9 Lower Regions Wetted by Possible Borated Water Leak Paths to Sumps B & C in Unit 2 – Side View

- The area in the lower regions of the containment, below an elevation of about 695 feet (just below the RHR suction pipes) or 697 feet (lowest floor elevation in containment), could have been wetted with borated water for much of plant life. Moist concrete experiences carbonation at a lower rate than dry concrete. Taking this into account together with the 1.5 inch depth of concrete cover of the rebar near the containment shell indicates that carbonation is not likely to have reached this rebar, such that no corrosion of the rebar is expected to have occurred in the possibly wetted area at the bottom of the containment.

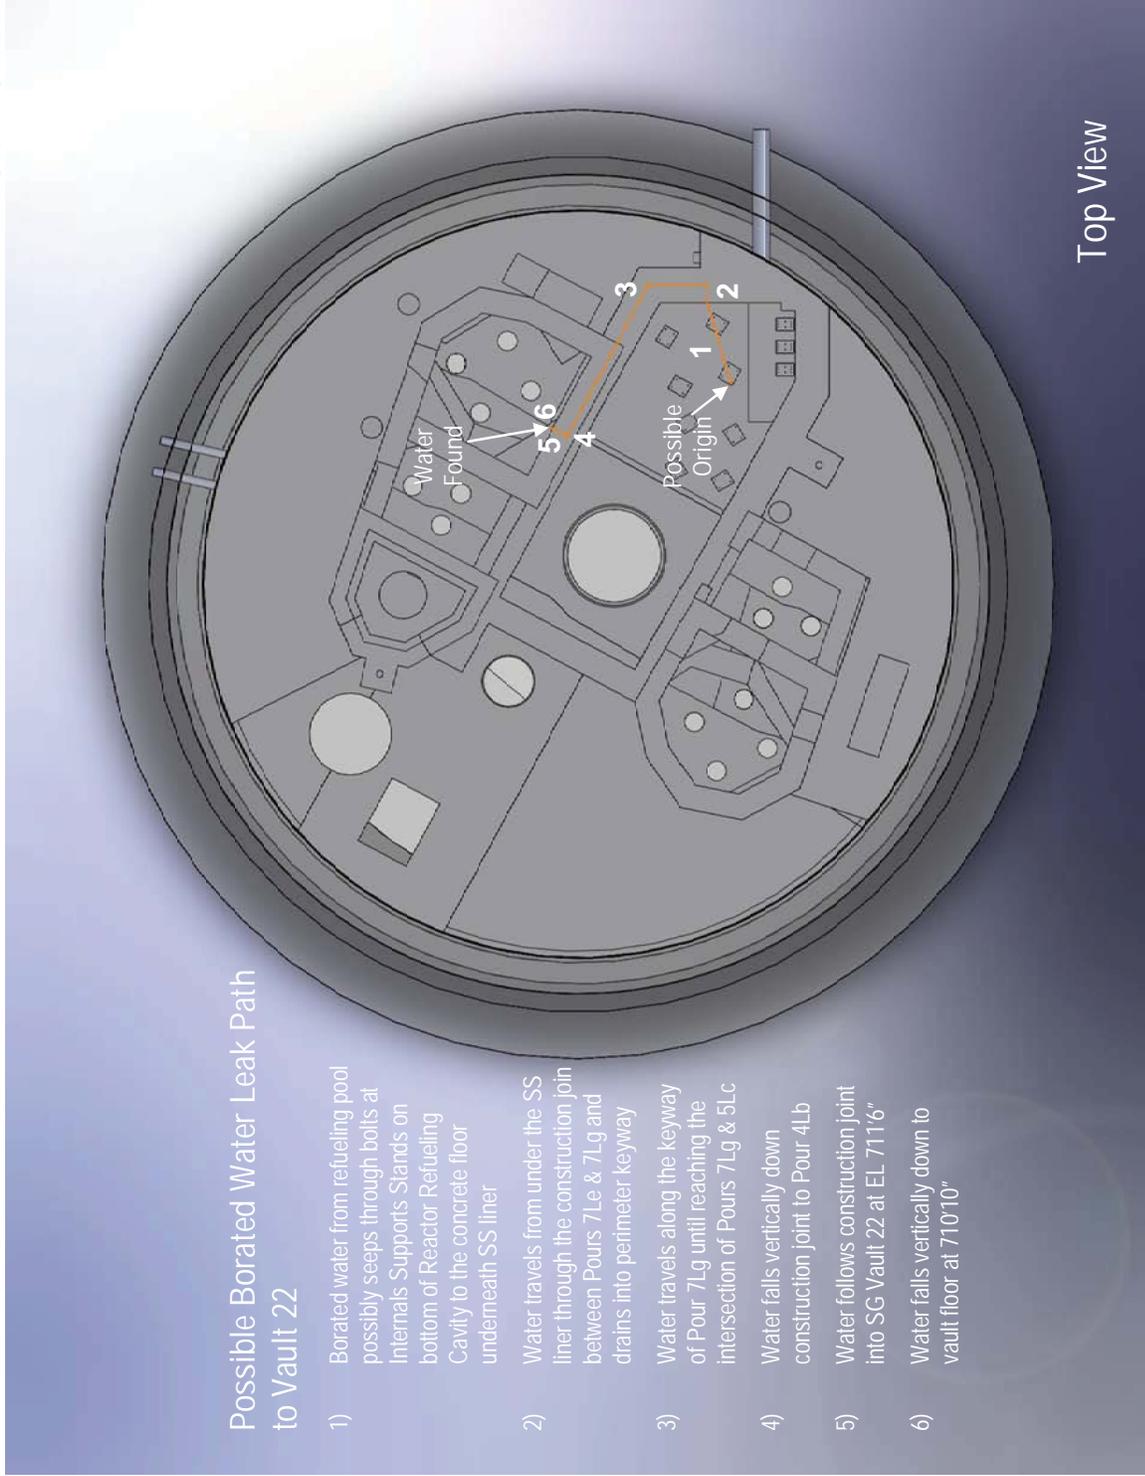
Figure A-13 Possible Borated Water Leak Path to Vault 22 – Top View

Possible Borated Water Leak Path to Vault 22

- 1) Borated water from refueling pool possibly seeps through bolts at Internals Supports Stands on bottom of Reactor Refueling Cavity to the concrete floor underneath SS liner
- 2) Water travels from under the SS liner through the construction joint between Pours 7Le & 7Lg and drains into perimeter keyway
- 3) Water travels along the keyway of Pour 7Lg until reaching the intersection of Pours 7Lg & 5Lc
- 4) Water falls vertically down construction joint to Pour 4Lb
- 5) Water follows construction joint into SG Vault 22 at EL 711'6"
- 6) Water falls vertically down to vault floor at 710'10"

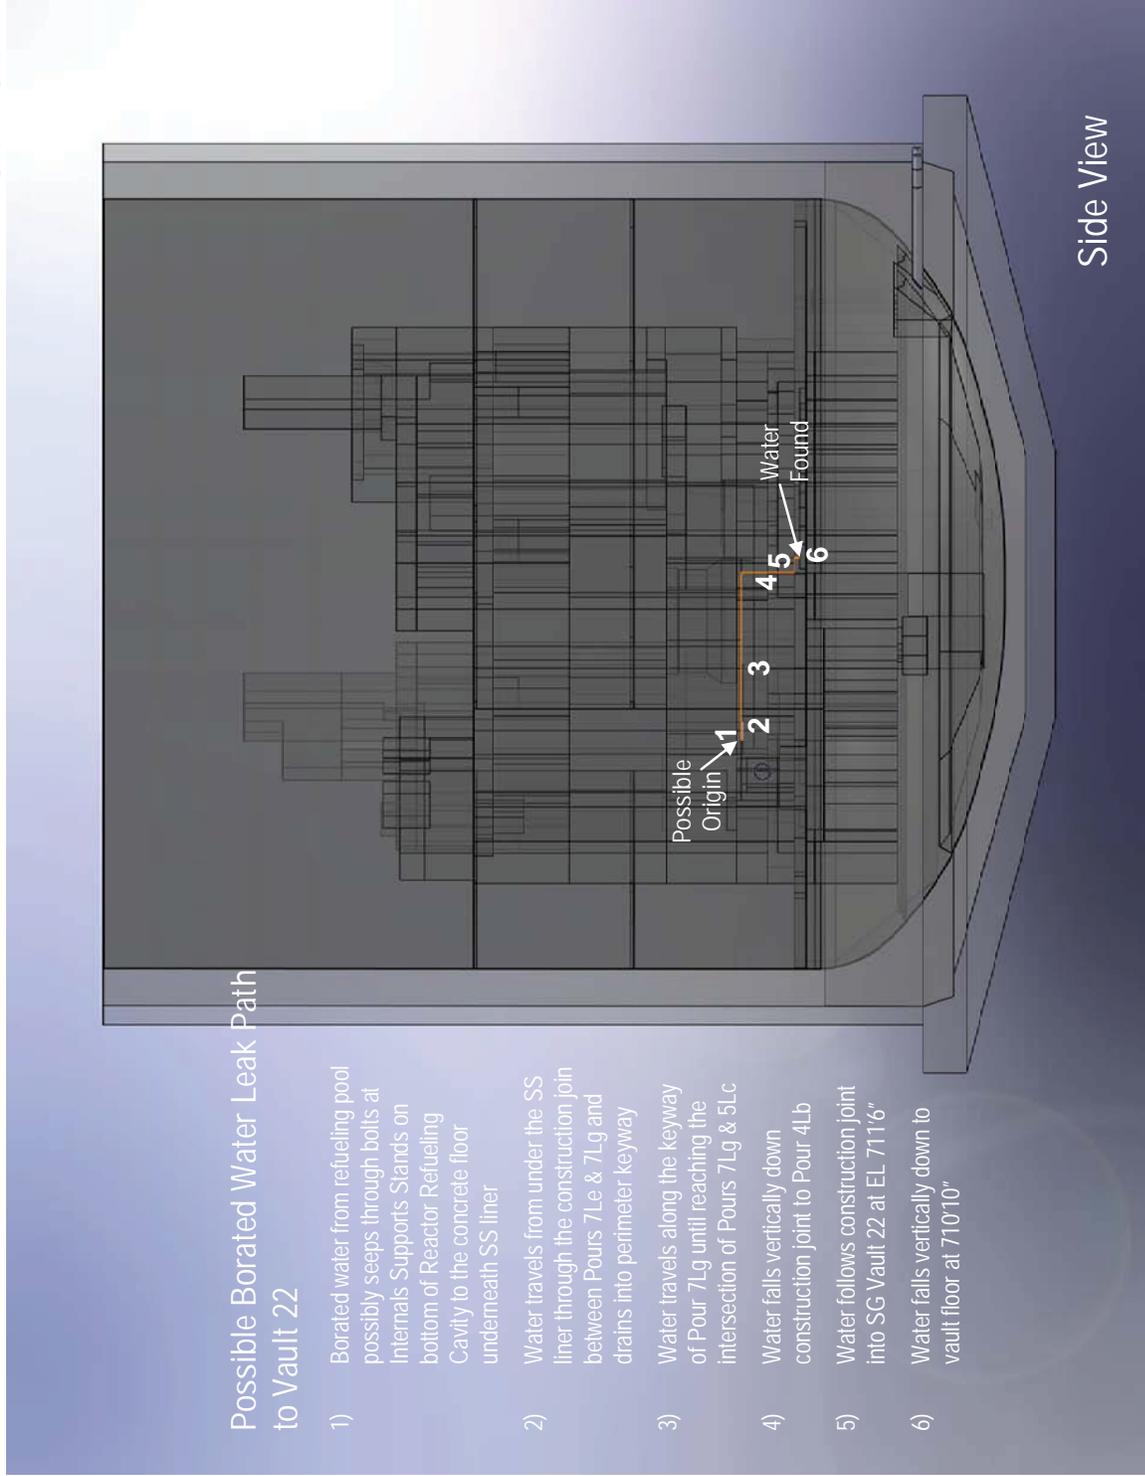
Figure A-16 Possible Borated Water Leak Path to Vault 22 – Transparent Side View

Possible Borated Water Leak Path to Vault 22

- 1) Borated water from refueling pool possibly seeps through bolts at Internals Supports Stands on bottom of Reactor Refueling Cavity to the concrete floor underneath SS liner
- 2) Water travels from under the SS liner through the construction joint between Pours 7Le & 7Lg and drains into perimeter keyway
- 3) Water travels along the keyway of Pour 7Lg until reaching the intersection of Pours 7Lg & 5Lc
- 4) Water falls vertically down construction joint to Pour 4Lb
- 5) Water follows construction joint into SG Vault 22 at EL 711'6"
- 6) Water falls vertically down to vault floor at 710'10"

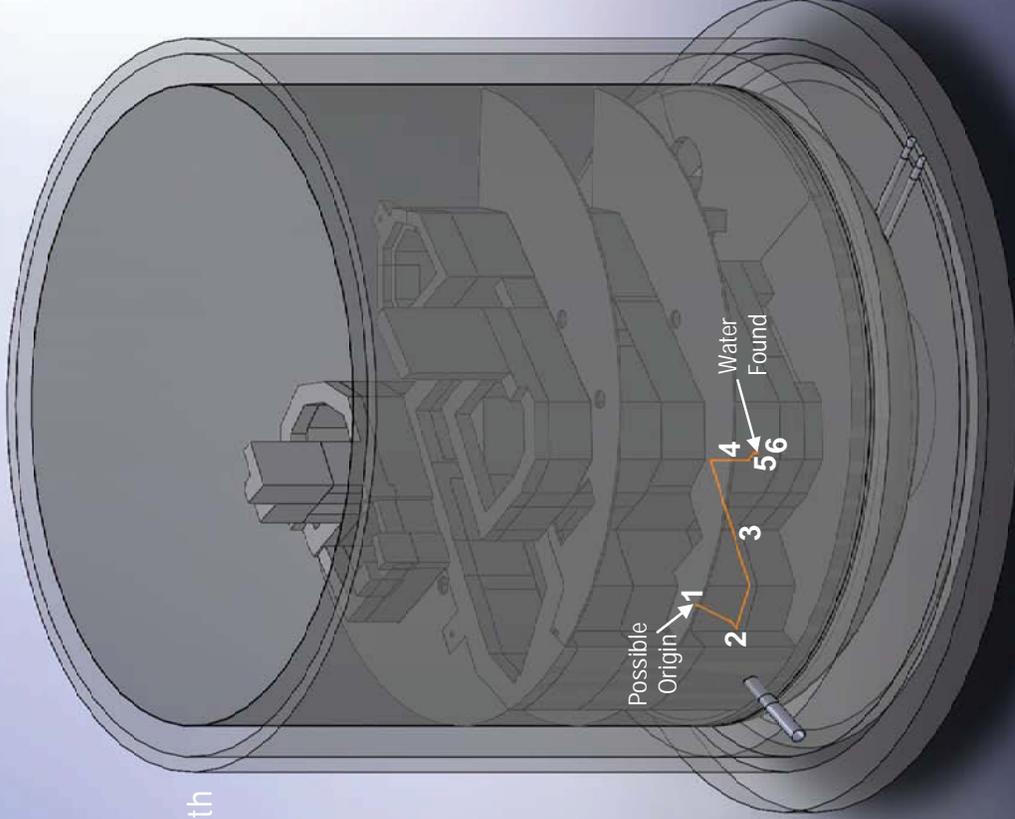
Figure A-17 Possible Borated Water Leak Path to Vault 22 – Top 3D View

Possible Borated Water Leak Path to Vault 22

- 1) Borated water from refueling pool possibly seeps through bolts at Internals Supports Stands on bottom of Reactor Refueling Cavity to the concrete floor underneath SS liner
- 2) Water travels from under the SS liner through the construction joint between Pours 7Le & 7Lg and drains into perimeter keyway
- 3) Water travels along the keyway of Pour 7Lg until reaching the intersection of Pours 7Lg & 5Lc
- 4) Water falls vertically down construction joint to Pour 4Lb
- 5) Water follows construction joint into SG Vault 22 at EL 711'6"
- 6) Water falls vertically down to vault floor at 710'10"

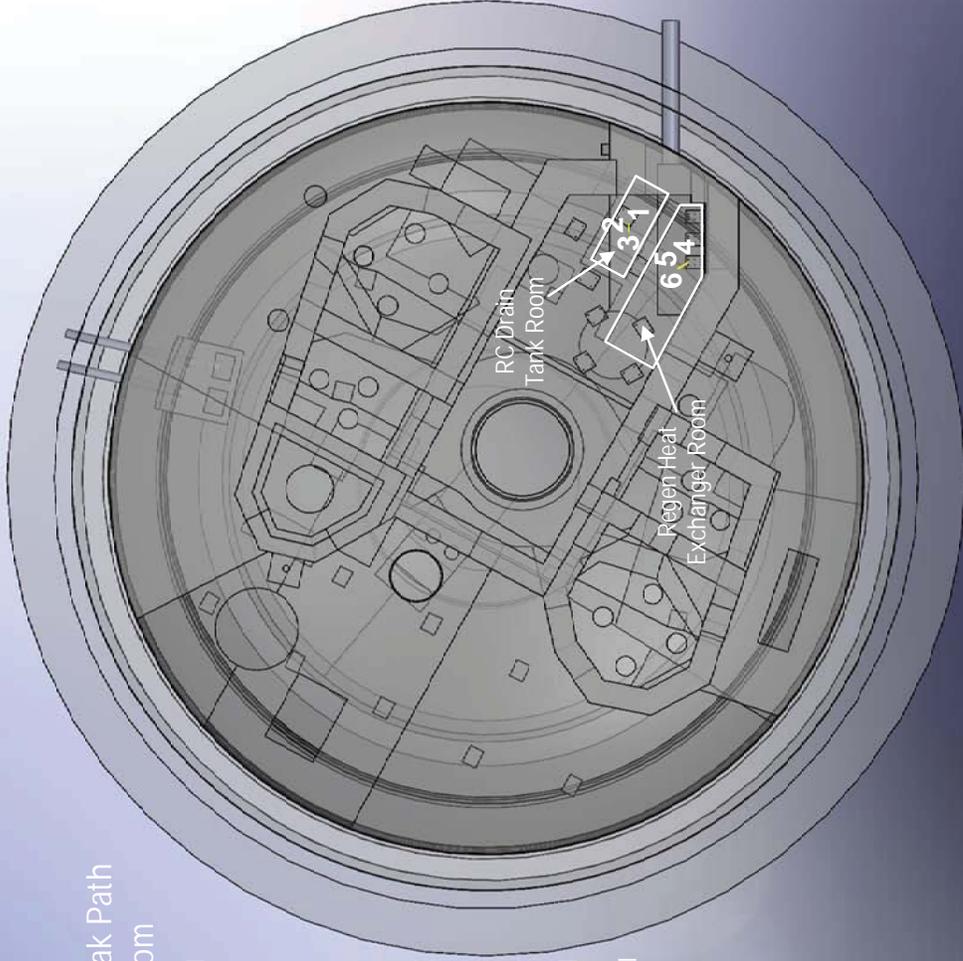
Figure A-19 Possible Borated Water Leak Path to RCDT Space and Regen HX Room in Unit 2 – Top View

Possible Borated Water Leak Path to RCDT and Regen HX Room

- 1) Borated water from refueling pool possibly seeps through bolts at Internals Supports Stands on bottom of Reactor Refueling Cavity to the concrete floor underneath SS liner
- 2) Under the liner the water travels to a crack in the concrete
- 3) Water travels through cracks in the concrete and enters RCDT Room below
- 4) Borated water from refueling pool possibly seeps through bolts at Change Fixture on bottom of Fuel Transfer Area to the concrete floor underneath the SS liner
- 5) Under the liner the water travels to a crack in the concrete
- 6) Water travels through cracks in the concrete and enters Regen Heat Exchanger Room below

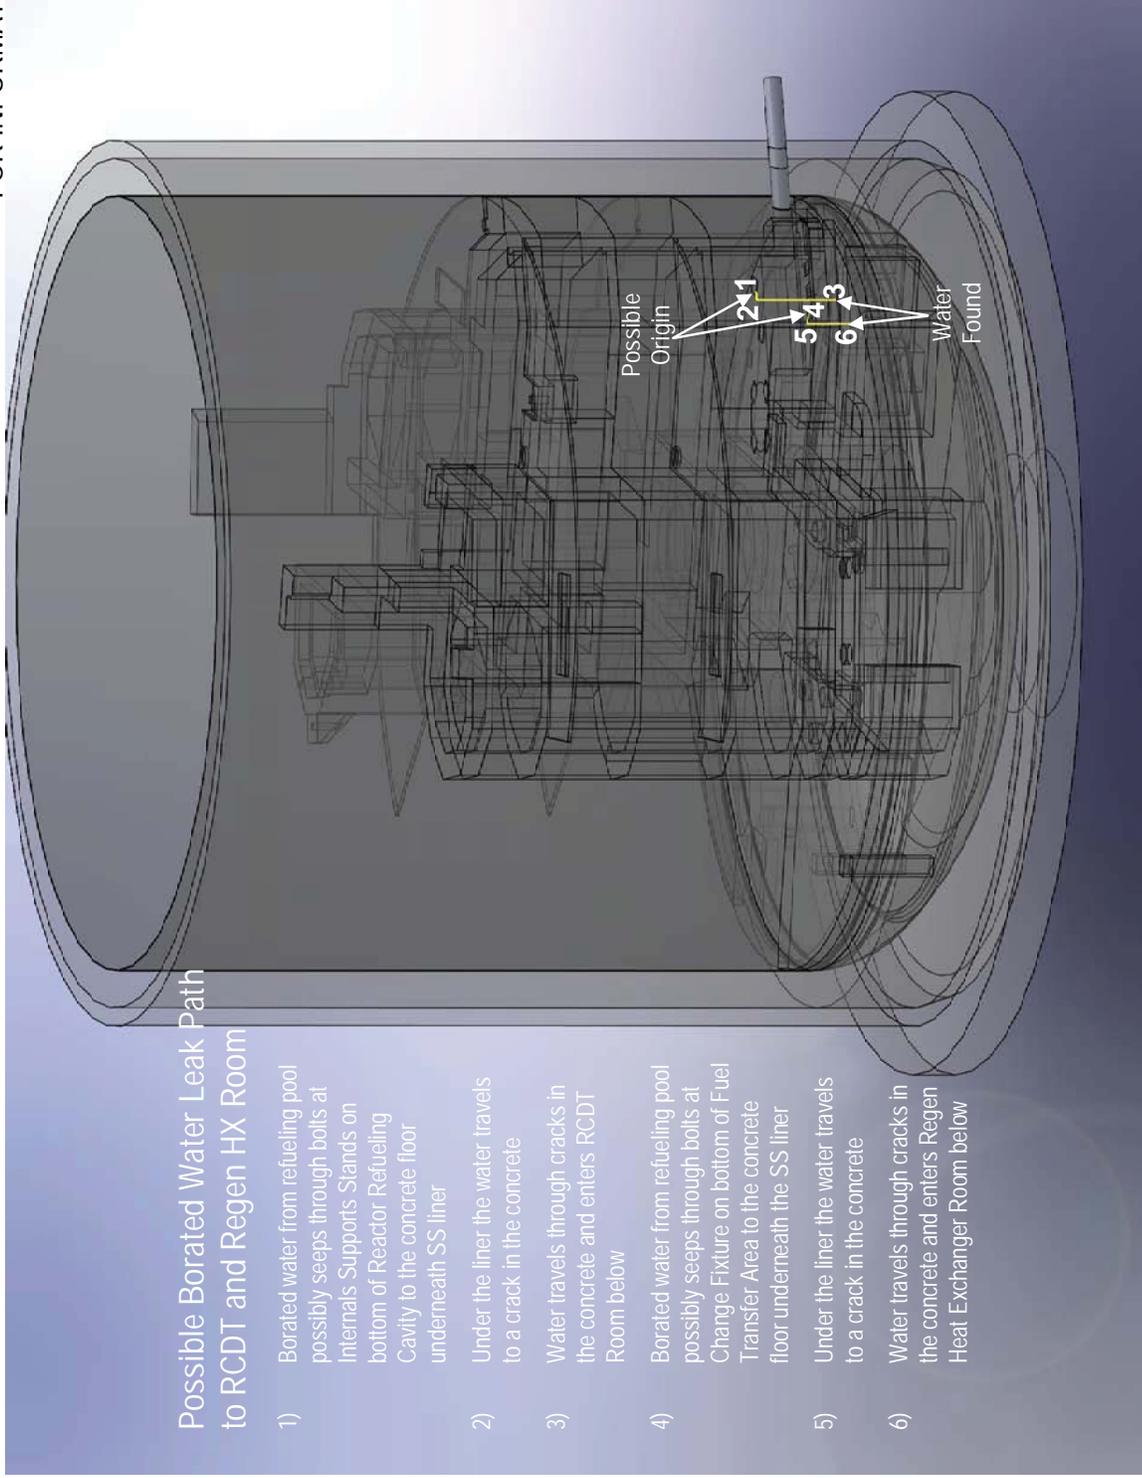
Possible Borated Water Leak Path to RCDT and Regen HX Room

- 1) Borated water from refueling pool possibly seeps through bolts at Internals Supports Stands on bottom of Reactor Refueling Cavity to the concrete floor underneath SS liner
- 2) Under the liner the water travels to a crack in the concrete
- 3) Water travels through cracks in the concrete and enters RCDT Room below
- 4) Borated water from refueling pool possibly seeps through bolts at Change Fixture on bottom of Fuel Transfer Area to the concrete floor underneath the SS liner
- 5) Under the liner the water travels to a crack in the concrete
- 6) Water travels through cracks in the concrete and enters Regen Heat Exchanger Room below
