Subject: June 2010 Inspection Report, Cameco Resources, Permits 603 and 633

**JUNE 2010 INSPECTION REPORT
DISTRICT 1/LAND QUALITY DIVISION**

COMPANY: Cameco Resources (CR), Highland Ranch, Permit #603
& Smith Ranch, Permit 633

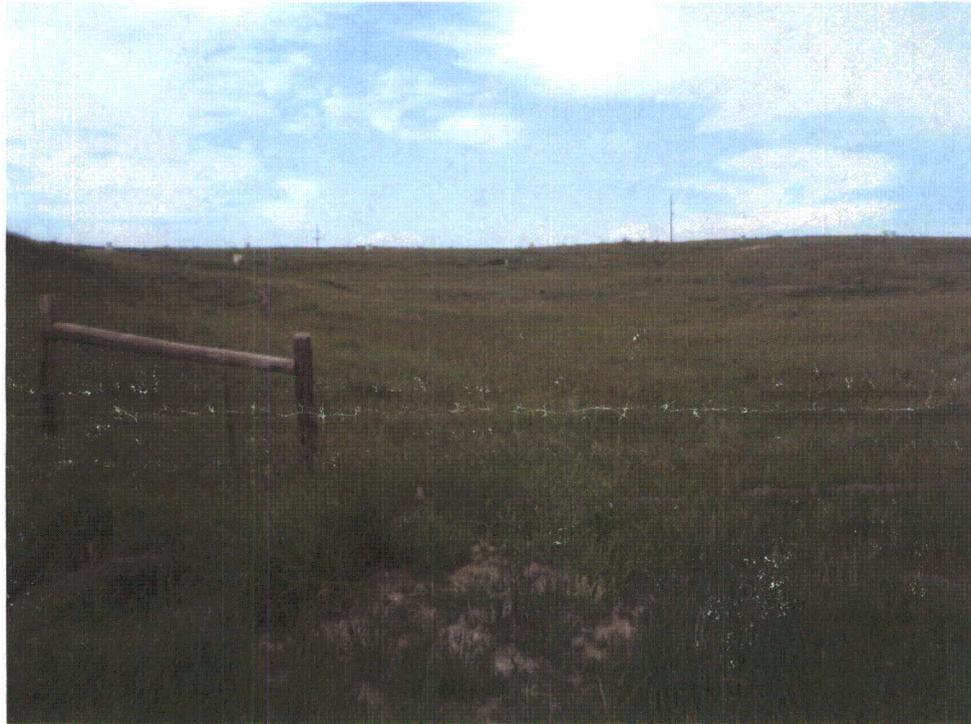
Photo #5: Upstream view (from the fenceline) of the Mine Unit H spill reclamation watershed in the vicinity of Header Houses #11 and #12. Watershed is stable and well vegetated.

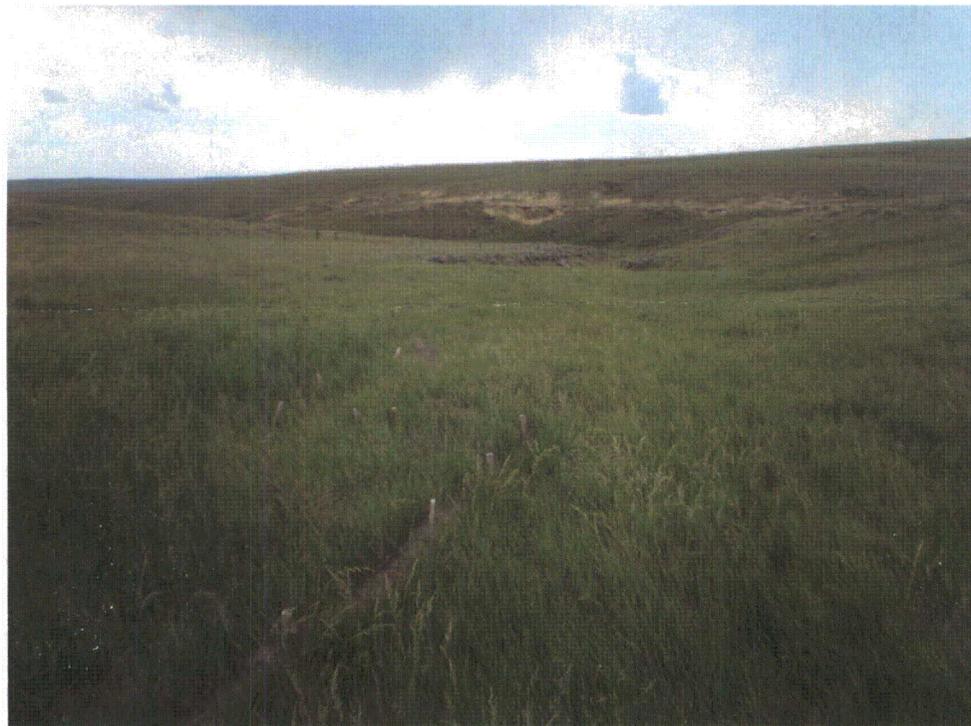
Photo #6: Downstream view (from the fenceline) of the Mine Unit H spill reclamation watershed in the vicinity of Header Houses #11 and #12. Watershed is stable and well vegetated.
