Subject: June 2010 Inspection Report, Cameco Resources, Permits 603 and 633

**JUNE 2010 INSPECTION REPORT
DISTRICT 1/LAND QUALITY DIVISION**

COMPANY: Cameco Resources (CR), Highland Ranch, Permit #603
& Smith Ranch, Permit 633

DATE OF INSPECTION: June 22, 2010

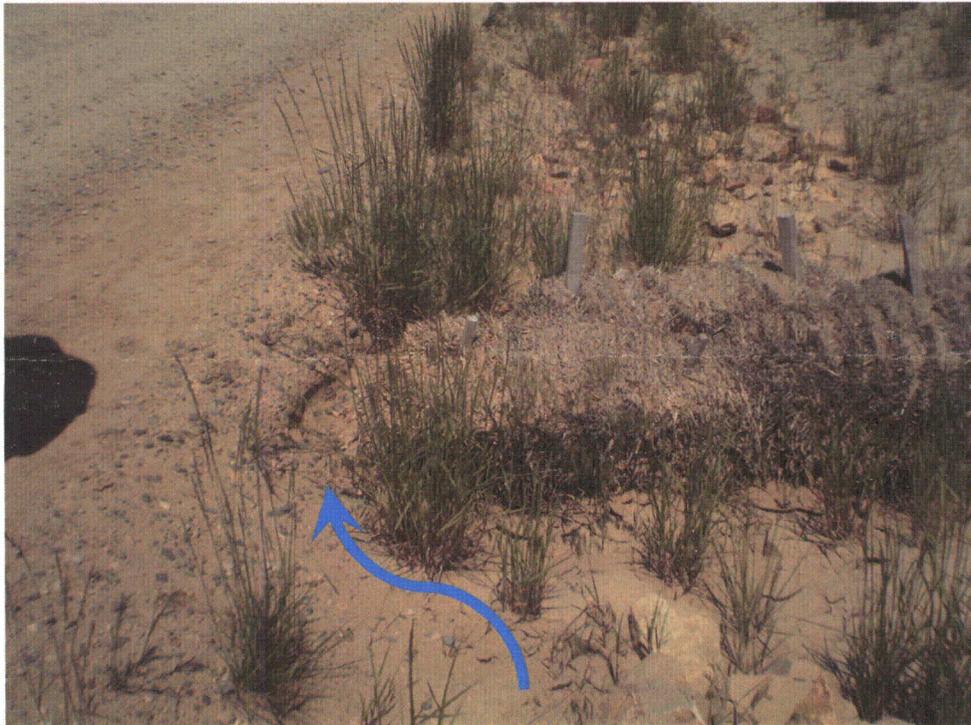
LQD inspected several roadside ditches along the main access roads throughout the mine. In most locations, CR has installed hay bale check dams to enhance deposition of sediment from roads within the ditches. The hay bale check dams are providing a moderate level of sediment control, but many of the individual structures are exhibiting problems related to maintenance and duration of installation. Common problems with many of the structures were related to the height of installation, and the amount of sediment deposition upstream of the structures. Many of the hay bales were installed with the top of the bale higher than the top of the ditch bank. This installation method is incorrect. LQD reviewed proper installation with CR, and informed CR that the structures need to be keyed-in to the bottom and sides of the ditch, the height of the center bale should be between one-half and two-thirds the depth of the ditch, sediment should be removed when the depth of deposition is approximately half the depth of the ditch, and that the hay bales should be replaced more frequently. **Photos #1 and #2** demonstrate deficiencies that were typically found with the hay bale check dams. Those deficiencies are: 1) top of the bales are too high, causing erosion around the structure and into the roadbed once sediment deposition fills to the height of the roadbed (blue arrow in Photo #1), 2) degradation of structure integrity as the hay bales become unconsolidated over time, and 3) sediment deposition allowed to remain

Photo #1: Example of common problem with hay bale check dams at the site – flanking scour as water flows around the structure once structure is filled with upstream sediment.

in-place after filling to the height of the roadbed. Considering that these structures are likely to remain in-place for many years, LQD recommended the replacement of the hay bale check dams with properly constructed rock check dams. The rock check dams should be installed with a low-flow point in the center, and used to provide long-term channel stability to allow the development of a densely vegetated roadside ditch. See attached Figure 1 for installation example drawings. CR should leave sediment deposition in-place, and hand seed all deposition upstream of the structures to encourage the development of a vegetated ditch.

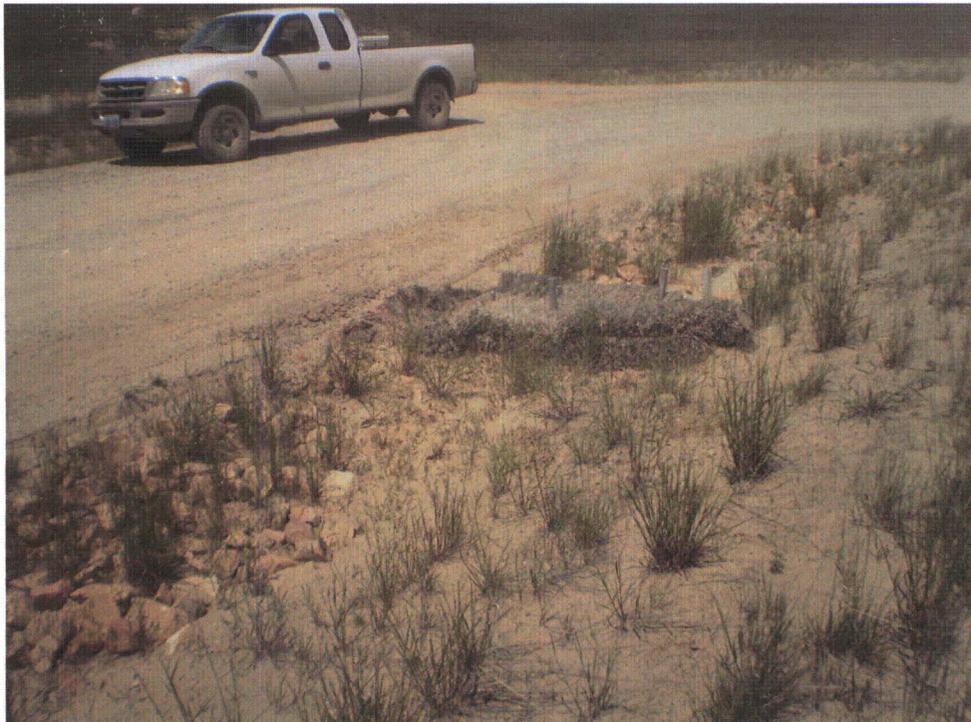
Photo #2: Typical hay bale check dam installation. Bales are installed too high creating the potential for flanking scour as the structure fills with sediment. Bales are degrading due to the amount of time in-place.

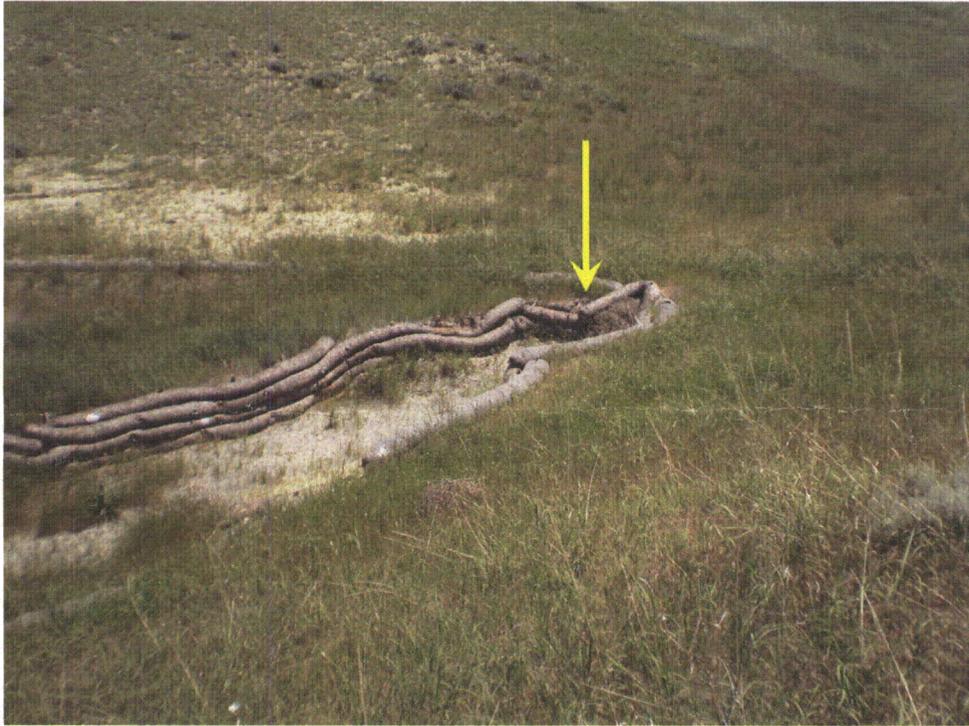
LQD inspected a headcut reclamation and channel stabilization project shown in **Photo #3**. CR made extensive use of straw wattles to stabilize the channel and headcut. In general, the work appears to have been installed appropriately and has been effective in stabilizing the erosion. The use of single-layer wattles as upslope diversion/sediment detention structures and as cross-channel check dams, and of stacked wattles as bank stabilization structures is generally acceptable to LQD. The use of stacked wattles to stabilize a headcut feature would be considered experimental. As shown in photo #3, one of the wattles used to stabilize the headcut knickpoint is no longer functioning as installed (yellow arrow). LQD suggested that CR continue monitoring this work on a regular basis, and if the structures do not appear to be functioning properly, consider replacing the wattles with rock structures (particularly to stabilize the headcut knickpoint).

Photo #3: Stabilization of headcut knickpoint, banks, and stream bed with wattles. The stabilization is generally successful, but monitoring of the knickpoint stabilization is warranted due to movement of wattles at the knickpoint.

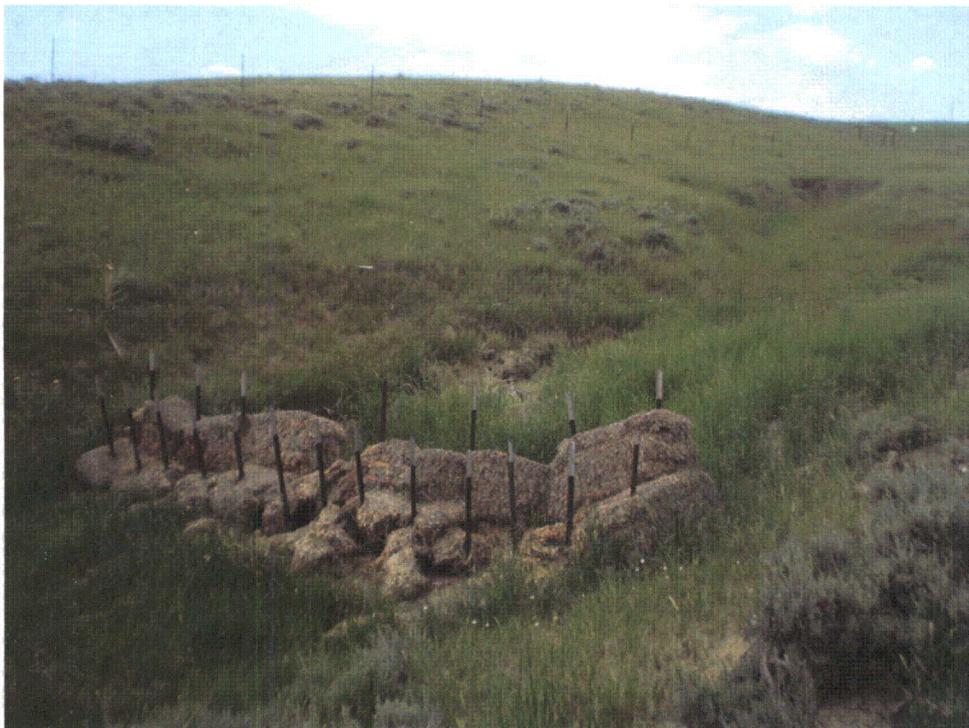
The reclamation is very successful in this area. At the downstream end of the reclaimed area, CR installed a large hay bale check dam as perimeter sediment control (**Photo #4**). The watershed in this reclaimed area is stable and well-vegetated with no erosion evident (**Photos #5 and #6**). Because the watershed is stable and well-vegetated, LQD believes it would be appropriate to remove the hay bale structure and the associated t-posts. The t-posts should be removed from the site. The straw from the bales may be spread lightly across the reclamation.

Photo #4: Degraded hay bale check dam in Mine Unit H spill reclamation. Structure can be removed due to the stability and vegetative success of the watershed upstream.

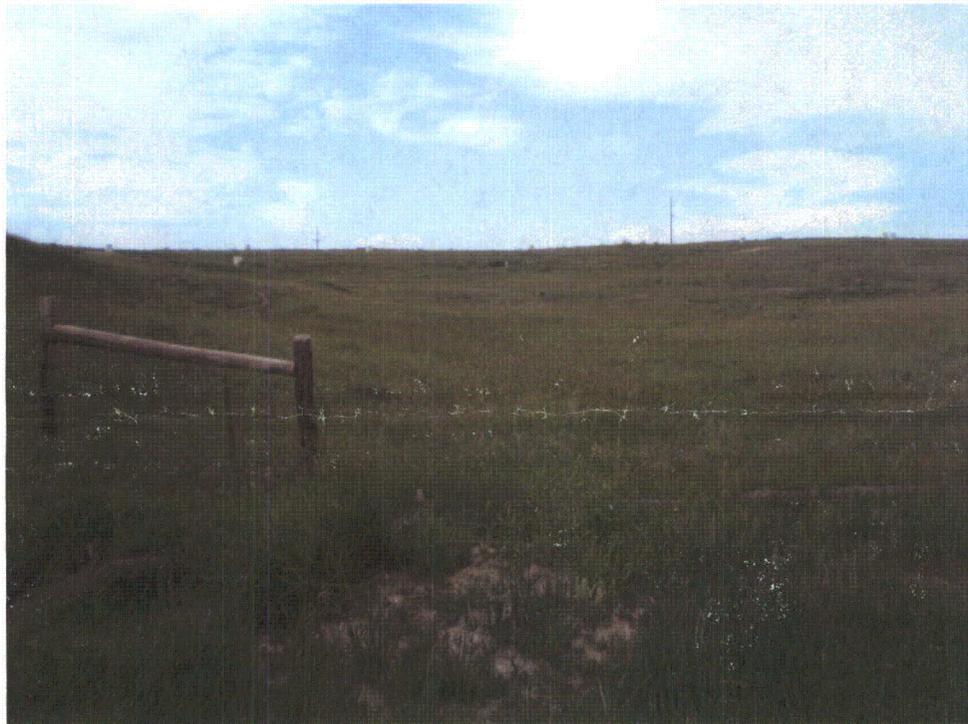
Photo #5: Upstream view (from the fenceline) of the Mine Unit H spill reclamation watershed in the vicinity of Header Houses #11 and #12. Watershed is stable and well vegetated.

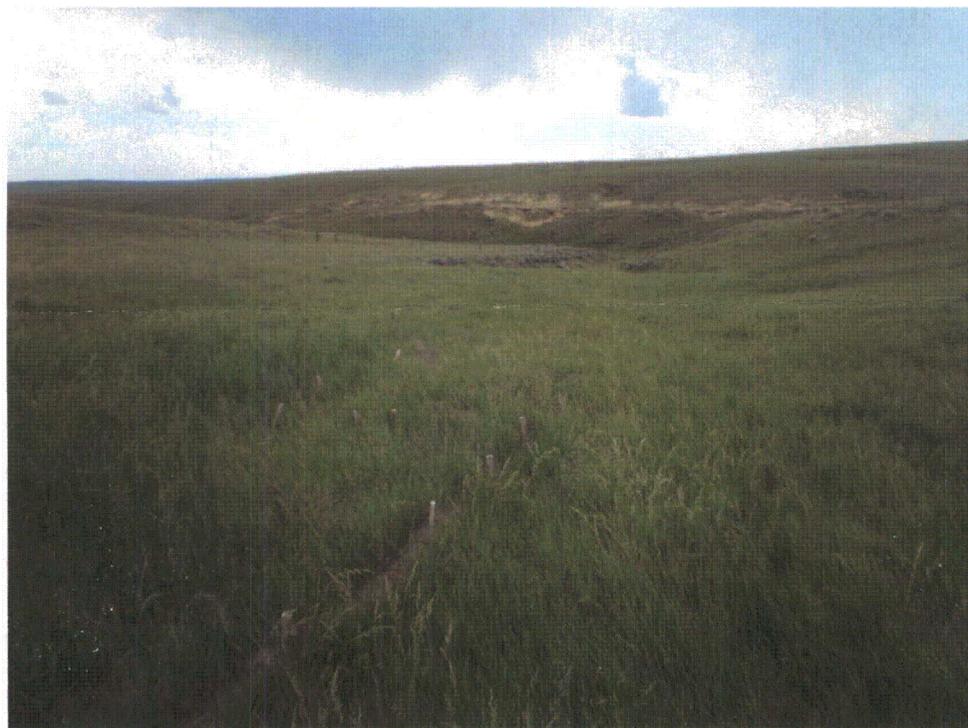
Photo #6: Downstream view (from the fenceline) of the Mine Unit H spill reclamation watershed in the vicinity of Header Houses #11 and #12. Watershed is stable and well vegetated.
