SRR-CES-2010-00047

Inadvertent Transfer of Salt Solution To Vault 4 Cell "F" 05/19/10

Facility: Saltstone – Z Area

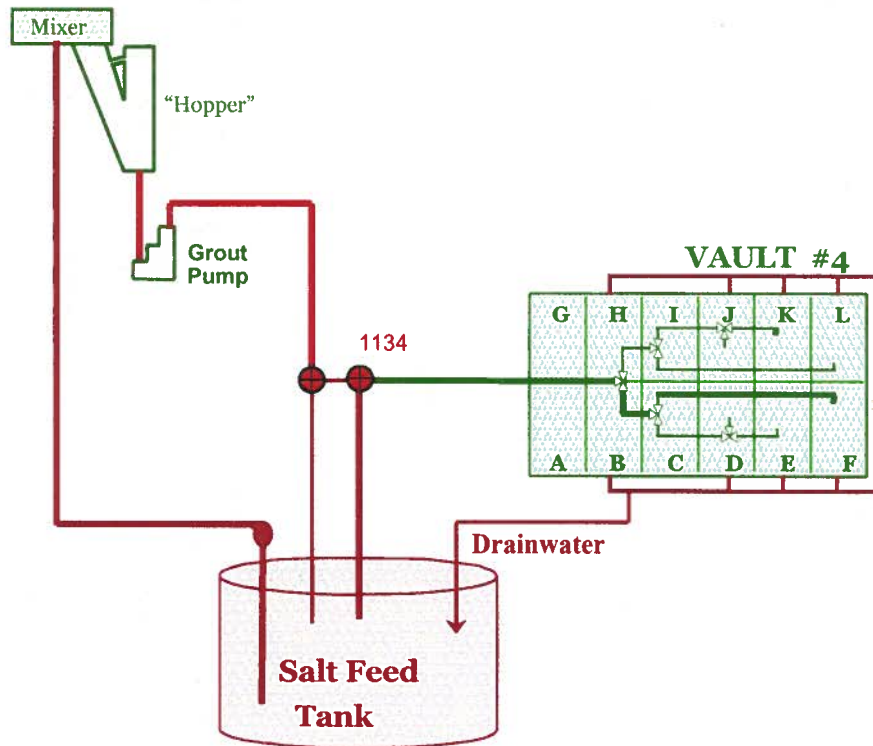
SCHEMATIC

- During performance of a Special Procedure to test Salt Feed Tank pump and agitator, about 1900 gallons of liquid was inadvertently transferred from the Salt Feed Tank to Vault #4 Cell F.
- The Bleed Water level increased in Vault #4 Cell F due to the material. The Drainwater Return System was utilized to return the liquid to the Salt Feed Tank.
- Event was the result of the operator's failure to position valve 1134 per the procedure coupled with a single point failure situation.
- Samples pulled (from hopper) and analyzed for pH, chromium, and mercury levels. Concentrations consistent with past samples (RCRA non-hazardous and LDR compliant)
- SC DHEC notified of the event, path forward and sample results.
- A Fact Finding has been conducted with Corrective Actions developed to prevent recurrence.

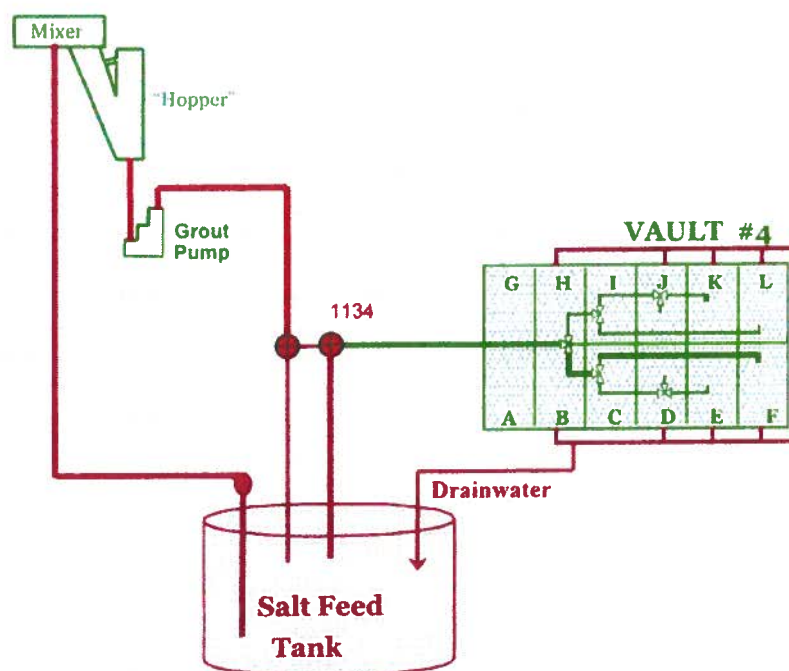
SCHEMATIC

While monitoring the process, the control room operator identified that the SFT level was unexpectedly decreasing. Operations personnel successfully secured the process to stop recirculation. It was determined that HCV-1134 was in the incorrect position (aligned to Vault 4). Approximately 1,900 gallons of low-level liquid waste from the SFT was inadvertently transferred to Vault 4 Cell F due to the valve misalignment. The Drain water level increased in Vault #4 Cell F due to the material. The Drainwater Return System is being utilized to return the material to the Salt Feed Tank. No material was released to the environment. The event has been reported under ORPS criteria 4B(5).
