**GROUNDWATER TRITIUM
STATUS REPORT
WATTS BAR NUCLEAR PLANT**

August 2005

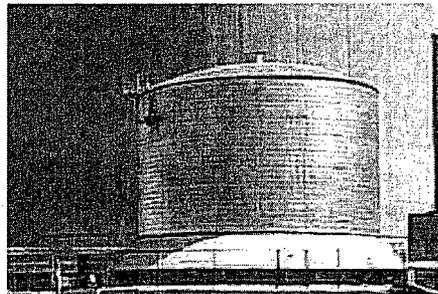
Photo 4

The RWST (Photo 4) is a large source of water used during refueling outages and is also a source of water to the reactor should there be a loss of coolant accident. The water from the RWST is used to fill the fuel transfer canal and the reactor cavity during refueling outages and is returned to the RWST at the conclusion of the outage.

Because the RWST is a large volume of water with elevated tritium concentration (approximately 28 million pCi/l) the integrity of the RWST was reviewed. The RWST was found to be losing water at a rate of approximately 150–200 gallons per day (gpd). Several valves associated with the piping to/from the RWST were examined and found to be leaking. The valves were repaired, reducing the water loss to approximately 45–50 gpd.

A transducer was installed in the RWST and water level was tracked between November 4 and December 18, 2003. The data was given to Pacific Northwest National Laboratory (PNNL) to perform a rough evaporation calculation. Results from PNNL indicate that most of the level loss can be attributed to evaporation.

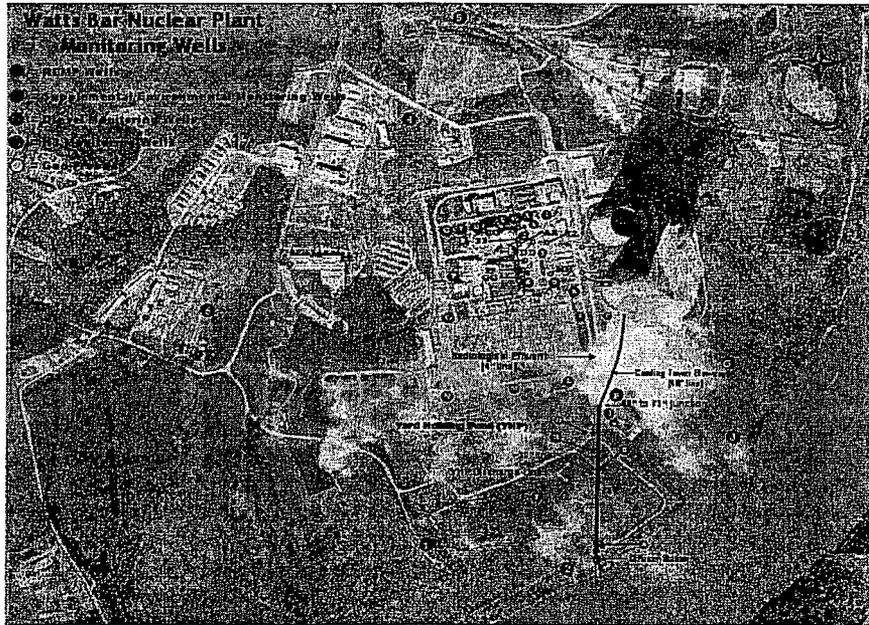
Figure 2

To further define the source of tritium, the two inputs were sampled. The northern perimeter drain input to the groundwater sump had more water input and a tritium concentration of approximately 4,500 pCi/L, while the southern input had much less water input and a tritium concentration 21,000 pCi/L. Based on this information, it appears that both legs of the drain system are collecting water with tritium.

Tritium levels in the groundwater sump have declined from the highest levels encountered (2003) and have remained relatively steady over the last year.
