2.12 Appendices

2.12.1 Certification Tests on CTU-1

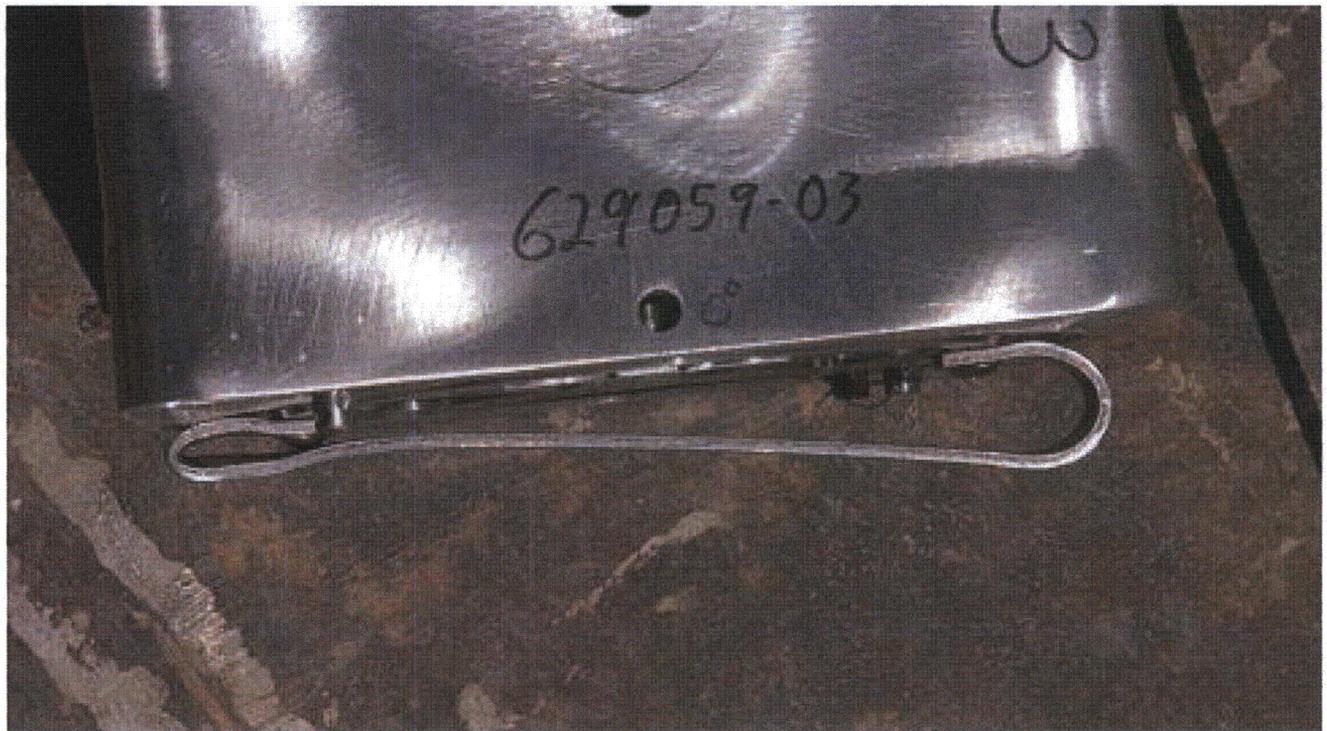
Figure 2.12.1-6 - CN1-1 Impact Damage

The impact location was at corner number 5 identified in Figure 2.12.1-4. Following impact, the CTU bounced slightly and tipped over onto its side. There was minor visible exterior damage at the impact corner. The maximum deformation at the corner was approximately 1/8 inch. The closure handle was also deformed as a result of the drop. The overall length of the package did not change other than the 1/8 inch at the impact corner and compression of the closure handle of approximately 1/2 inch on one side. There was also a 1/8 inch deformation on the side corner approximately 1 ¼ inch from the impact corner. There was no visible deformation or rotation of the closure, other than the handle. Figure 2.12.1-6 and Figure 2.12.1-7 show the CTU following the NCT drop.

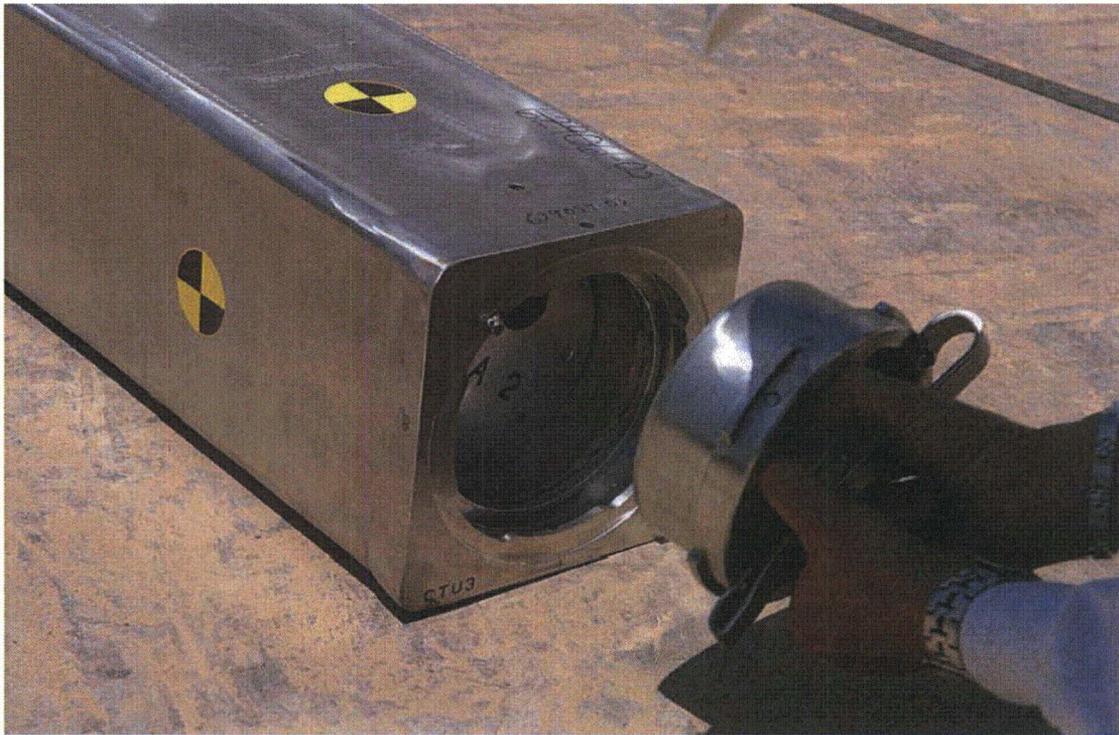
Figure 2.12.1-9 – CD1-1 Impact Side

| Test No. | Test Description | Comments |
|---|---|---|
| CD1-1 | Flat side drop, pocket side down | Flat side drop from 30 ft. Minor visible scratches and impact marks. Closure functions properly. Package opened and inspected. One locking pin on closure bent slightly but still operable. No visible damage to fuel element. |

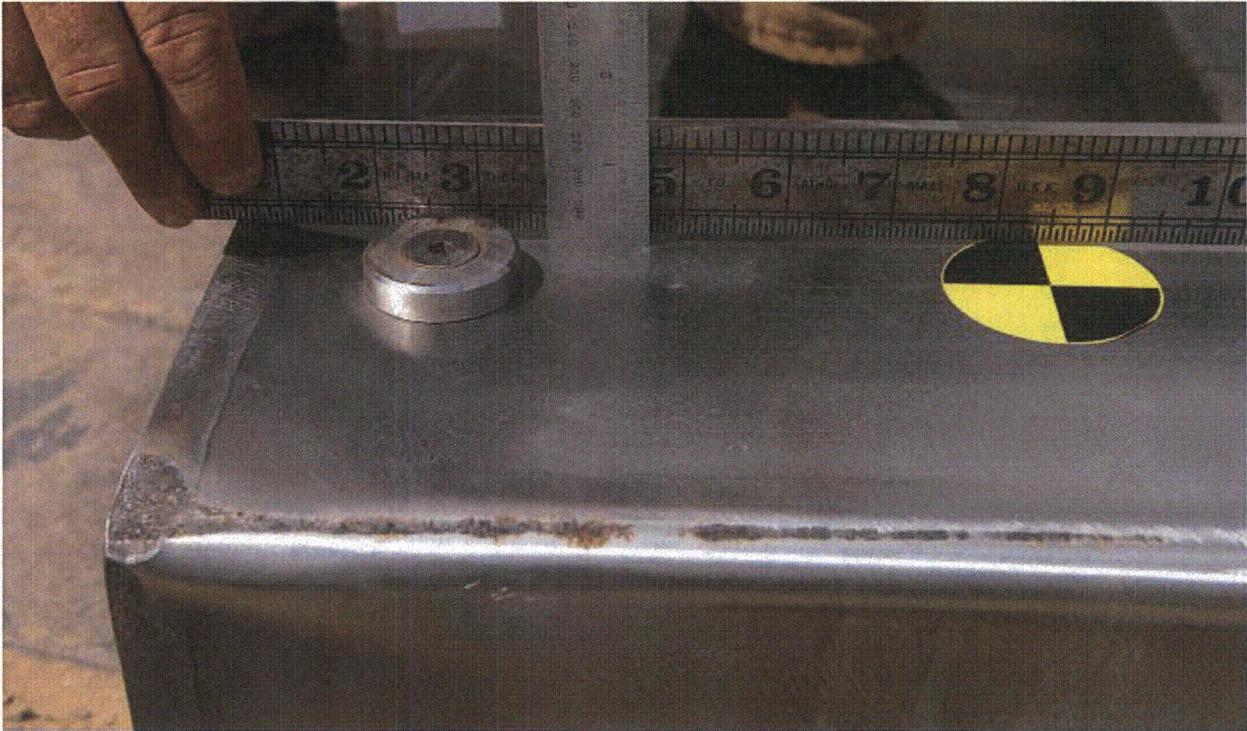
Figure 2.12.1-15 - Index Lug Near Closure End, CD2.A-1

Following impact, the CTU bounced and spun in the air about its longitudinal axis. After viewing the high speed video it was confirmed that the CTU impacted the drop pad at a slight angle on the longitudinal axis which caused the CTU to spin during the rebound. The index lugs did receive much of the impact but due to the angle it may not have been the worst case impact to the index lugs. There was visible exterior damage resulting from the drop at the index lugs. The index lugs were both pressed inward approximately 1/8 inch. There were no visible signs of broken welds.

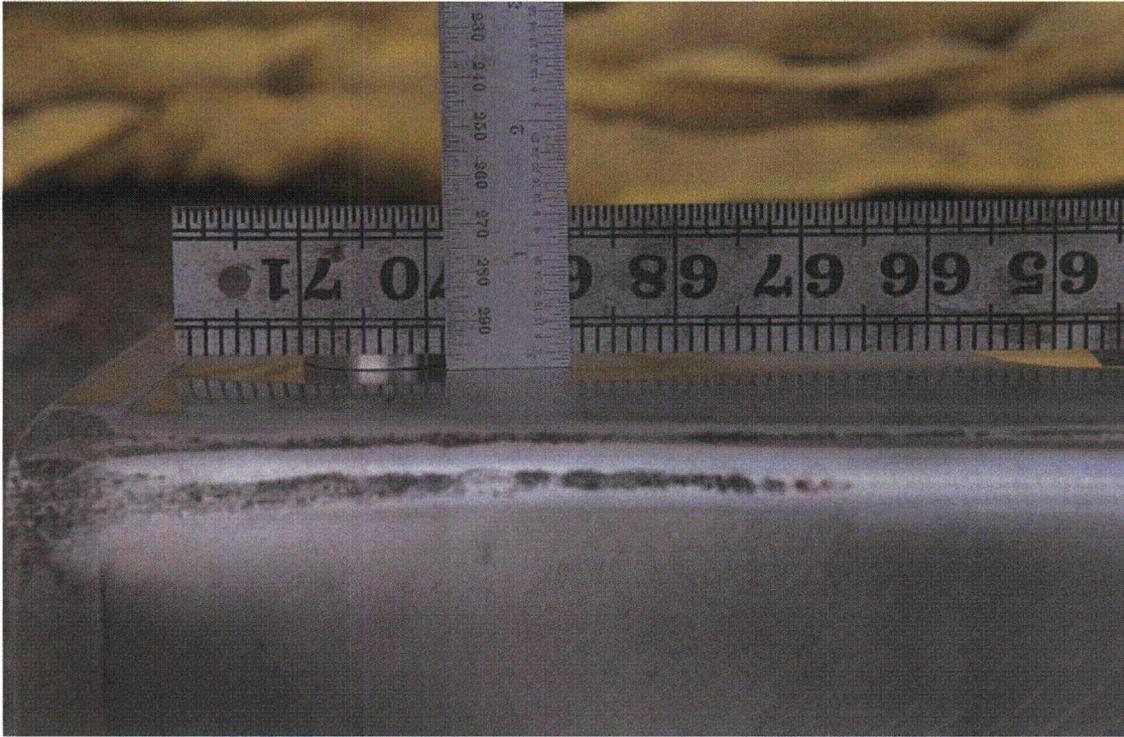
Figure 2.12.1-19 - CTU Position Following CD2.B-1 Drop

During the drop the high speed video showed that the CTU rotated past the horizontal position in the air and impacted at an incline again. Furthermore, the rigging caught a gust of wind and blew to the side and caught the North stadia board. Following impact, the CTU bounced and spun in the air about the longitudinal axis indicating a non-flat impact. The index lugs were both pressed inward approximately 3/16 inch, at the greatest point, from the original surface of the tube. There were no visible signs of broken welds. The handle of the closure assembly broke loose at point #6 shown in Figure 2.12.1-4. The two screws both sheared off and the opposite side remained attached. There was no other significant visible deformation. There was no visible deformation or rotation of the closure and the locking pins remained in the locked position following the drop. During a functional test of the closure assembly the locking pins functioned well (with the locking pin near #8 binding in the open position) and the closure could rotate approximately ¼ inch. Figure 2.12.1-19 and Figure 2.12.1-20 show the CTU following the drop.

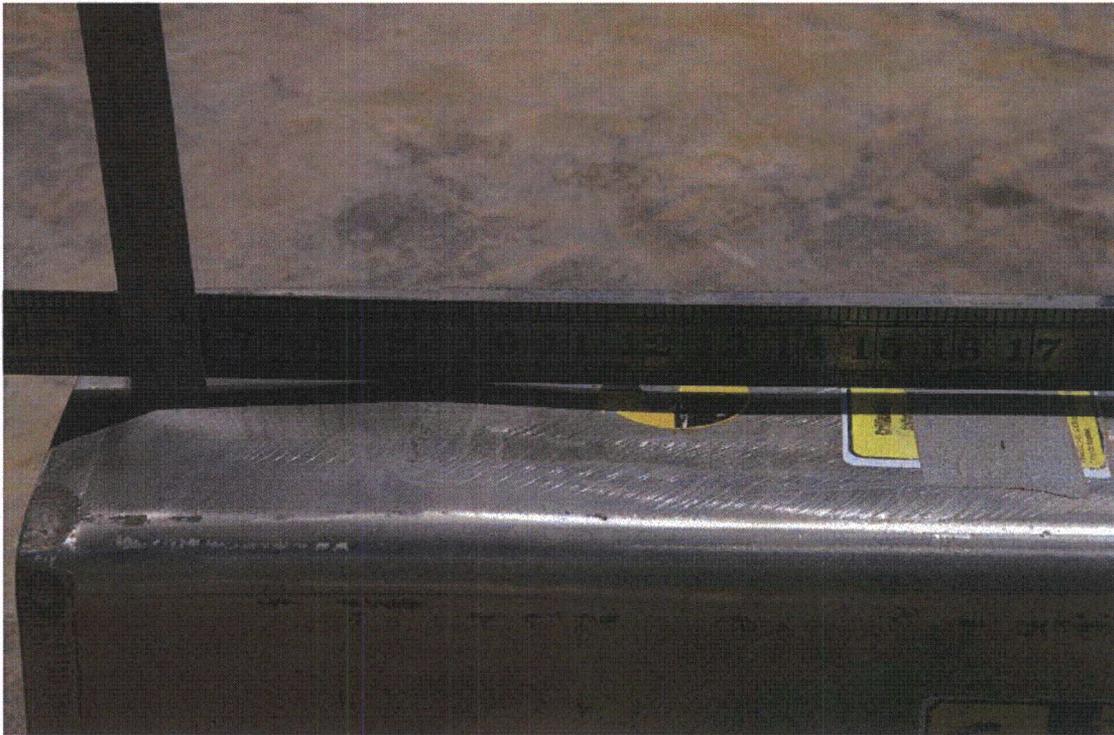
Figure 2.12.1-27 - View of Impact End Following CD4-1

Following impact the outer shell of the CTU exhibited minor bowing near the impact end with the greatest deformation measuring approximately 1/8 inch on the 90° side per Figure 2.12.1-4. The overall length of the package body was compared with the initial measurements at the eight locations and found to have compressed a maximum of approximately 1/8 inch. There was no visible deformation or rotation of the closure following the drop and the functionality of the closure assembly did not change. Figure 2.12.1-27 and Figure 2.12.1-28 show the CTU following the drop.

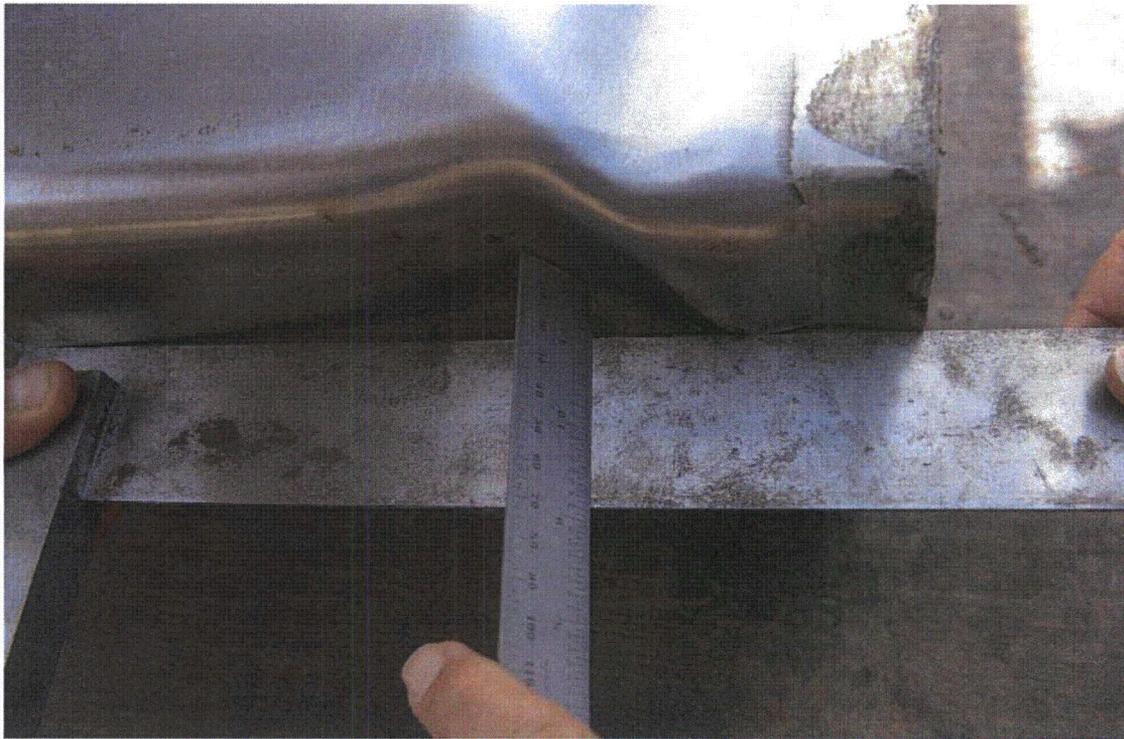
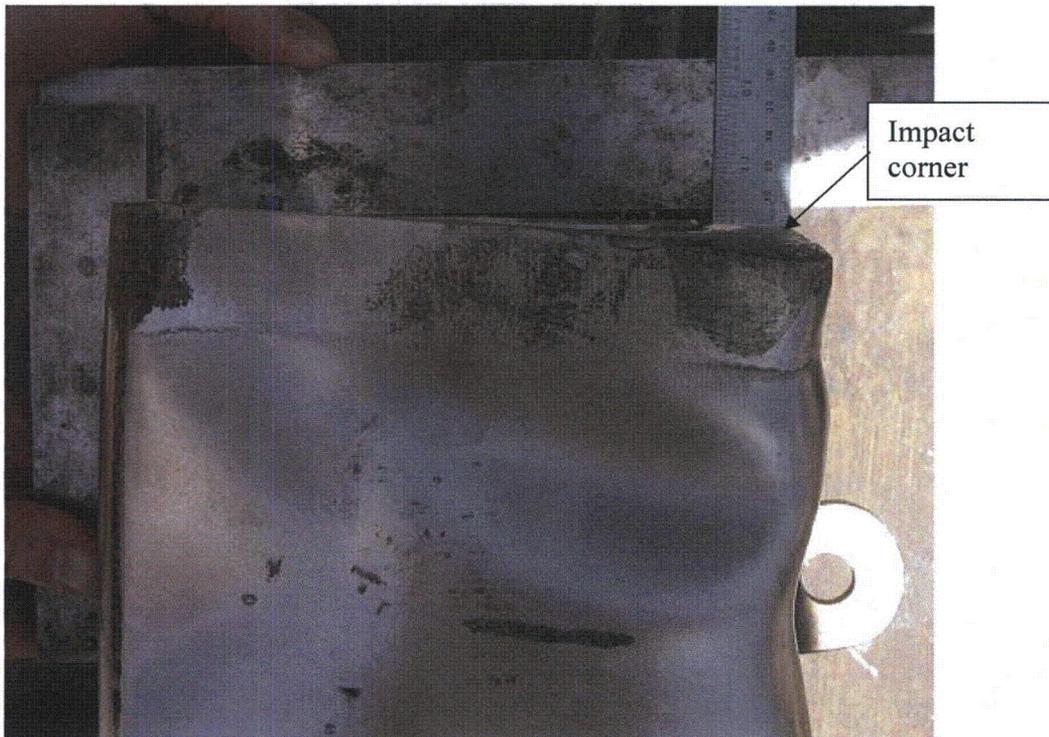
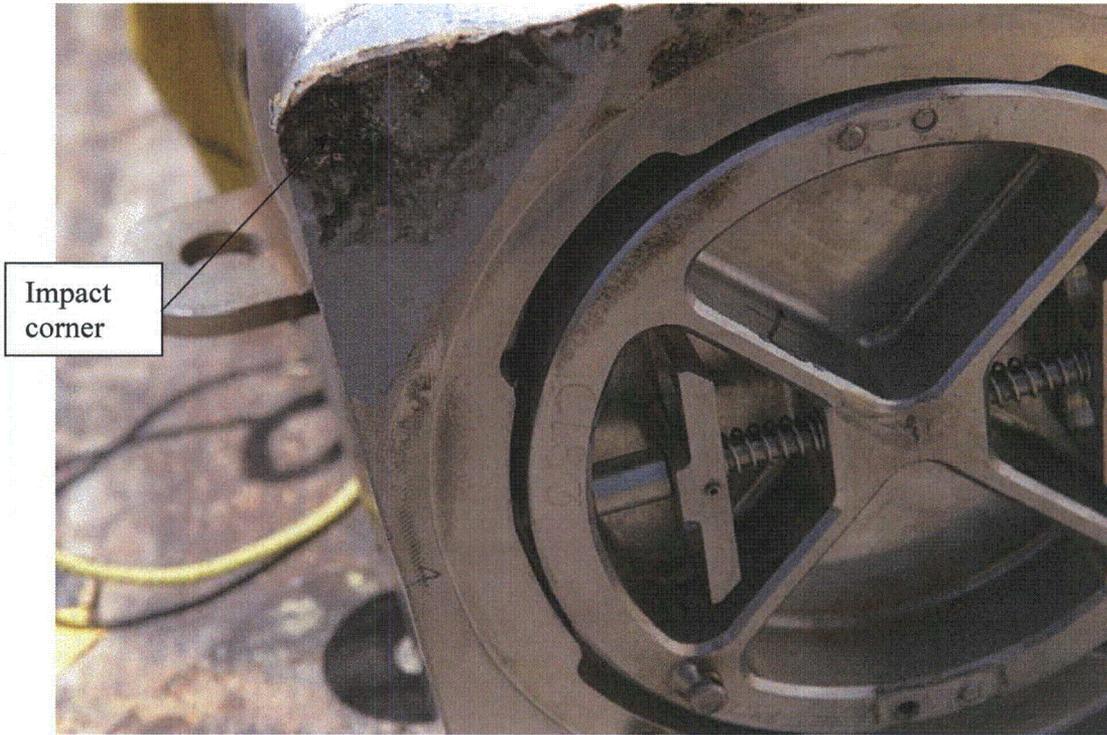
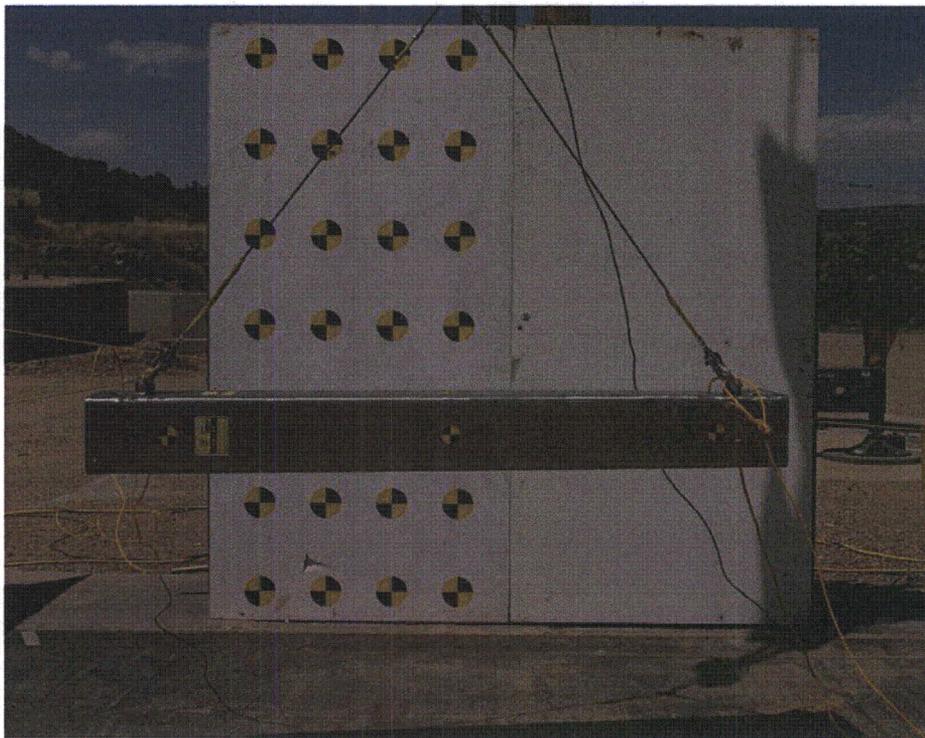
bowing of the package over its length is estimated at approximately $\frac{1}{4}$ inch. During the CD5-1, CG over corner HAC drop, deformation of the outer wall caused the width of the package to increase from 8 inches to approximately $8 \frac{5}{8}$ inches. The same CD5-1 impact caused the outer wall to deform inward approximately $\frac{1}{2}$ inch.

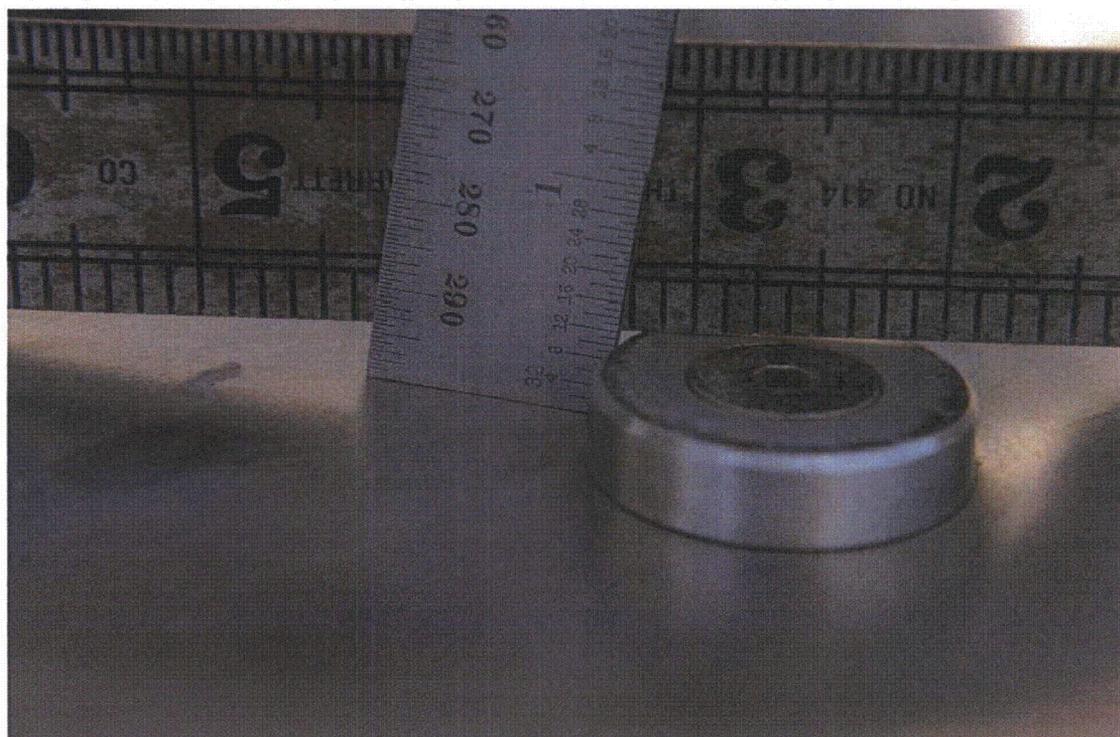
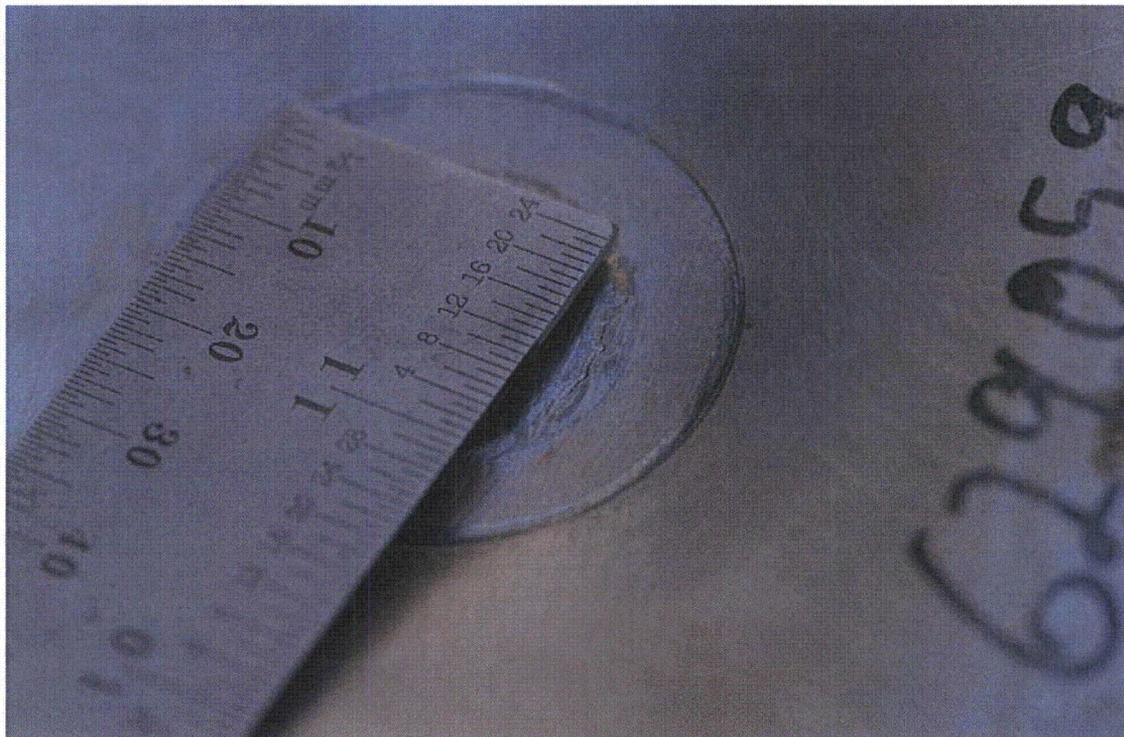
The third try produced a satisfactory drop orientation. Following impact, the CTU bounced and spun just slightly indicating the impact was directly on the index lugs. The index lugs were both pressed inward. The index lug at the closure end was flush with the general surface. The index lug at the bottom end was pushed in to approximately 1/8 inch from the general surface. Figure 2.12.1-38 and Figure 2.12.1-39 show the index lugs following the drop. The index lugs were removed and a cracked weld was revealed under the index lug near the closure end as shown in Figure 2.12.1-40. The length of the cracked weld was approximately 1/2 inch. There was no other significant visible deformation. There was no visible deformation or rotation of the closure as a result of the drop.

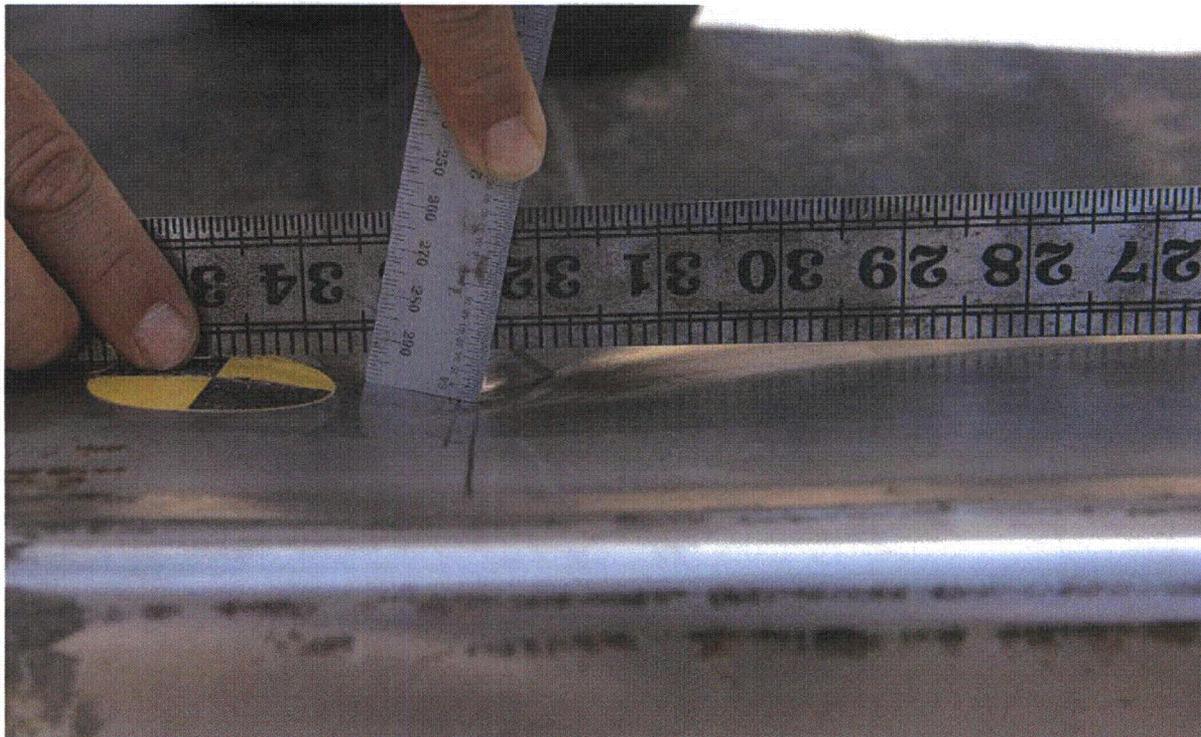
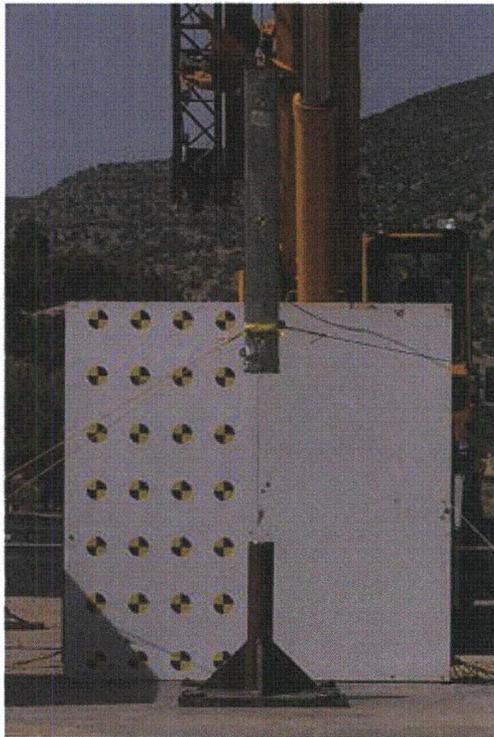
As the CTU impacted the puncture bar, there was no tearing or severe deformation. The initial impact caused a deformation of approximately 1/2 inch deep by 5 inches across with a radius the same as the puncture bar. There was no fracture of the outer shell. Figure 2.12.1-42 and Figure 2.12.1-43 show the CTU following the CP2-1 drop.

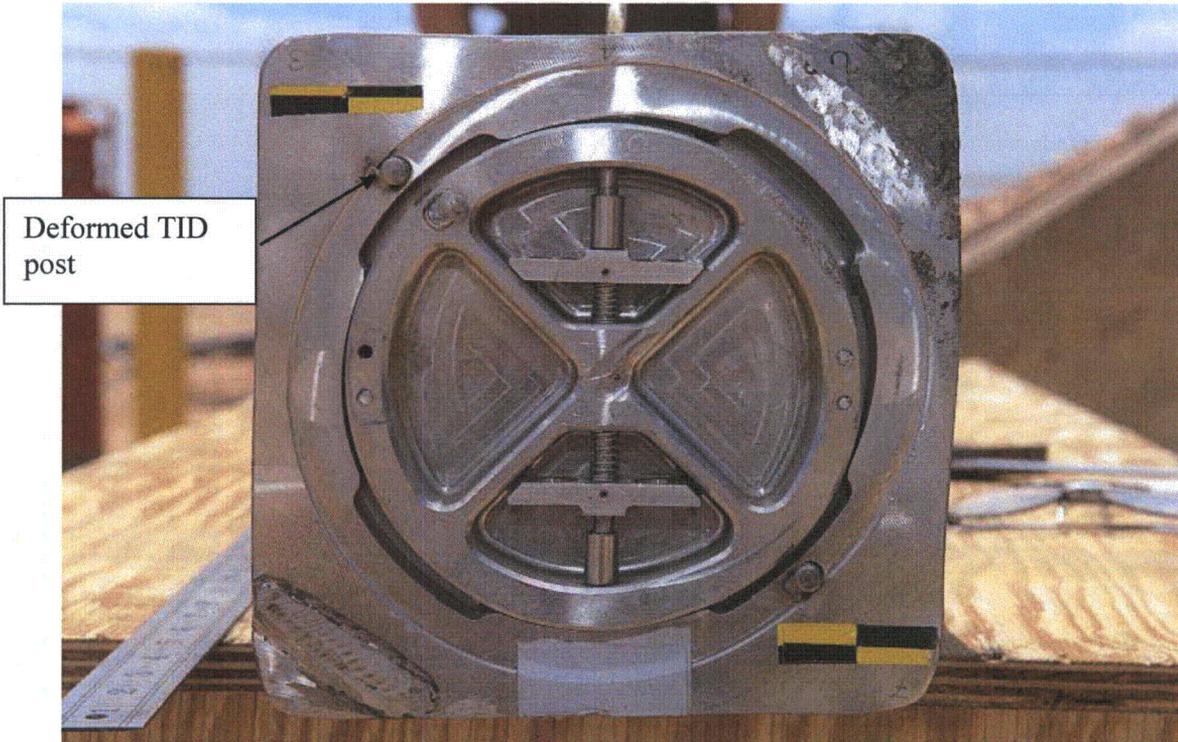
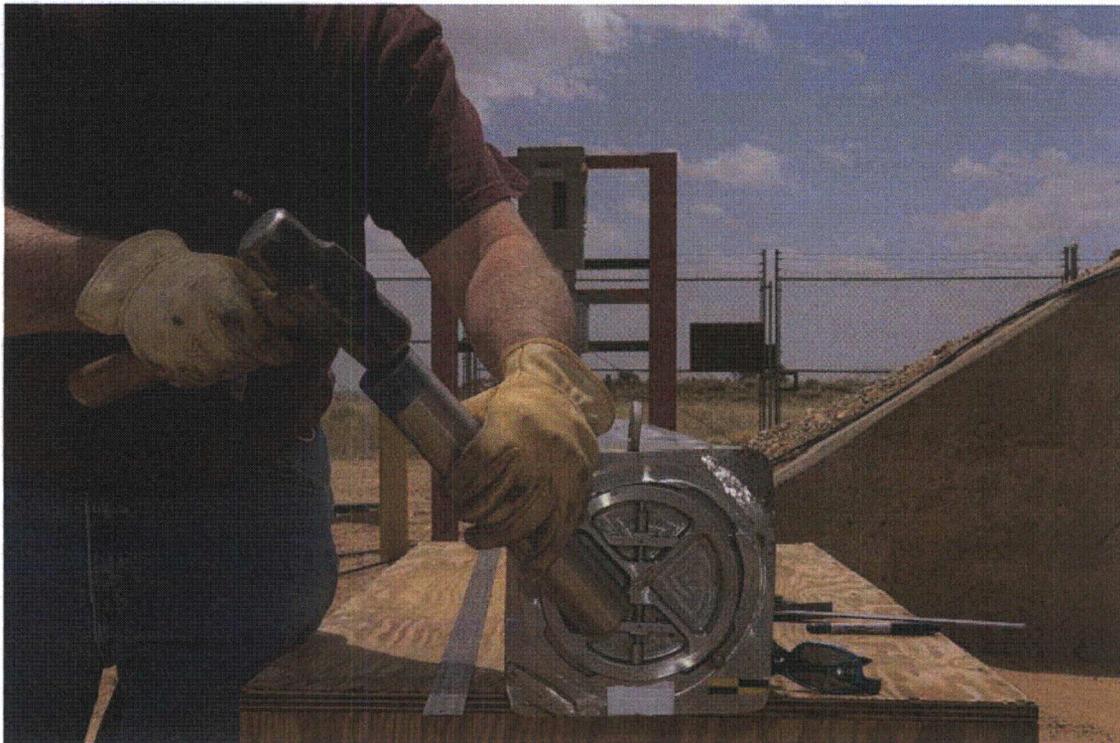
| Test No. | Test Description | Comments |
|---|---|--|
| CP1-1 | CG over center of closure (Vertical) | Vertical puncture drop on closure from 40 in.. The tamper indicating device stud pushed into closure assembly. No other visible damage. No rotation of closure assembly. |

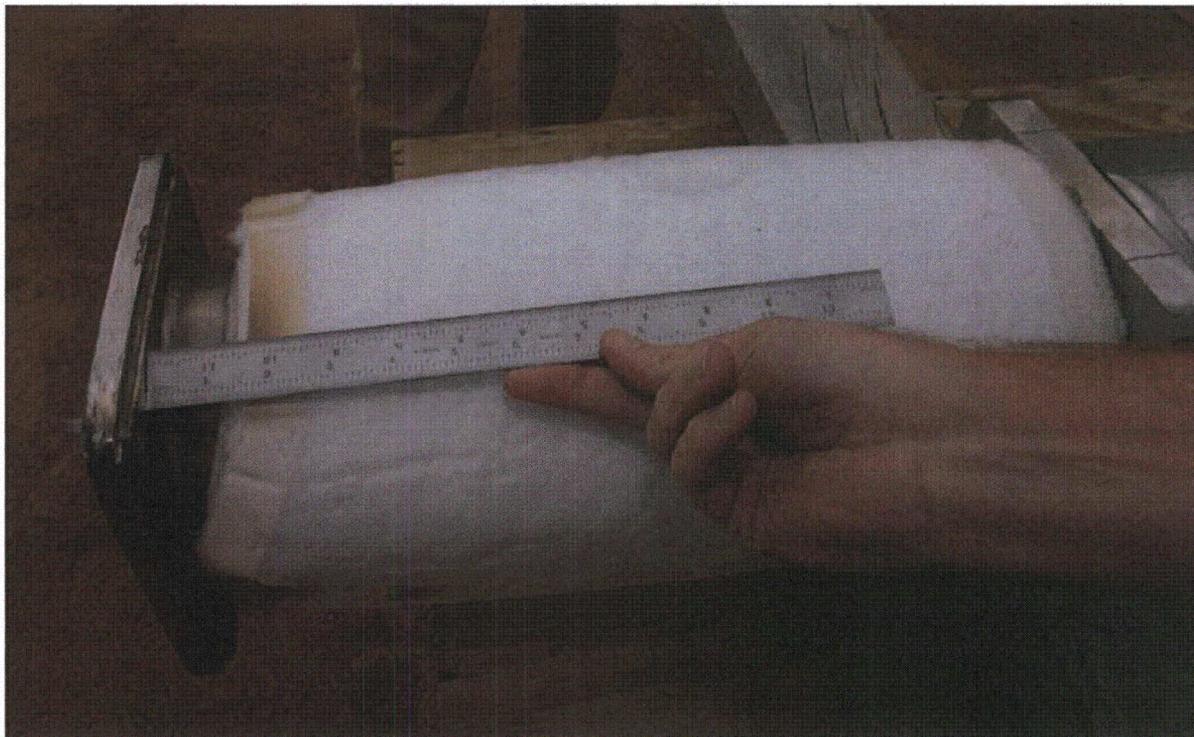
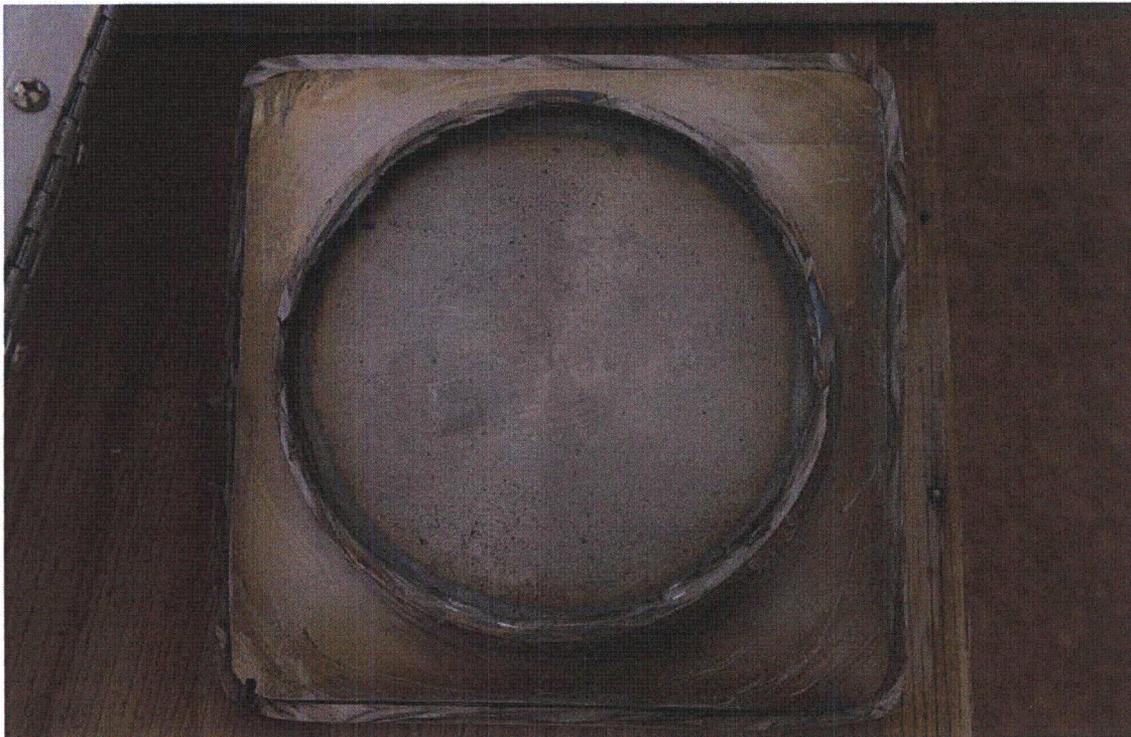
The package was cut with an abrasive saw lengthwise along two opposite corners and at the ends to expose the thermal shield. Figure 2.12.1-48 through Figure 2.12.1-50 show the condition of the thermal shields and insulation. The thermal shields were in relatively good shape with dents from both the index lug bosses and pockets on the shields. There was also some minor deformation at each end of the shields by the stiffening rib plates.

Two thermal shield designs were used; one with a simple overlapping design and the other secured by rivets. There was no appreciable difference between the performance of either design. Both experienced minor deformation at the pockets and index lugs, and at the ends due to impacting the adjoining plates. Furthermore, the compaction of the insulation under each shield was very similar. On the riveted design, there was no failure of any rivet.

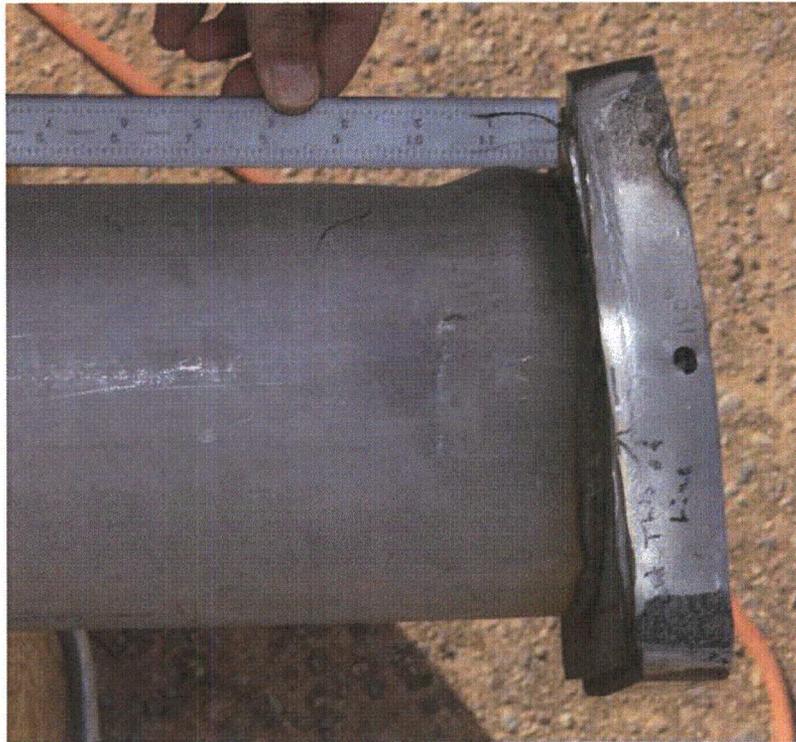
Figure 2.12.1-51 - Bottom End Plate Condition

The thermal shields and insulation were removed and using an abrasive saw the bottom end plate was removed by cutting the inner tube. Figure 2.12.1-51 illustrates the condition of the bottom end plate. There were no large deformations or punctures of the stainless steel plate. There were no visual indications of broken welds or other damage near the end plate.

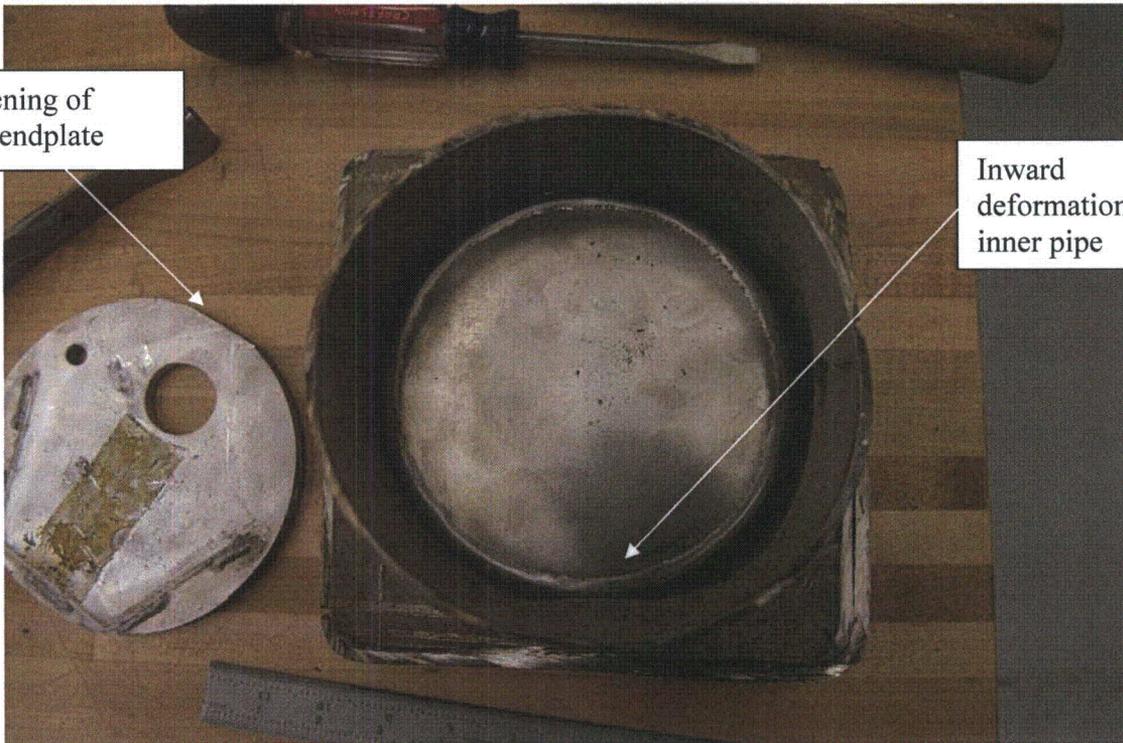
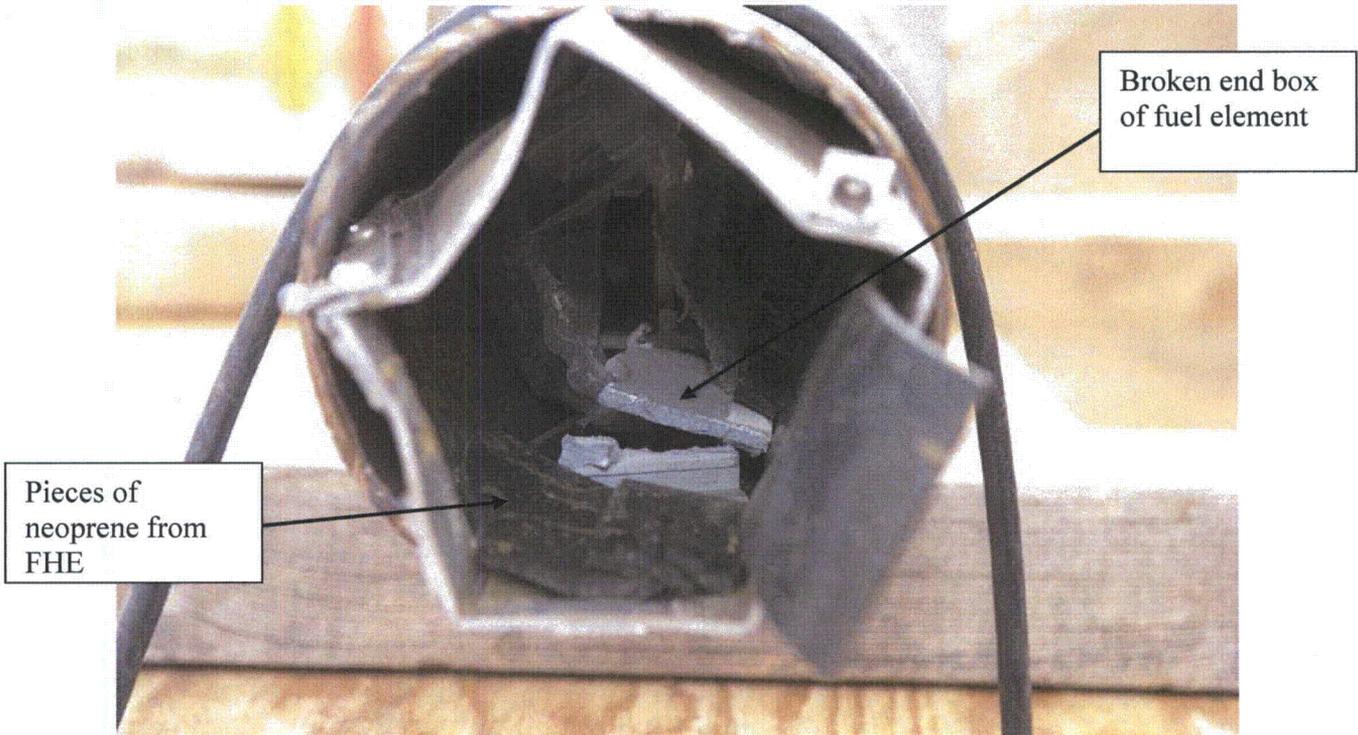
As shown in Figure 2.12.1-52 and Figure 2.12.1-53, the inner tube was inspected and the photographs show the areas of greatest deformation. Due to the CG over corner drop deformation, CD5-1, the inner tube bowed out approximately $\frac{1}{4}$ inch. The inner tube also bowed inward approximately $\frac{3}{16}$ inch slightly deforming the FHE aluminum end plate. There were no visible signs of any weld failures associated with the inner tube.

Flattening of
FHE endplate

Inward
deformation of
inner pipe

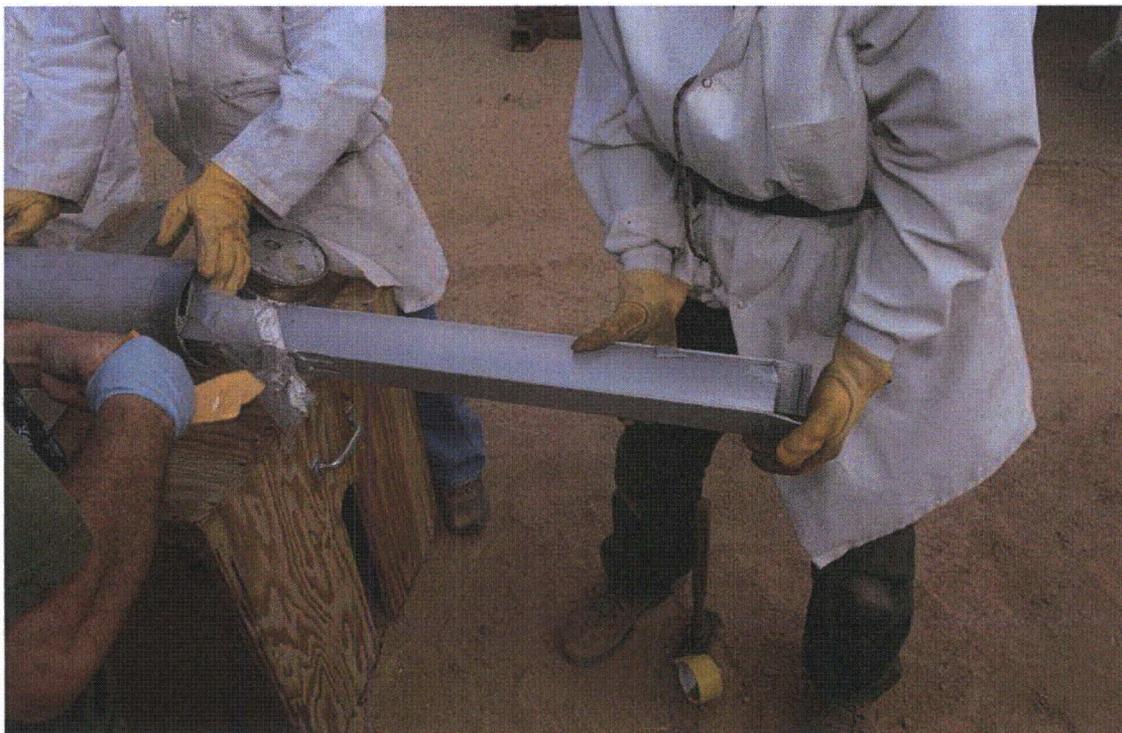
Figure 2.12.1-54 - End View (Bottom) of Opened CTU

Figure 2.12.1-54 illustrates the relatively unchanged position of the FHE and fuel element within the CTU. Also seen in this figure are pieces of the broken end box at the bottom end and also pieces of neoprene padding from the FHE during removal. The FHE was somewhat difficult to remove and the aluminum end plate had broken off so the ATR fuel element was carefully pulled from the bottom end of the package as illustrated in Figure 2.12.1-55. Both end boxes of the fuel element had shattered into several pieces. These pieces were collected and kept with the fuel element. There were no pieces of the fuel element end boxes found outside the FHE. Once the fuel element was removed, the FHE was pulled from the inner tube. The welds securing each FHE end plate to the body were completely broken and both the end plates were loose. Figure 2.12.1-56 illustrates the area of greatest deformation to the FHE which was at the closure end.

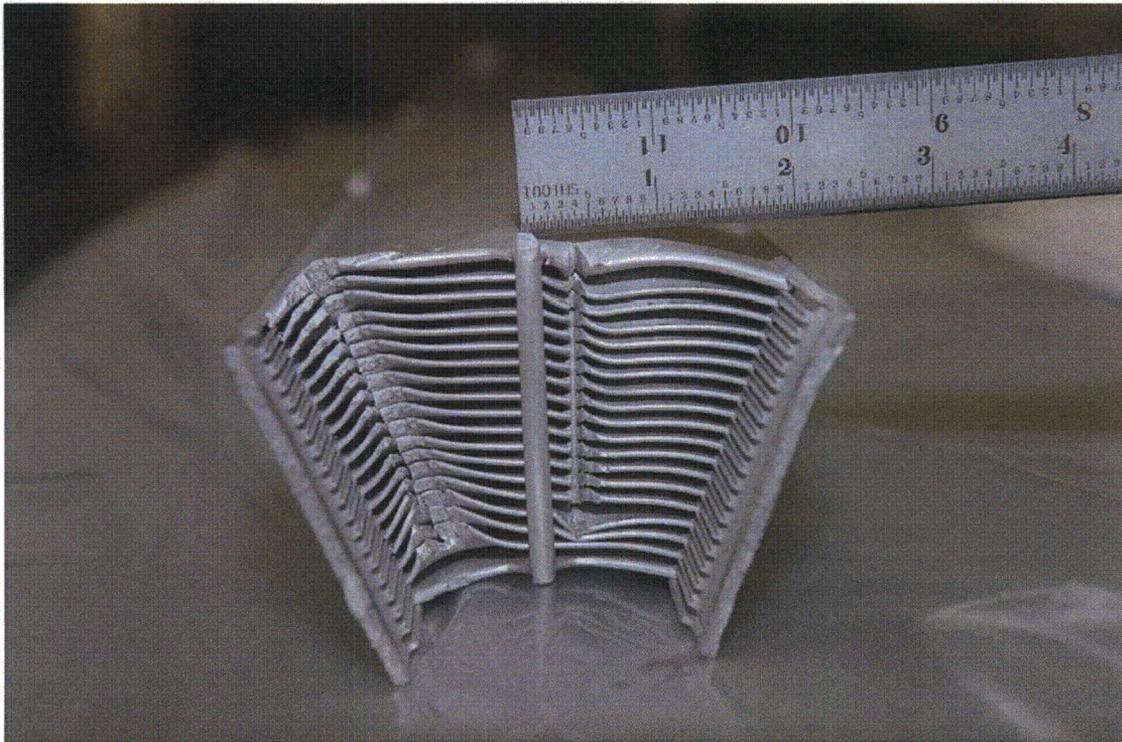
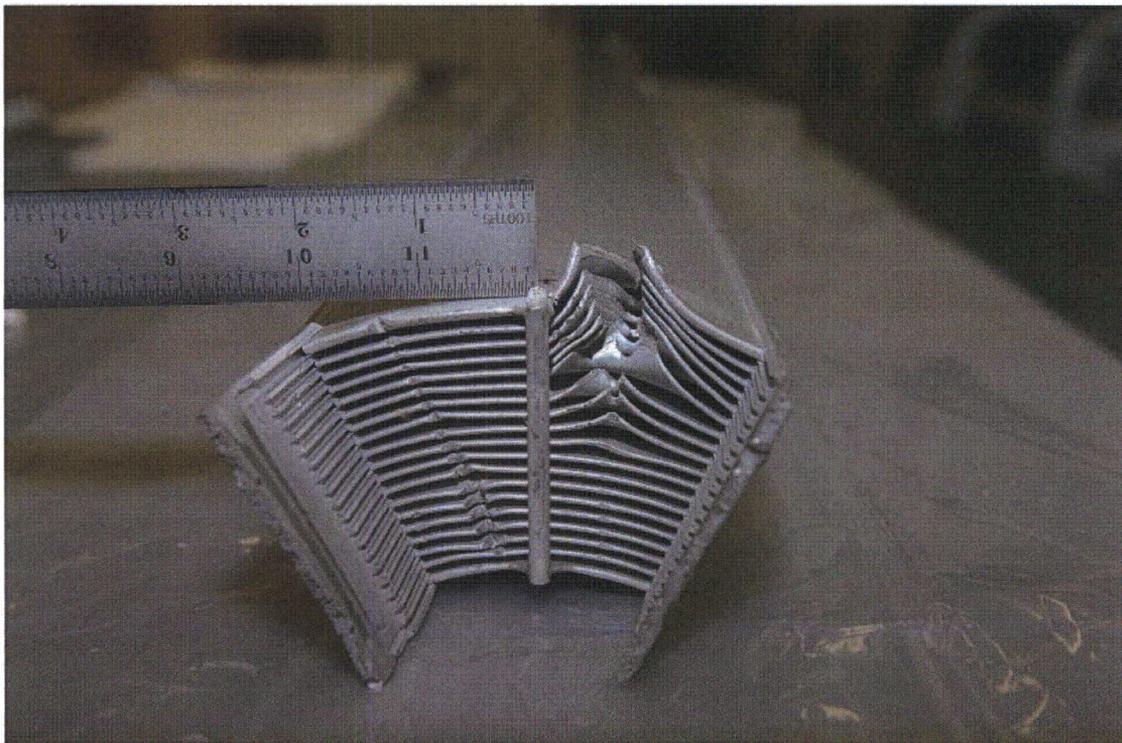
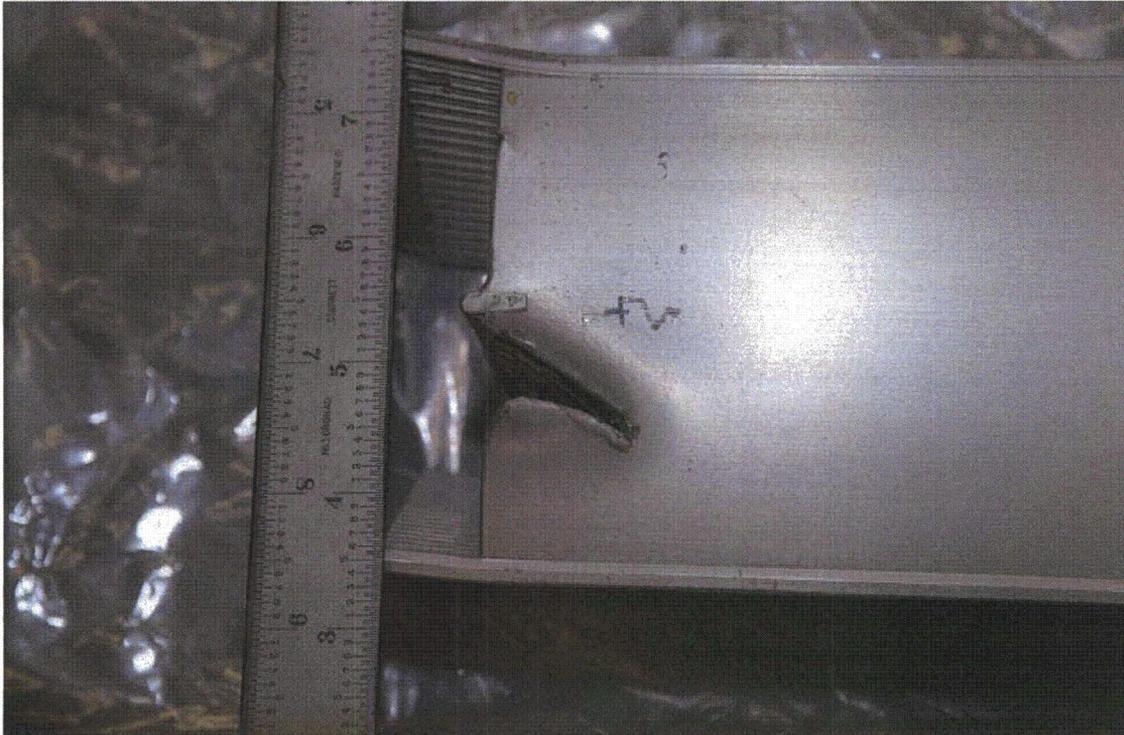
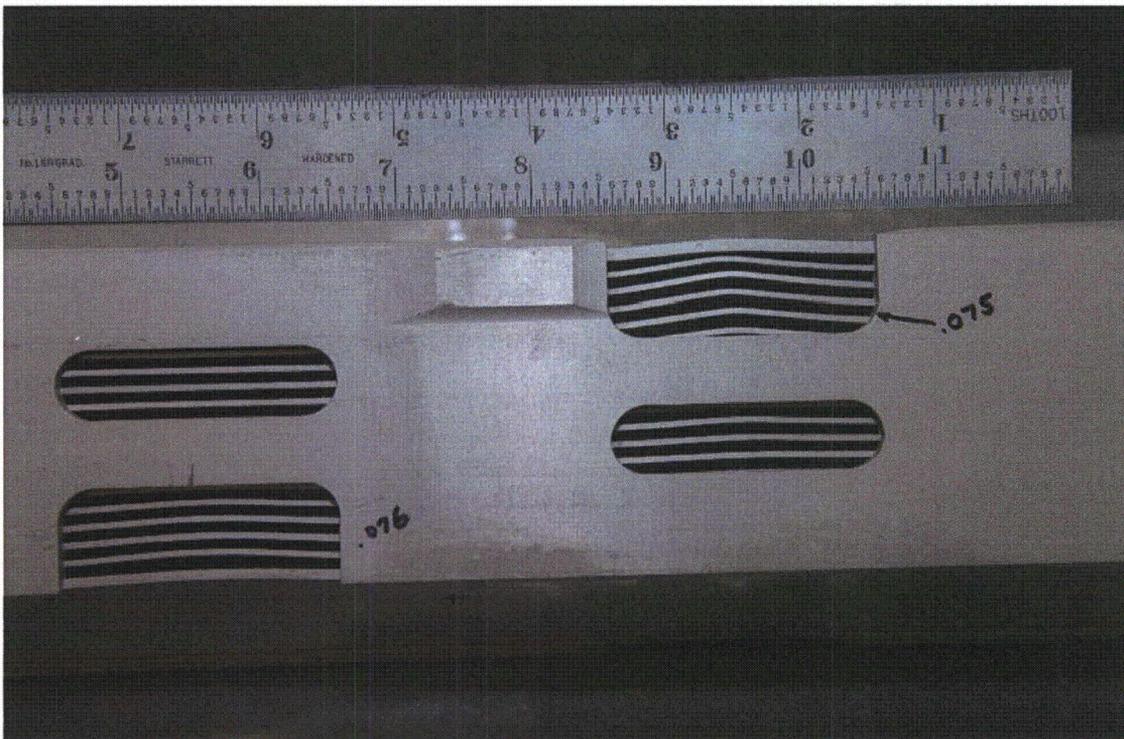
Figure 2.12.1-57 through Figure 2.12.1-62 illustrate the condition of the ATR fuel element. As shown in Figure 2.12.1-58 and Figure 2.12.1-59, fragments from the fuel element end boxes deformed and cut into the ends of the fuel plates during testing. At no point did the fuel meat, the embedded uranium within the aluminum cladding, become exposed.
