2.12 Appendices

2.12.1 Certification Tests on CTU-1

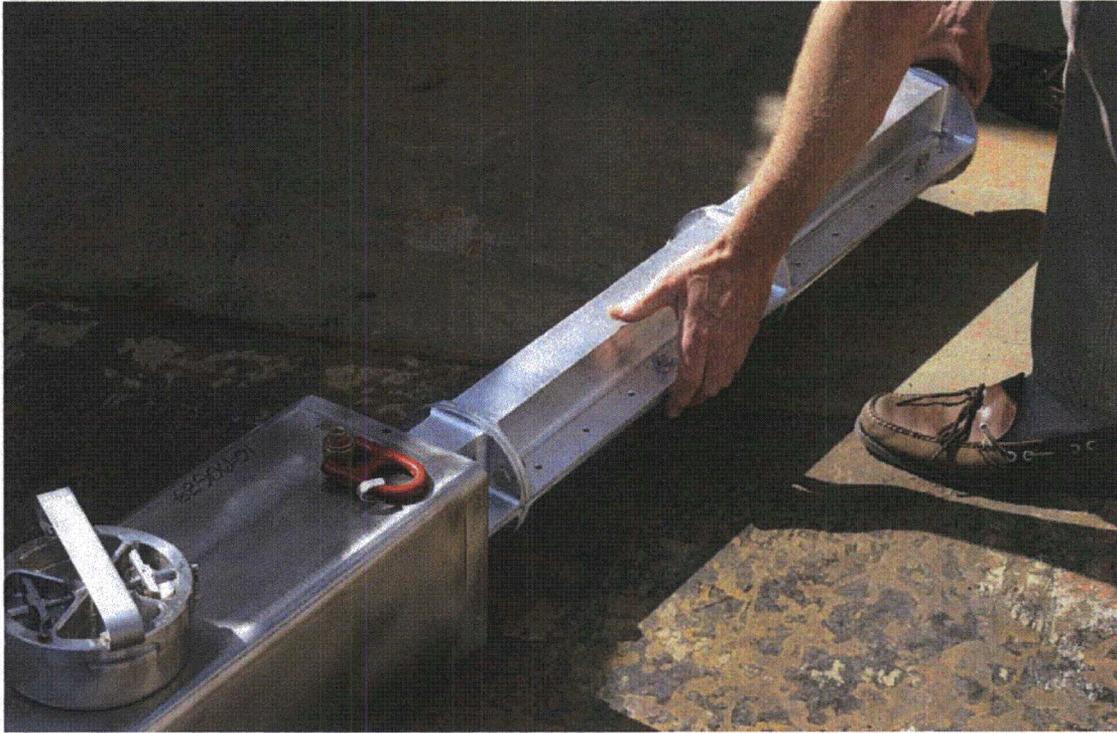
Figure 2.12.2-6 - CTU Following CD1-2 Impact
(impact side facing up)

Following impact, the CTU bounced slightly and landed on the impact side. There was minor visible exterior damage, principally scuff marks, resulting from the drop. Close examination of

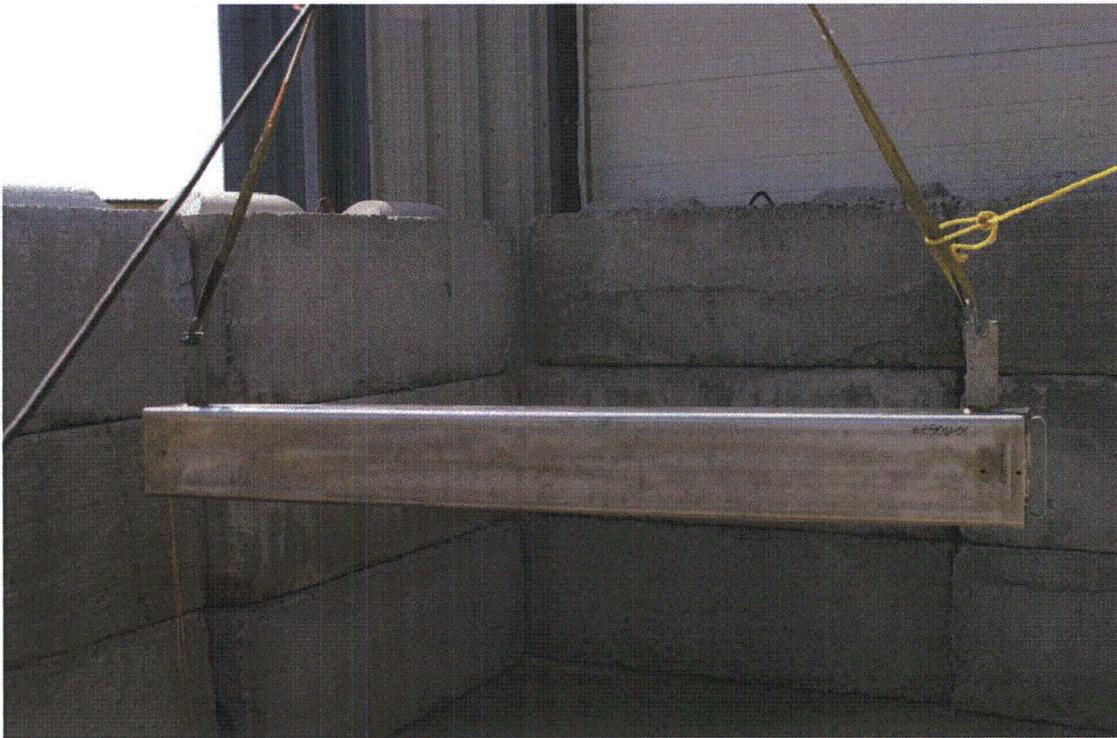
Figure 2.12.2-7 - CD1-2, Extracting Basket Following Drop

The closure was opened and the basket removed following the drop. The basket exhibited no signs of any deformation but the finger tightened basket screws were loosened approximately 1 turn by the drop.

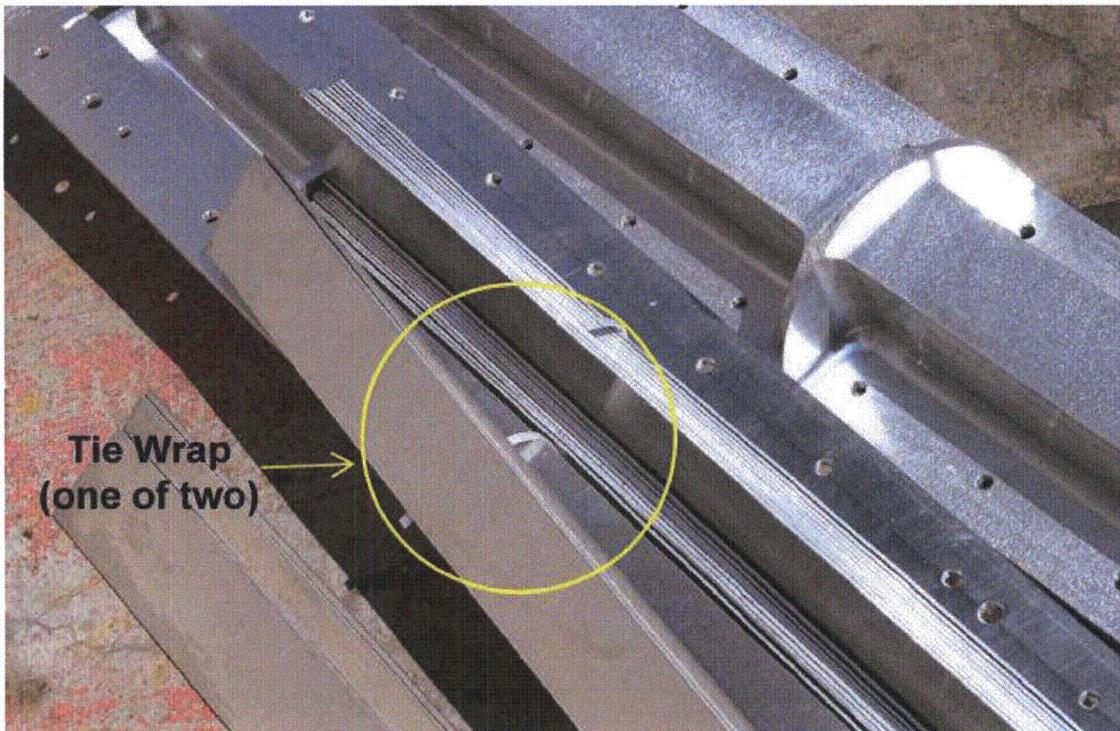
Figure 2.12.2-9 - CD3-2 Deformation at Stiffening Rib Location

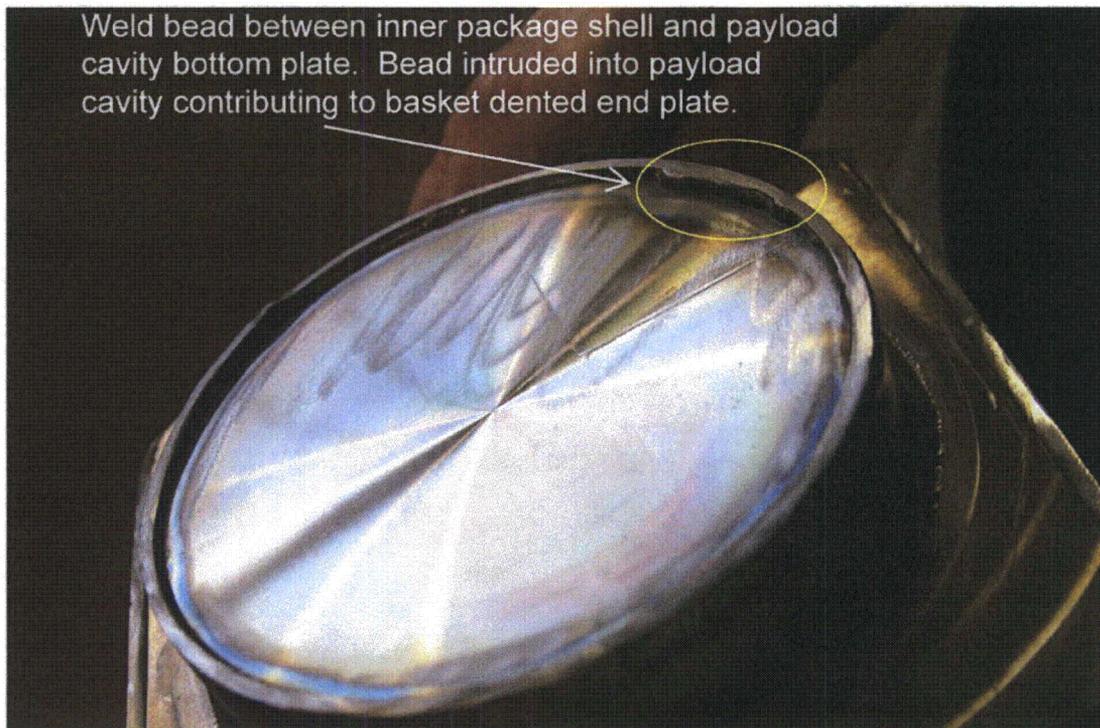
Figure 2.12.2-12 - CD4-2 Impact Damage to Package

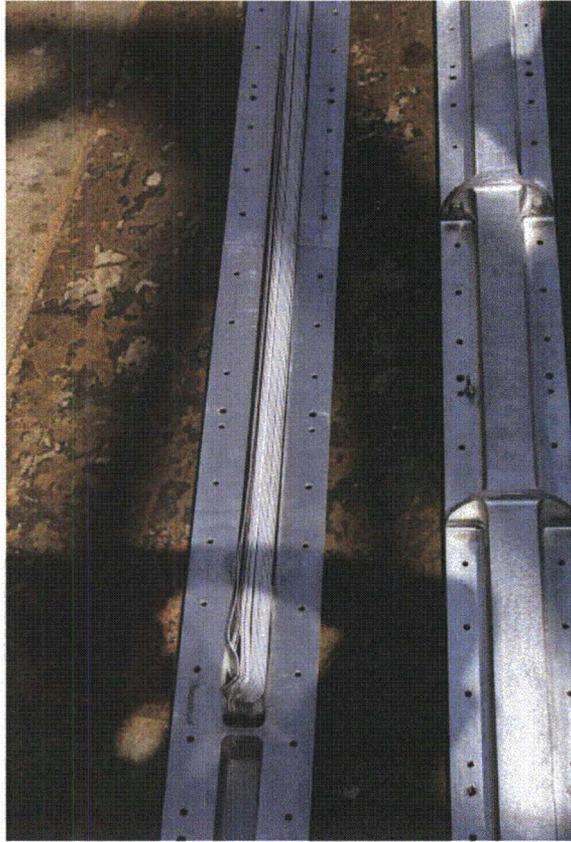
Figure 2.12.2-14 - Dented area – basket end plate

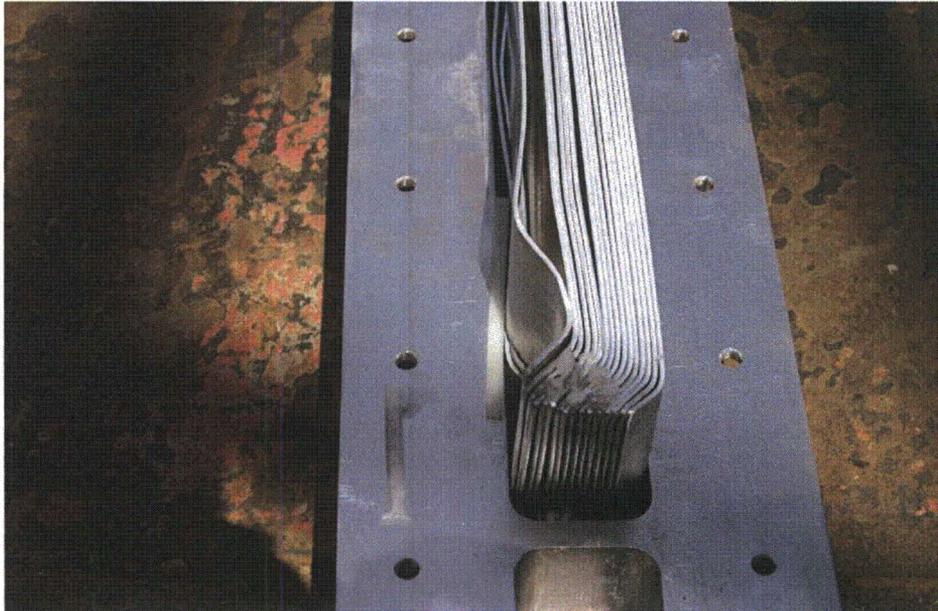
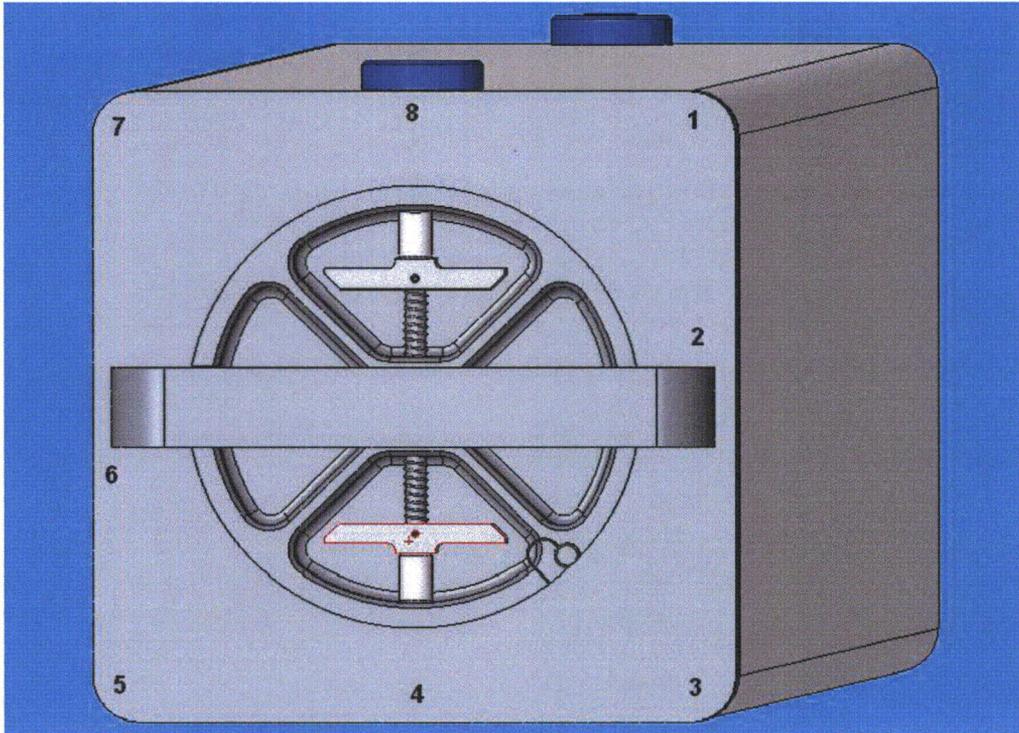
Figure 2.12.2-15 - CD4-2 Impact Damage to Simulated Fuel Plates

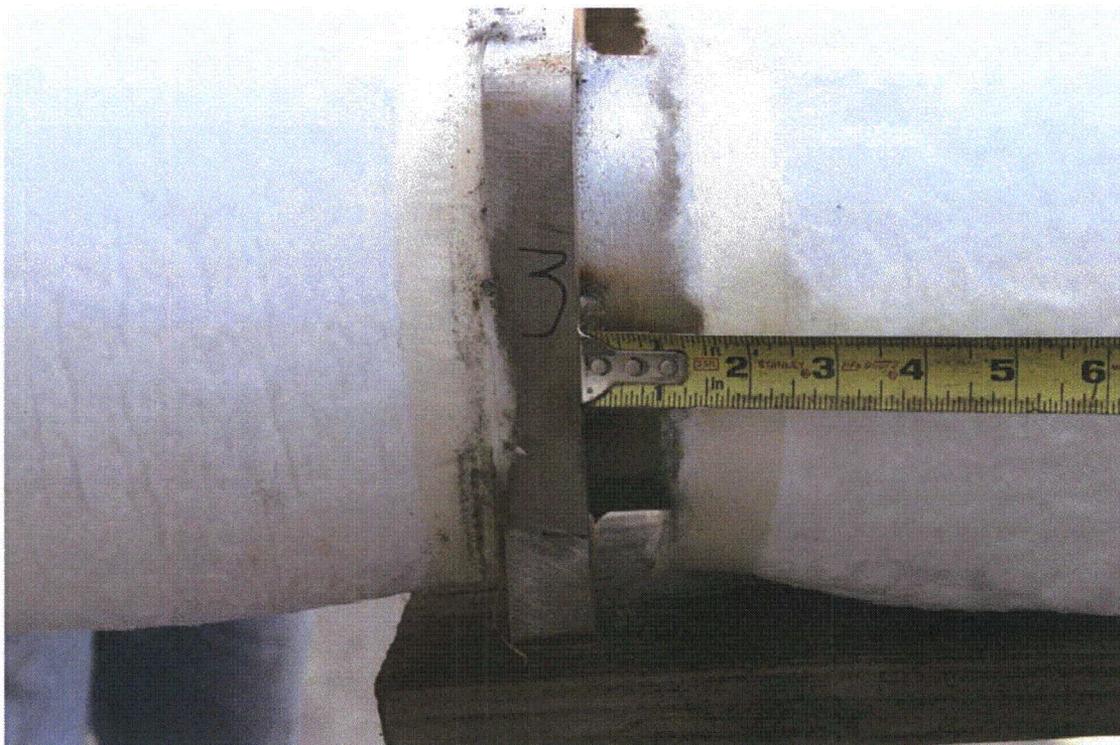
Figure 2.12.2-23 - Insulation Gap at Package Closure End

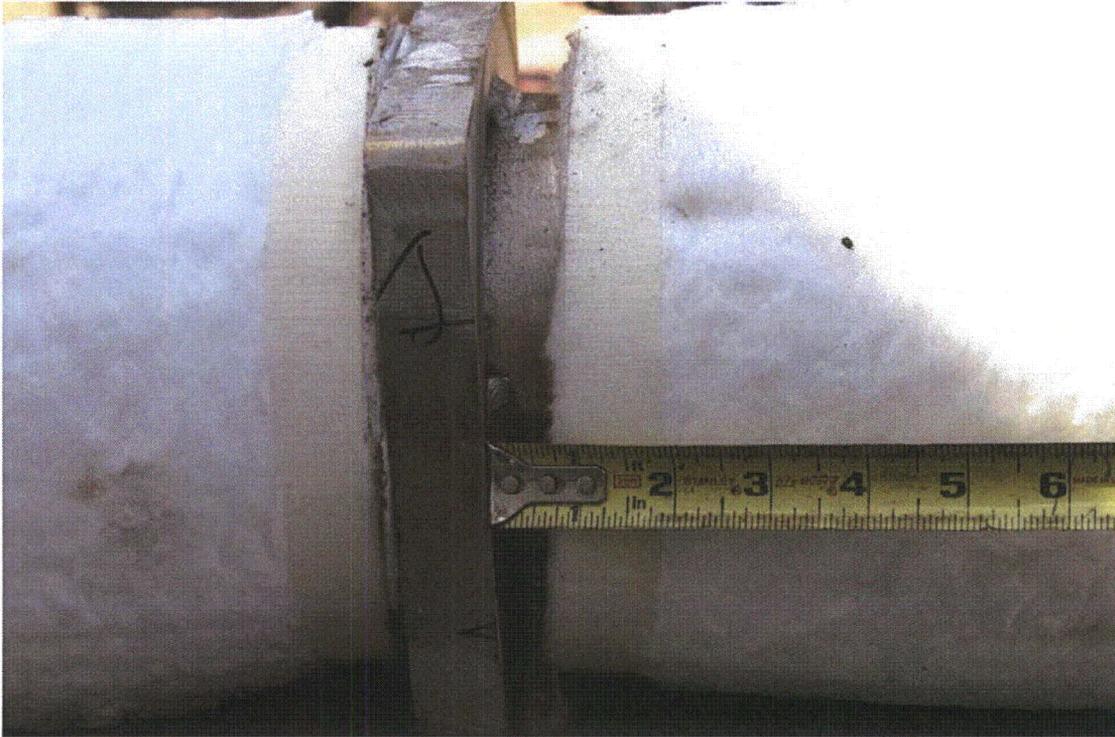
Figure 2.12.2-25 - Insulation Gap at Rib #2
