2.12 Appendices

2.12.1 Certification Tests on CTU-1

This report describes the methods and results of a series of tests performed on the Advanced Test Reactor (ATR) Fresh Fuel Shipping Container (FFSC) transportation package shown in Figure 2.12.1-1. The objective of testing was to conduct drop tests in accordance with the requirements of 10 CFR 71, §71.71 Normal Conditions of Transport (NCT), and §71.73 Hypothetical Accident Conditions (HAC). The verification of the loose fuel plate basket structural integrity and the performance of the package insulation are supported by the tests described in Section 2.12.1, *Certification Tests on CTU-2*.

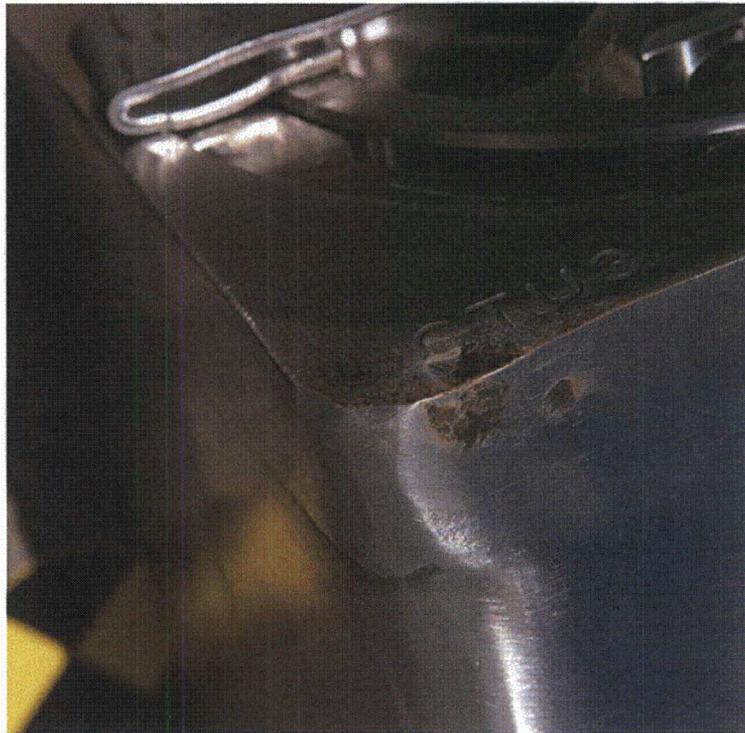
Figure 2.12.1-5 - CN1-1 Drop Orientation

The impact location was at corner number 5 identified in Figure 2.12.1-4. Following impact, the CTU bounced slightly and tipped over onto its side. There was minor visible exterior damage at the impact corner. The maximum deformation at the corner was approximately 1/8 inch. The closure handle was also deformed as a result of the drop. The overall length of the package did not change other than the 1/8 inch at the impact corner and compression of the closure handle of approximately 1/2 inch on one side. There was also a 1/8 inch deformation on the side corner approximately 1 ¼ inch from the impact corner. There was no visible deformation or rotation of the closure, other than the handle. Figure 2.12.1-6 and Figure 2.12.1-7 show the CTU following the NCT drop.

Impact
corner

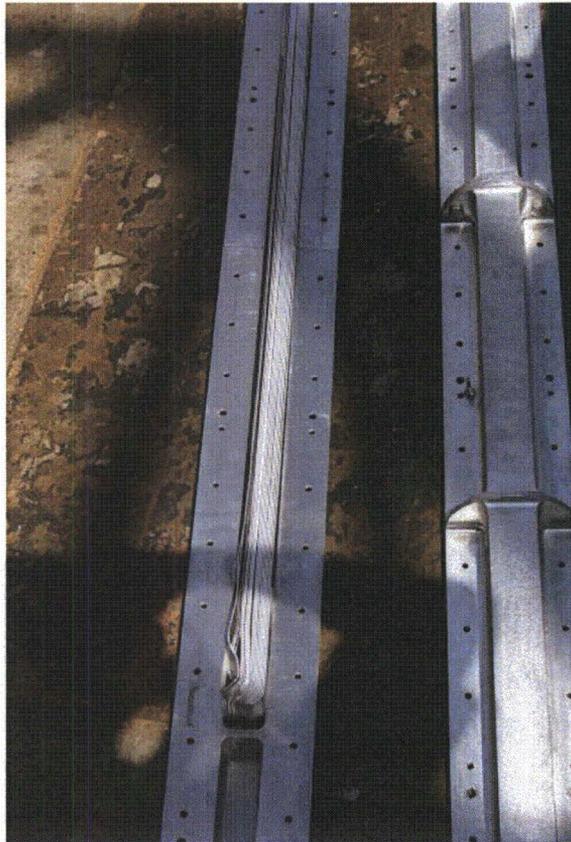
Figure 2.12.2-14 - Dented area – basket end plate

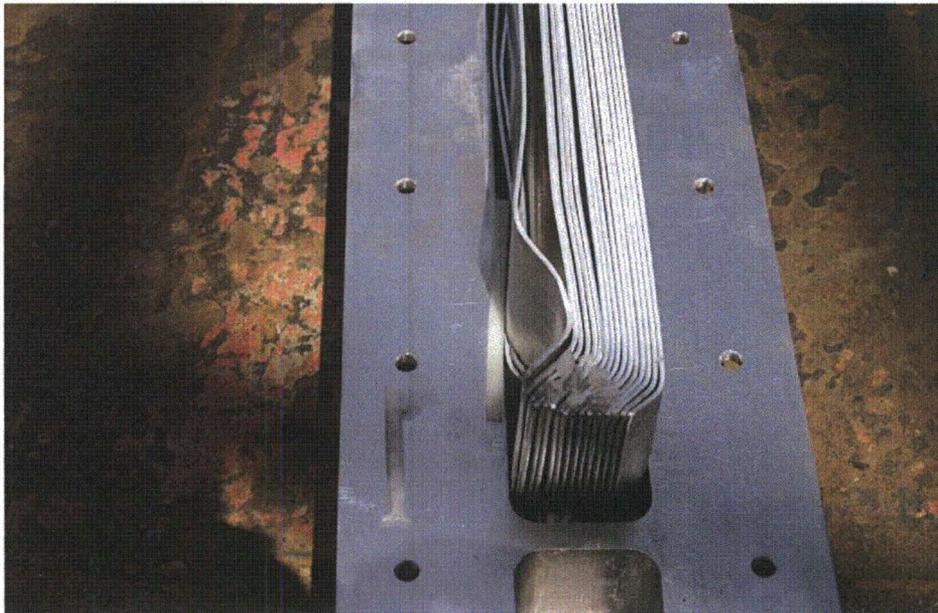
Figure 2.12.2-15 - CD4-2 Impact Damage to Simulated Fuel Plates

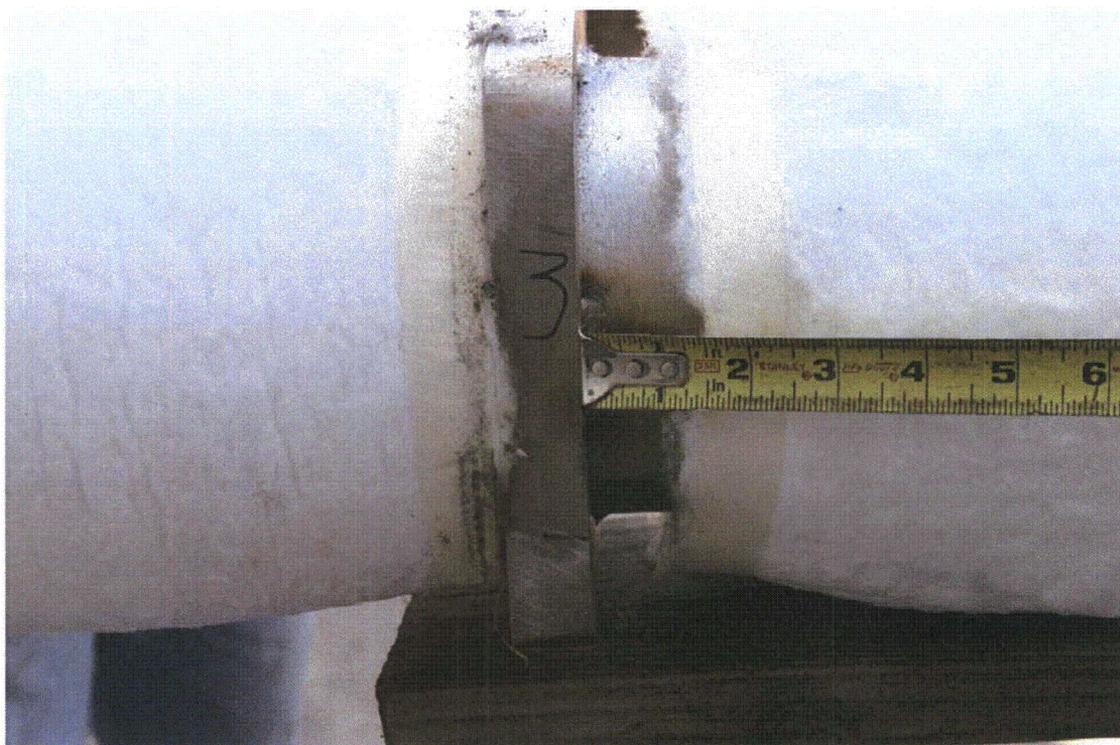
Figure 2.12.2-23 - Insulation Gap at Package Closure End

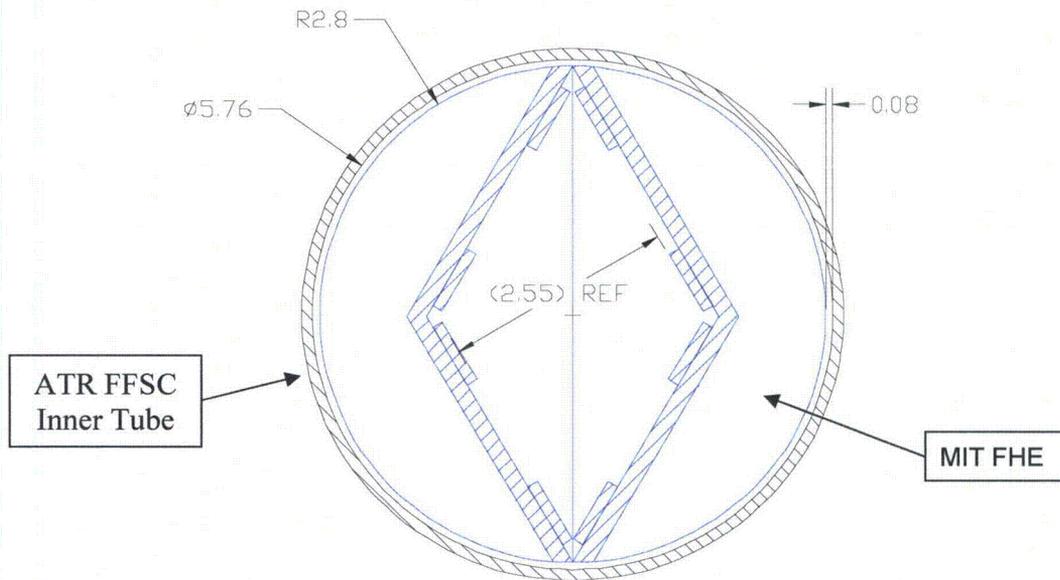
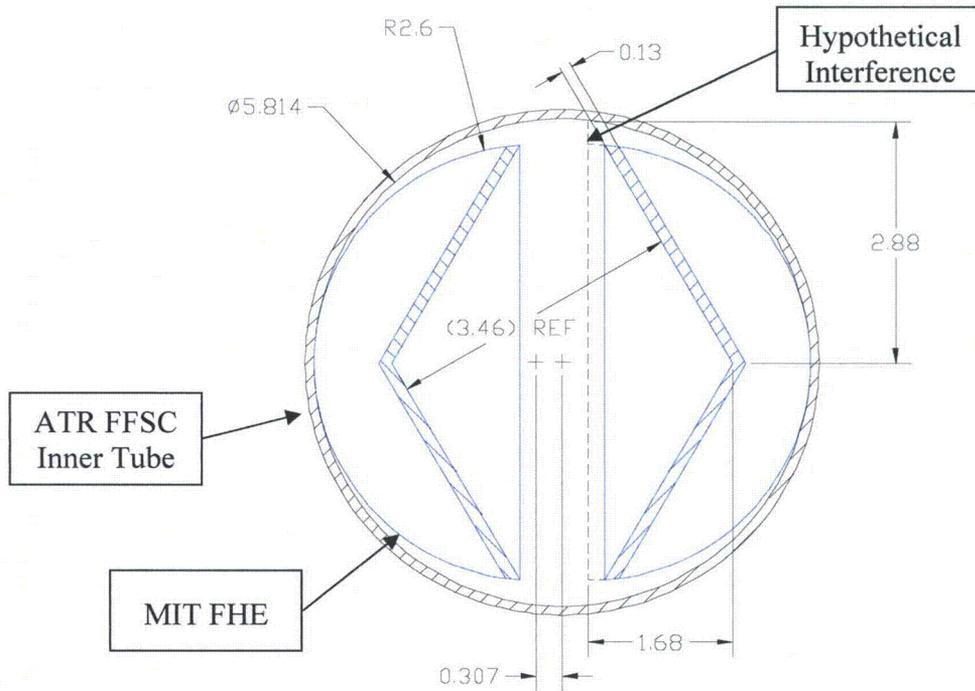
Figure 2.12.3-3 – MIT FHE Damage

Due to the conservative assumptions utilized for the thermal and criticality evaluations, the allowable damage to the FHEs is considered severe and therefore far exceeding the physical testing results performed using the ATR fuel element and LFPB payloads covered in Section 2.12.1, *Certification Tests on CTU-1*, and Section 2.12.2, *Certification Tests on CTU-2*.
