Buried Piping – Inspecting Something You Can't See

By Jeremy Bowen, NRR/DIRS/IRIB

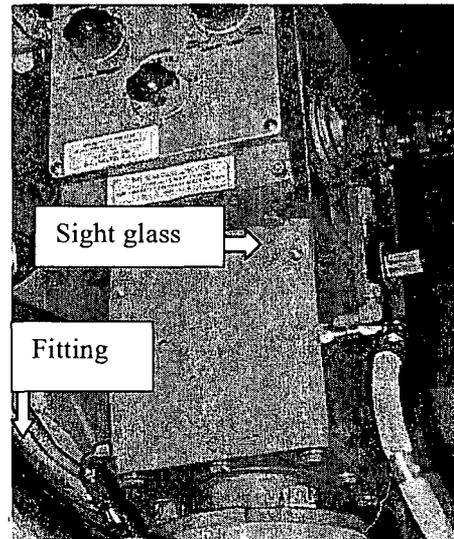
The problem. On August 13, while performing a walkdown of the redundant Unit 2 SBO DG, the resident inspector saw that the engine governor sight glass had no visible oil. The inspector immediately reported the condition to the work control center, and operators verified that the oil level was not visible. The oil had leaked out through a loose fitting at the bottom of the governor oil reservoir and collected into a well formed by engine supports beneath the governor; oil leakage was not readily visible from the floor. The fitting was found to be only finger-tight.

Investigation. The SBO diesel modification installed a new governor to replace the existing obsolete governor that did not have an oil level sight glass. Followup investigation revealed that this modification had recently been completed on the Unit 2 SBO DG and technicians did not follow work instructions to correctly tighten the fitting, resulting in a slow leak. Further investigation revealed that, as part of this modification, a change was initiated to operator rounds to check the governor oil level; but the procedure was scheduled to be completed on August 29, 2008—three months after the physical modification was completed. No interim equipment checks were put in place, and operators had apparently not checked the oil level sight glass on the SBO DG governor since the modification was completed. A check of the operator rounds for
