**Subject: June 2010 Inspection Report, Second Part-Vegetation Inspection
Cameco Resources, Permits 603 and 633**

**JUNE 2010 INSPECTION REPORT
DISTRICT 1/LAND QUALITY DIVISION**

COMPANY: Cameco Resources (CR), Highland Ranch, Permit #603
& Smith Ranch, Permit 633

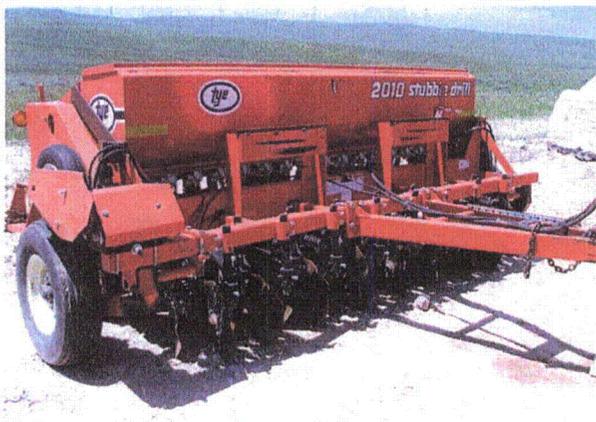
Photo 1. tye[®] seed drill.

DEQ-LQD noted winterfat seed in the hopper of the seed drill and mentioned that this type of seed is likely too light to pass through a conventional drill. Cameco verified this observation, which prompted DEQ-LQD to suggest Cameco contact Mr. Kyle Wendtland at Antelope Coal Mine (ACM) to discuss the re-configuration of conventional seed drills for adaptation to the rigors of mine land reclamation.

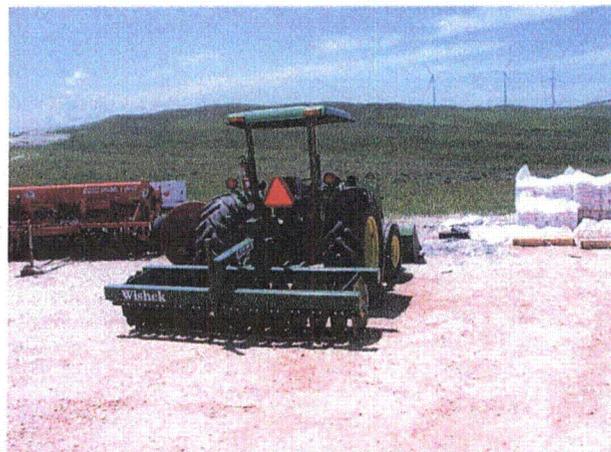
Photo 2. Tractor and mulch crimper.

DEQ-LQD noted that much of the mulch was mostly laying on the soil surface rather than sticking-up, like wheat or grain stubble, which is more typical when mulch is crimped into a seeding unit. This led DEQ-LQD to believe the crimper (Photo 2) had not been weighted during the mulch crimping operation. The implication of this observation was an afterthought by DEQ-LQD and was not related to Cameco during the inspection. Perhaps Cameco should consider the addition of some weight plates to the crimper (Photo 2) next time there are crimping operations. Crimping mulch in such a way produces stubble that aids the soil to resist wind erosion at the surface. Indeed, maybe Cameco did use weight during crimping but this was not apparent based upon the state of the mulch in unit MU9 and the observation of the crimper with no additional weight plates (Photo 2).

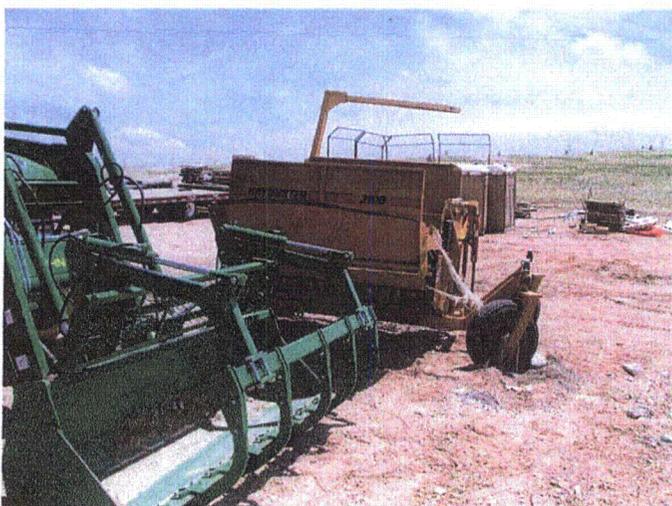
Photo 3. Bale grinder and bale handler.

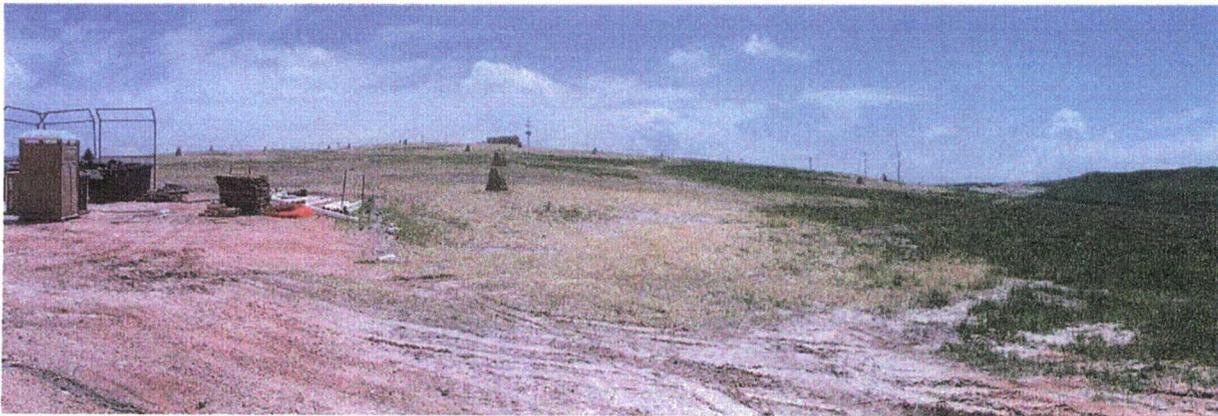
Photo 4. The recently seeded and mulched Unit MU9.

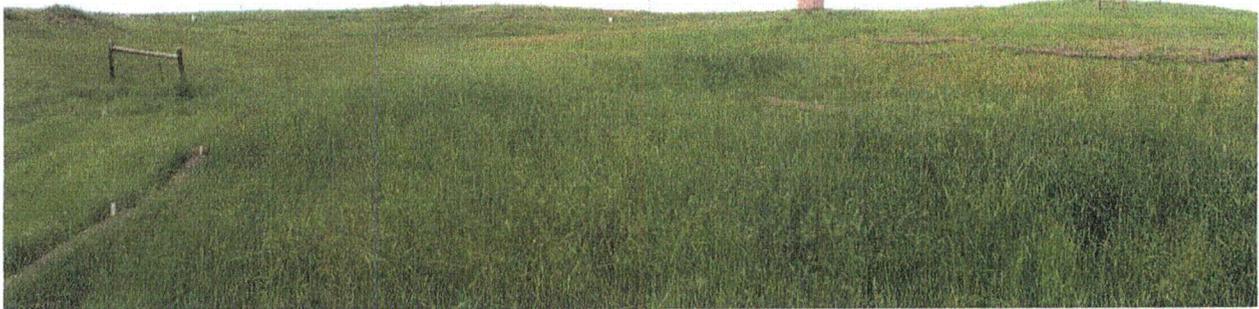
Photo 5. H-Field mitigated surface spill area.

Next, the soil contamination area in H-Field was visited. This area had experienced a surface spill of “pregnant” well fluid a couple of years ago. The mitigation included removal of contaminated soil and the import of clean subsoil and topsoil that was subsequently seeded. The area is well re-vegetated (Photo 5) and it appears as if the mitigation measures were successful.
