Appendix 2.12.3, Excerpted from Safety Analysis Report for the Century Champion Type B Package Immersion Test

Immersion Test

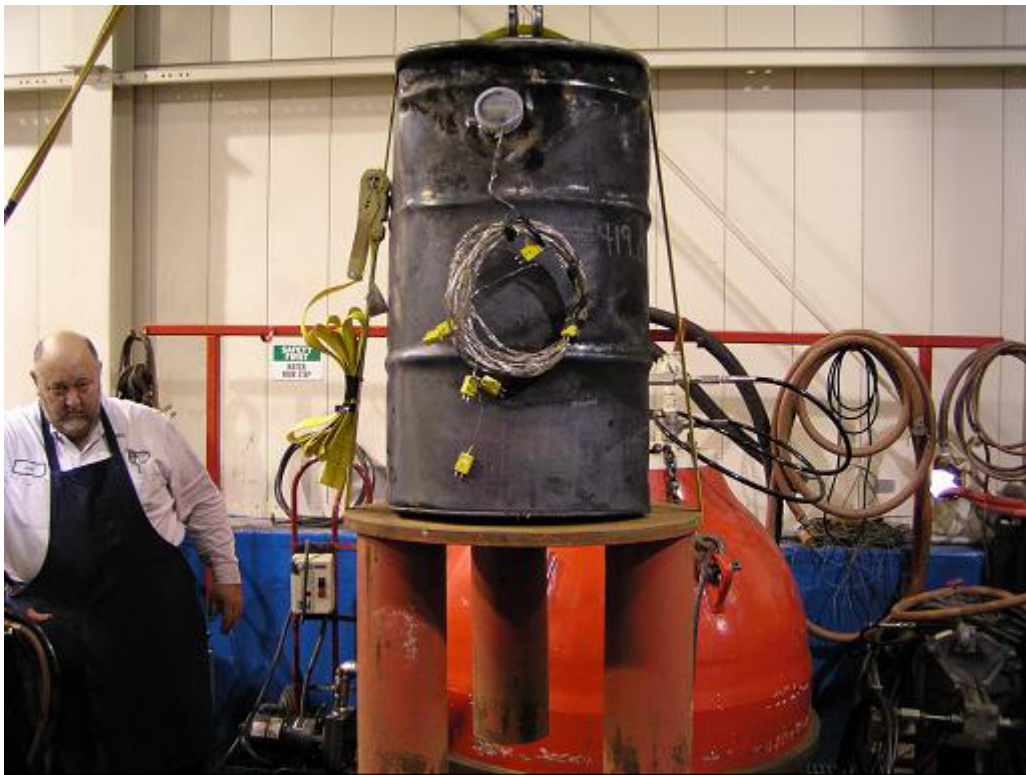
Figure 2.5.3-1 shows the Century Champion Package rigging post-thermal test. Figure 2.5.3-2 displays the package being loaded into the pressure chamber. Figure 2.5.3-3 displays the package during the immersion testing.

Figure 2.5.3-2 Champion Package during Immersion Testing Phase

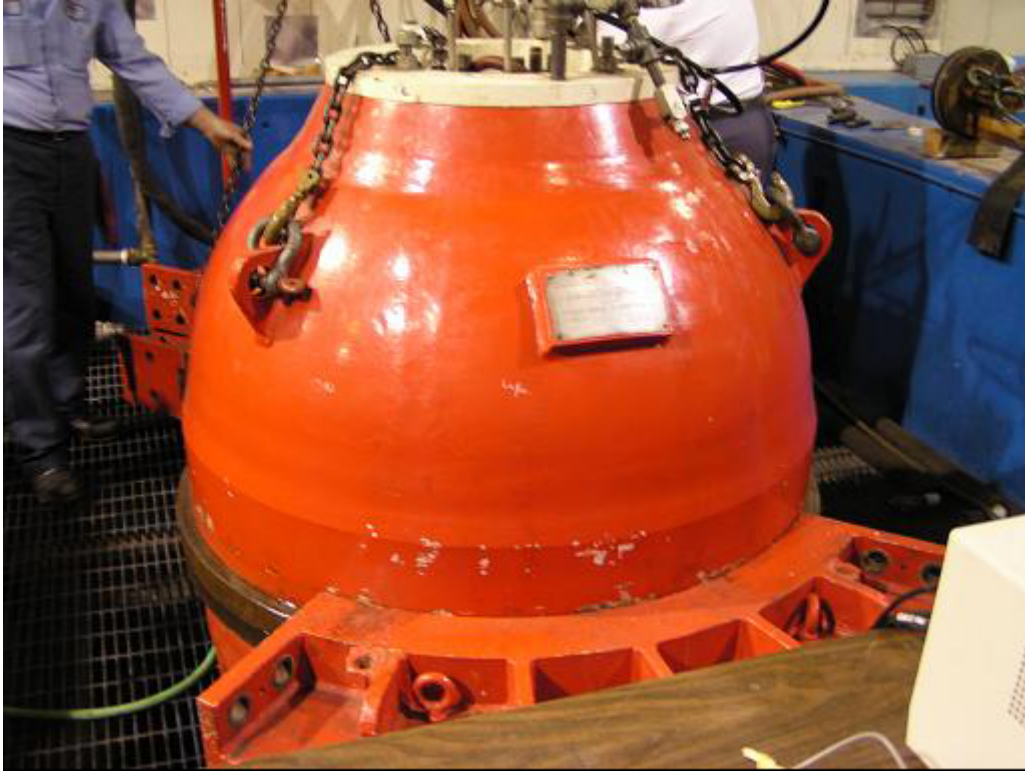
Pages 15 and 16 of the Champion Safety Analysis Report are provided as pages 5 and 6 to Appendix 2.5.3. The test results indicate that immersion testing of a damaged prototype package to a pressure of 23.0 ± 1.0 psig during a 15-minute produce no additional damage.

Figure 2.5.3-3 Champion Package during Immersion Test
