PORC	January 24 1 pm Walnut	06- 004
Chemistry	Unplanned Environmental Tritium Releases Root Cause Report #428868  UFSAR req'd 300 ci/unit but BW does 1200000 ci/unit?	Dudek Ambler Walrath Wrigley Smith Gayheart Daly Leasure

## ROOT CAUSE REPORT

Event and Causal Factor Chart  
 Tritium Event  
 Root Cause Report  
 IFR 00428988

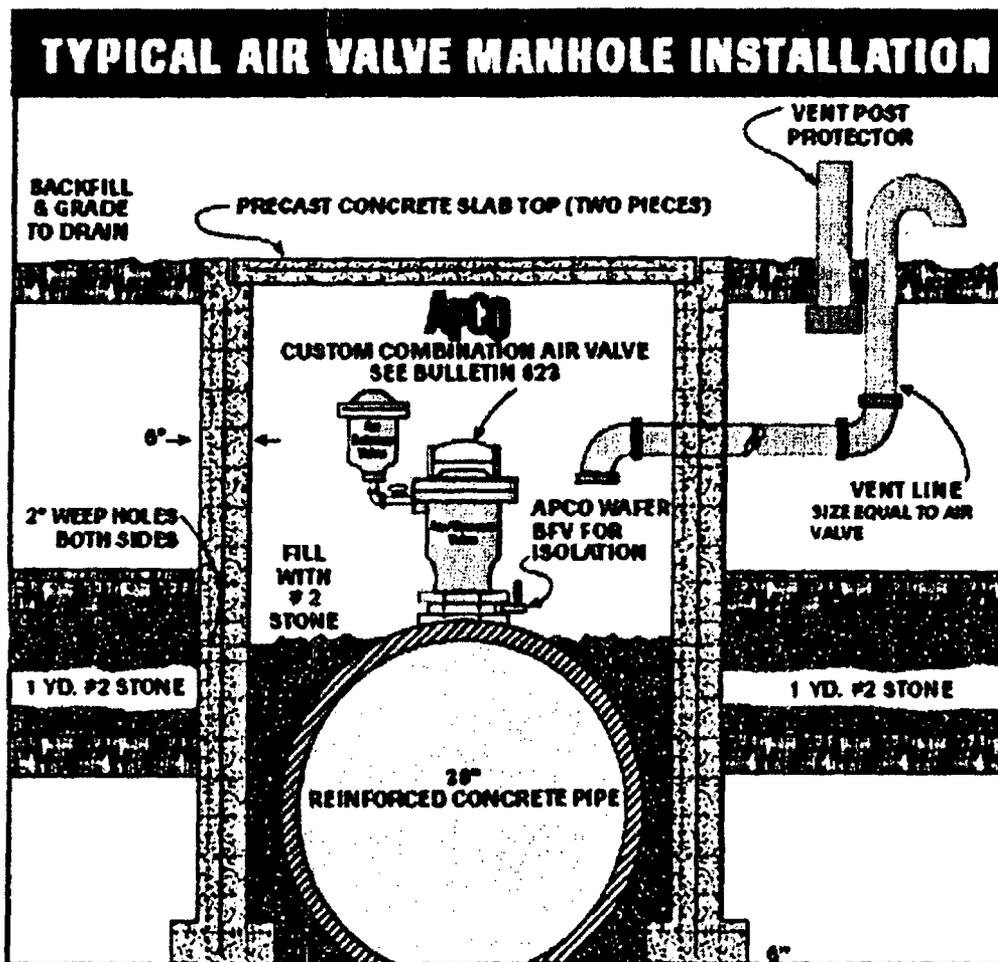
The Circ Water Blowdown system was originally designed to be maintained full and pressurized. This was accomplished through manipulation of the Blowdown Spray Valves, 0CW018A/B at the Kankakee River blowdown structure. These valves were susceptible to freezing due to their location and system operation requirements. Based on this, other maintenance issues, and parts obsolescence, these valves were eventually abandoned in the full open position in the late 1980's. To allow air release from the piping on start-up and to allow air

introduction to protect against vacuum damage to the piping, vacuum breakers were installed.

System control was transferred to the upstream motor operator isolation valves (1/2CW018) located in the turbine building. This modification caused the blowdown line to operate in a partially voided condition in various locations, depending on elevation which allowed column separation water hammer events to occur when flow rates were changed significantly, i.e.; during system start-up or shut down. Events were not initially seen because blowdown was essentially in service all the time. As a result of this modification, the blowdown system would no longer be maintained full and pressurized upon shutdown. Minimal technical review was performed on the hydraulic transient effects on the vacuum breakers from this method of operation (i.e.: surge check valves were not evaluated for system incorporation).

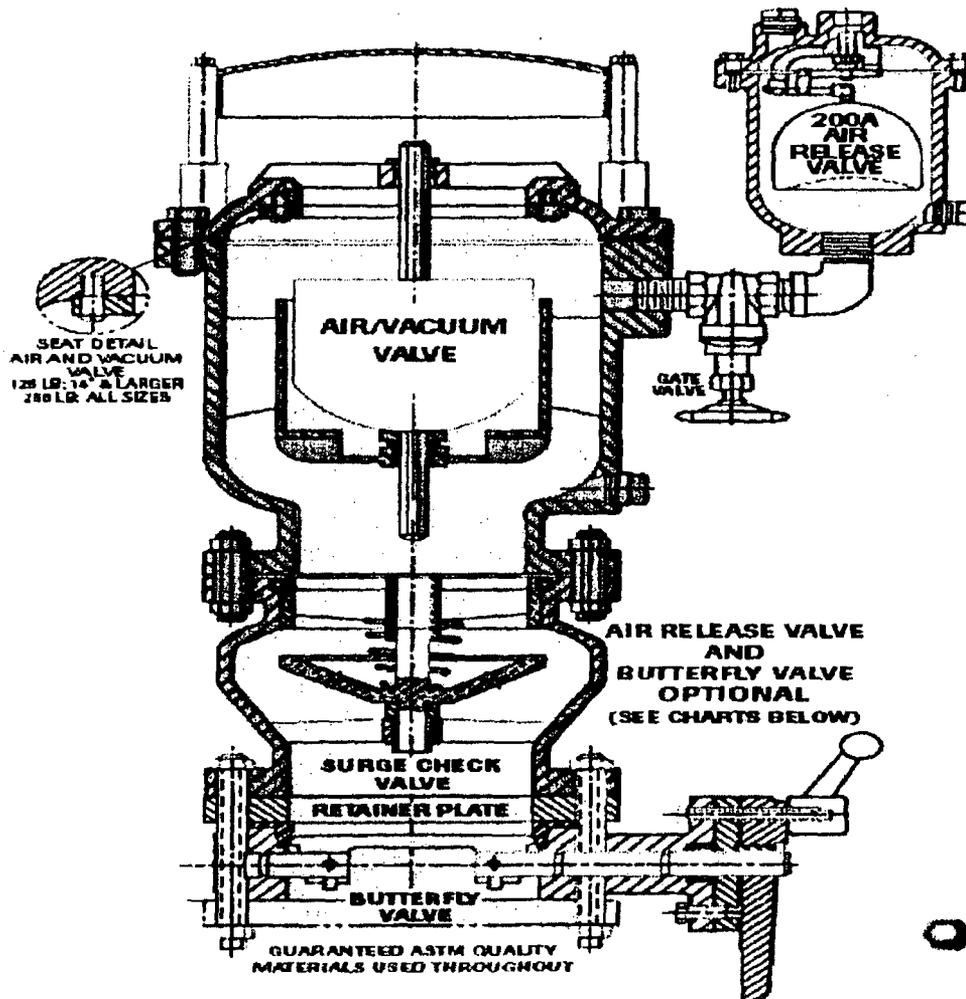
Typical vacuum breaker:

Work history on the Circulating Water Blowdown System vacuum breakers was reviewed. There were no recorded vacuum breaker float assembly failures prior to 2000, however several instances of leaking air release valves were noted from the review. The OCW060 air release valve was discovered leaking in 12/98. PIF # A1998-04324 was generated to address the flooding of site property and the Smiley Road ditch immediately adjacent to site property. The piping to the air release valve on the OCW058 failed in 12/96. The complete vacuum breaker assembly including air release valve was replaced with a new assembly in 6/97. It should be noted that the OCW058 vacuum breaker failed again on 11/20/2000 while this root cause investigation was in progress. The float assembly broke at the bowl to guide bar weld. No other significant work history was identified.

The failure of the OCW136 float assembly was discussed with the vendor. Based on the failure description, the vendor indicated that it appeared to be consistent with the effects of a pressure surge (i.e.: water hammer). The vendor indicated that surge protection check valves should be considered for a vacuum breaker

The RCR 38237 CAPR 2 replaced the current design vacuum breaker assembly with a surge-protected configuration. These two CAPRs were successfully implemented and an effectiveness review was performed under A/R # 00038237-08 two years after the root cause was created. The effectiveness review determined that the CAPR's were effective in eliminating the possibility of another vacuum breaker failure. ? by 2000 standard (water hammer)

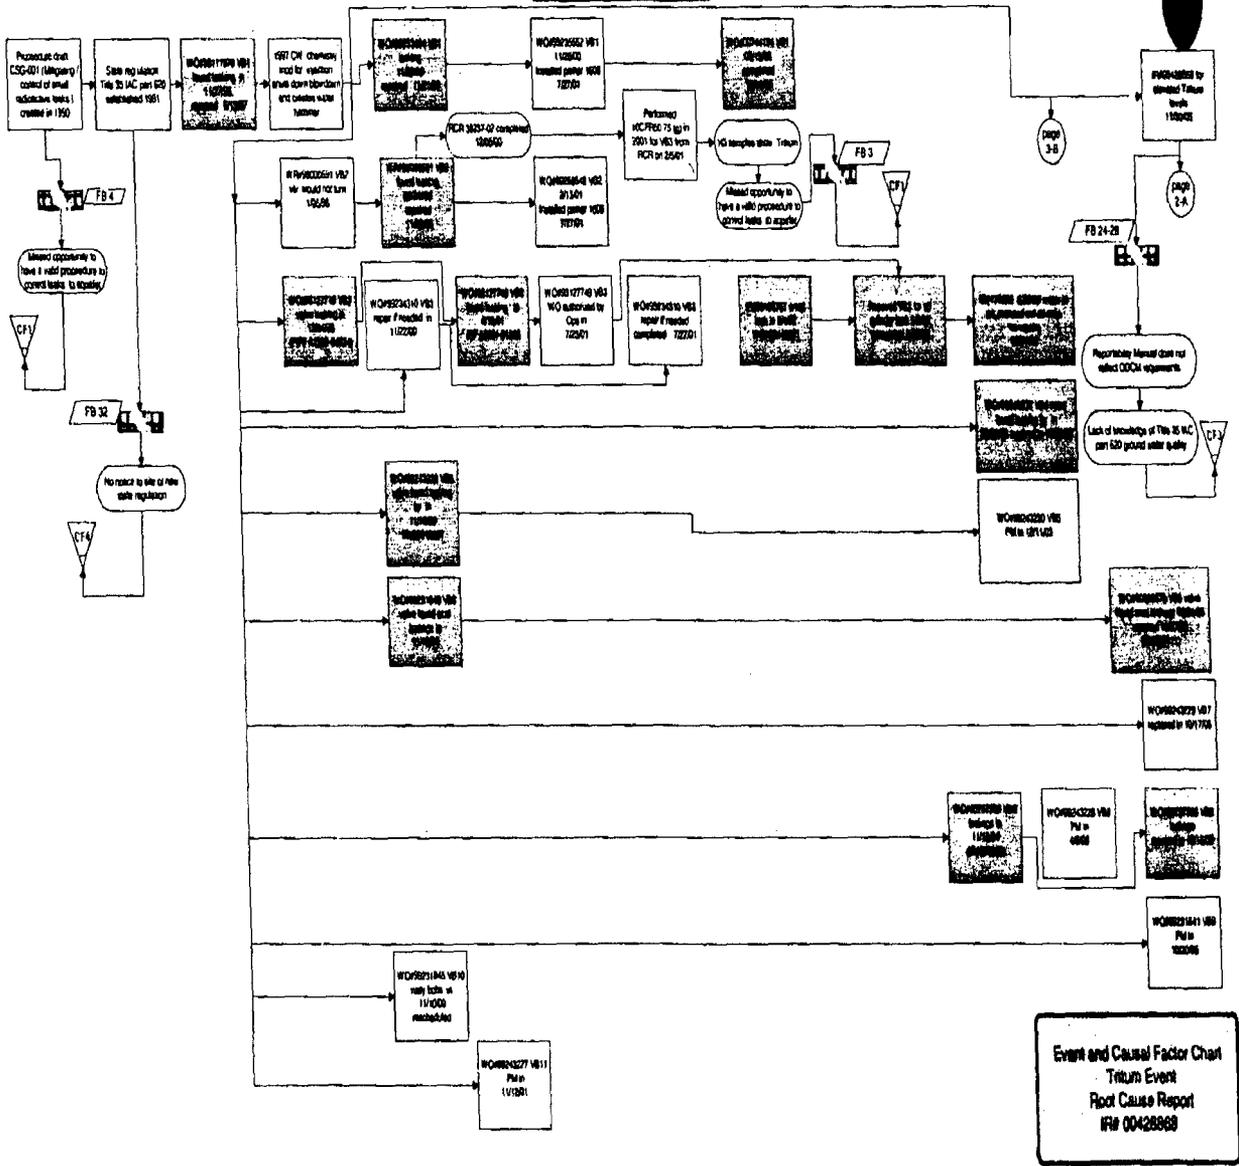
Page 1 for history of blowdown vacuum breakers

Review of the history of all the Circulating Water Blowdown vacuum breakers showed there were three equipment failures that caused major leaks. In 1996, VB-1 had a leak of approximately 250,000 gallons due to a primer valve failure. The only documented response to this event was the repair of the valve. During the review of this event, the team could not find any documentation of sample analysis for radioactive materials. There was no documentation that there was any spill remediation performed. Elevated levels of tritium as of January 2006 have been identified in the groundwater on the Braidwood property close to (northeast of) VB-1. In two locations, the elevated levels were above or near EPA drinking water standards. The elevated levels associated with this location do not extend beyond Braidwood property.

In 1998, VB-3 failed and released approximately three million gallons to the ground. Once again, the only response to this event was to repair the valve as soon as possible. During the review of this event, the team could not find any documentation of sample analysis for radioactive materials. The NPDES Coordinator was notified and determined that there were no environmental concerns because the water had not reached a waterway. There was no documentation that there was any spill remediation performed.

In 2000, VB-2 failed and released approximately three million gallons to the ground. A local resident reported the spill to the station. RP was notified a day later about this issue. The RP Manager spoke with the RP Technical Superintendent and discussed the need to collect samples of available water. The sample results indicated >20,000 pCi/L tritium was present. Once again, the only response to this event was the repair of the valve as soon as possible. The water was pumped back into the B/D line and wells were installed in the area of the 2000 leak to characterize the local hydrology. Based on calculations and conclusions by a professional hydrologist, underground water in the area of VB-2 would take approximately 15 years to flow off-site. Therefore, subsequent actions only included spill clean up and 10CFR50.75(g) documentation completion. No further groundwater tritium analysis was performed.
