PORC	January 24 1 pm Walnut	06- 004
Chemistry	Unplanned Environmental Tritium Releases Root Cause Report #428868 UFSAR req'd 300 ci/unit but BW does 1200000 ci/unit?	Dudek Ambler Walrath Wrigley Smith Gayheart Daly Leasure

The **Root Cause** was determined to be a lack of integrated procedural guidance to ensure proper identification, timely mitigation and evaluation of the spill events, including knowledge of local hydrology, the impact of low-level tritium leaks, and groundwater regulations.

ROOT CAUSE REPORT

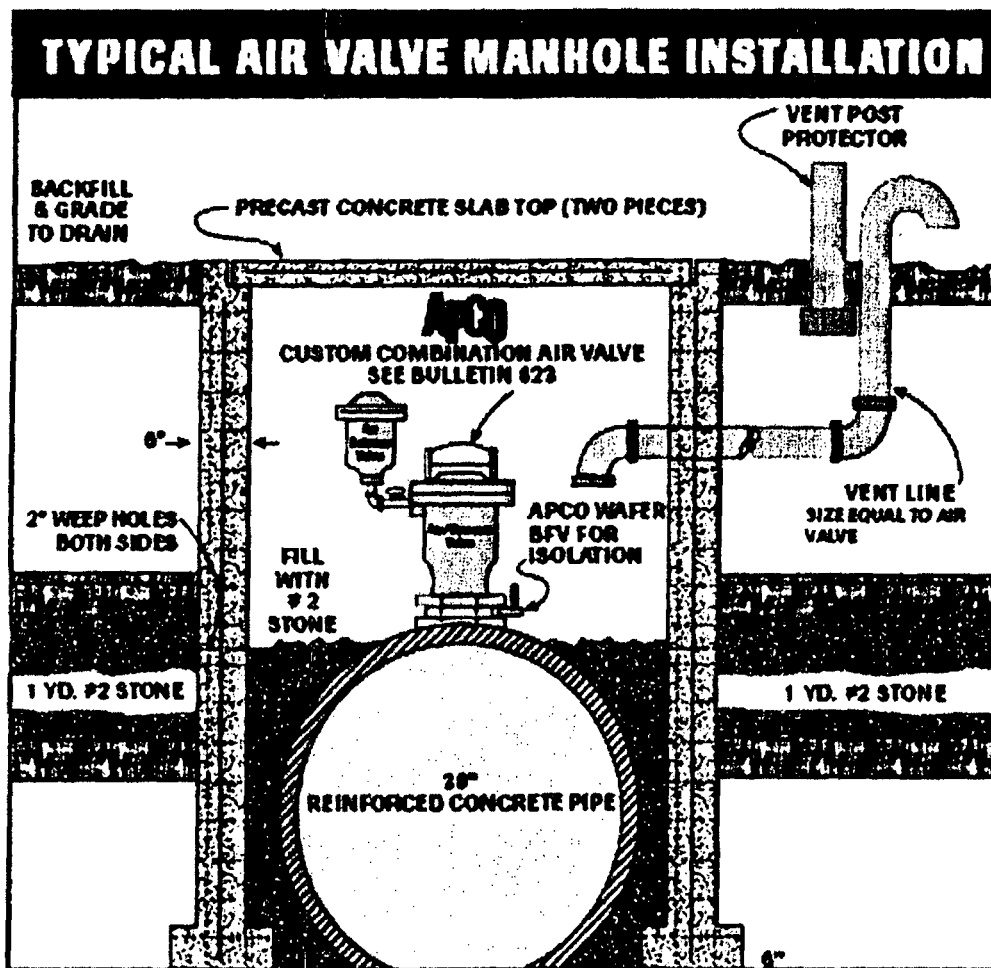
The Circ Water Blowdown system was originally designed to be maintained full and pressurized. This was accomplished through manipulation of the Blowdown Spray Valves, 0CW018A/B at the Kankakee River blowdown structure. These valves were susceptible to freezing due to their location and system operation requirements. Based on this, other maintenance issues, and parts obsolescence, these valves were eventually abandoned in the full open position in the late 1980's. To allow air release from the piping on start-up and to allow air

introduction to protect against vacuum damage to the piping, vacuum breakers were installed.

System control was transferred to the upstream motor operator isolation valves (1/2CW018) located in the turbine building. This modification caused the blowdown line to operate in a partially voided condition in various locations, depending on elevation which allowed column separation water hammer events to occur when flow rates were changed significantly, i.e.; during system start-up or shut down. Events were not initially seen because blowdown was essentially in service all the time. As a result of this modification, the blowdown system would no longer be maintained full and pressurized upon shutdown. Minimal technical review was performed on the hydraulic transient effects on the vacuum breakers from this method of operation (i.e.: surge check valves were not evaluated for system incorporation).

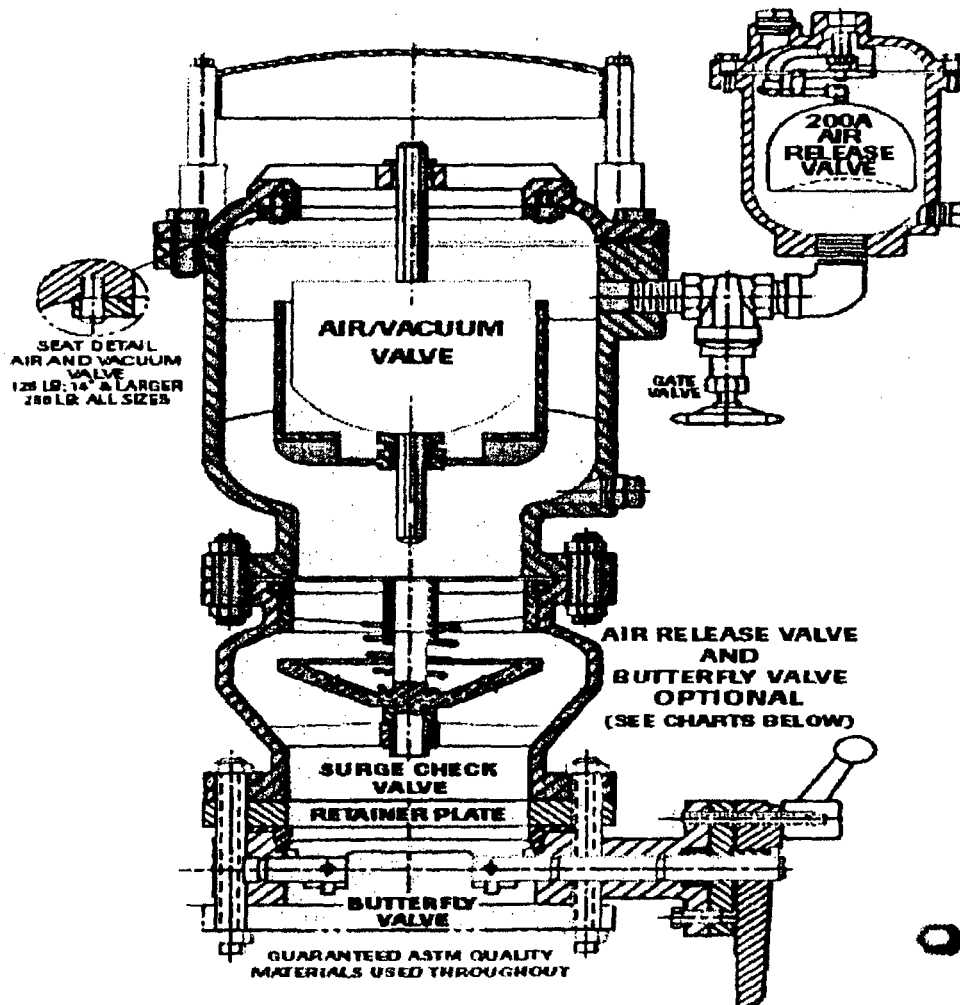
Typical vacuum breaker:

Work history on the Circulating Water Blowdown System vacuum breakers was reviewed. There were no recorded vacuum breaker float assembly failures prior to 2000, however several instances of leaking air release valves were noted from the review. The OCW060 air release valve was discovered leaking in 12/98. PIF # A1998-04324 was generated to address the flooding of site property and the Smiley Road ditch immediately adjacent to site property. The piping to the air release valve on the OCW058 failed in 12/96. The complete vacuum breaker assembly including air release valve was replaced with a new assembly in 6/97. It should be noted that the OCW058 vacuum breaker failed again on 11/20/2000 while this root cause investigation was in progress. The float assembly broke at the bowl to guide bar weld. No other significant work history was identified.

The failure of the OCW136 float assembly was discussed with the vendor. Based on the failure description, the vendor indicated that it appeared to be consistent with the effects of a pressure surge (i.e.: water hammer). The vendor indicated that surge protection check valves should be considered for a vacuum breaker

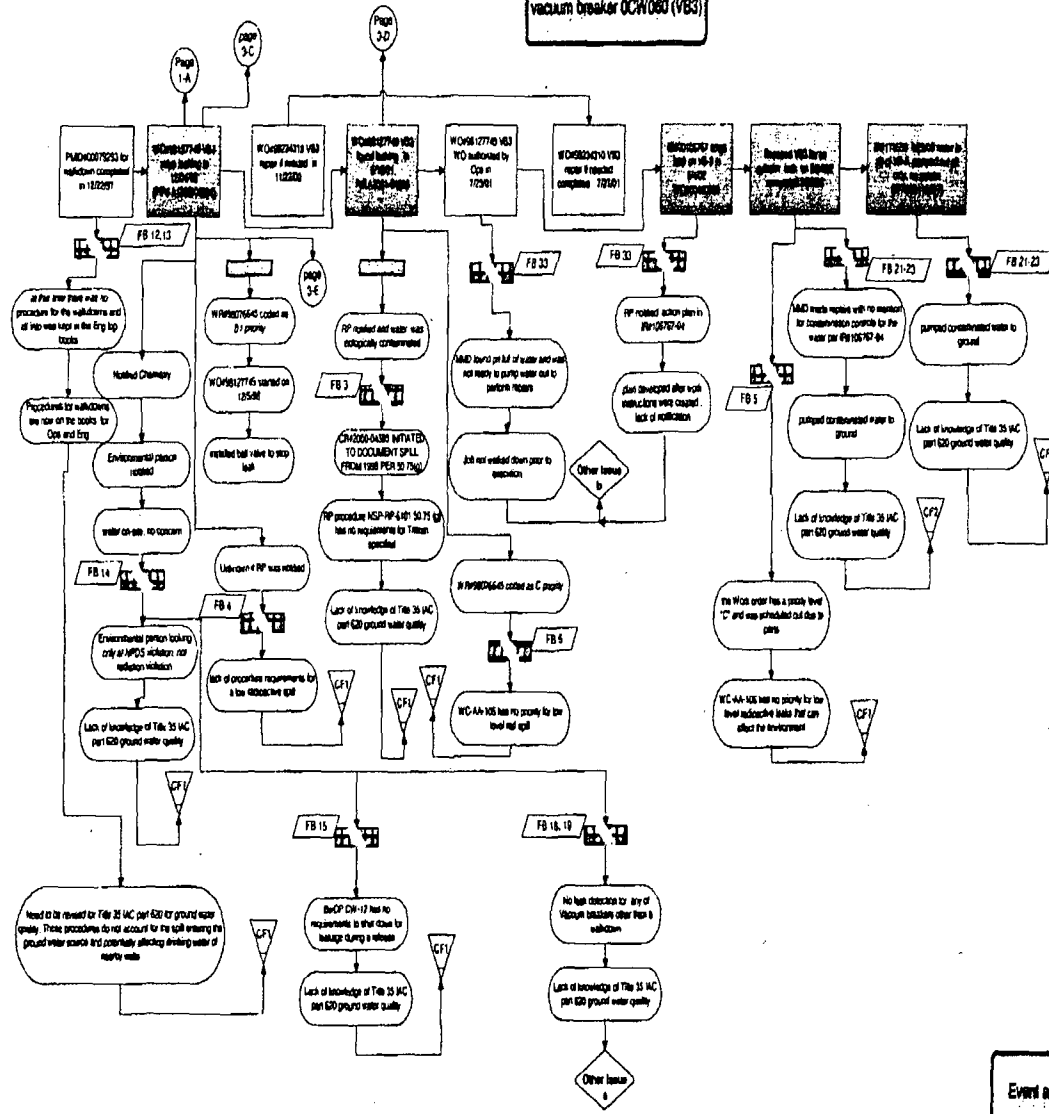
Page 2 for history of blowdown vacuum breaker OCW060 (VB3)

In 1998, VB-3 failed and released approximately three million gallons to the ground. Once again, the only response to this event was to repair the valve as soon as possible. During the review of this event, the team could not find any documentation of sample analysis for radioactive materials. The NPDES Coordinator was notified and determined that there were no environmental concerns because the water had not reached a waterway. There was no documentation that there was any spill remediation performed.
