Title: **Evaluation of Effect of Borated Water Leaks on Concrete, Reinforcing Bars, and Carbon Steel Plate of the Containment Vessels at Prairie Island Units 1 and 2**

Number: R-4448-00-01

**Evaluation of Effect of Borated Water Leaks
on Concrete, Reinforcing Bars, and
Carbon Steel Plate of the Containment Vessels at
Prairie Island Units 1 and 2**

Revision 0

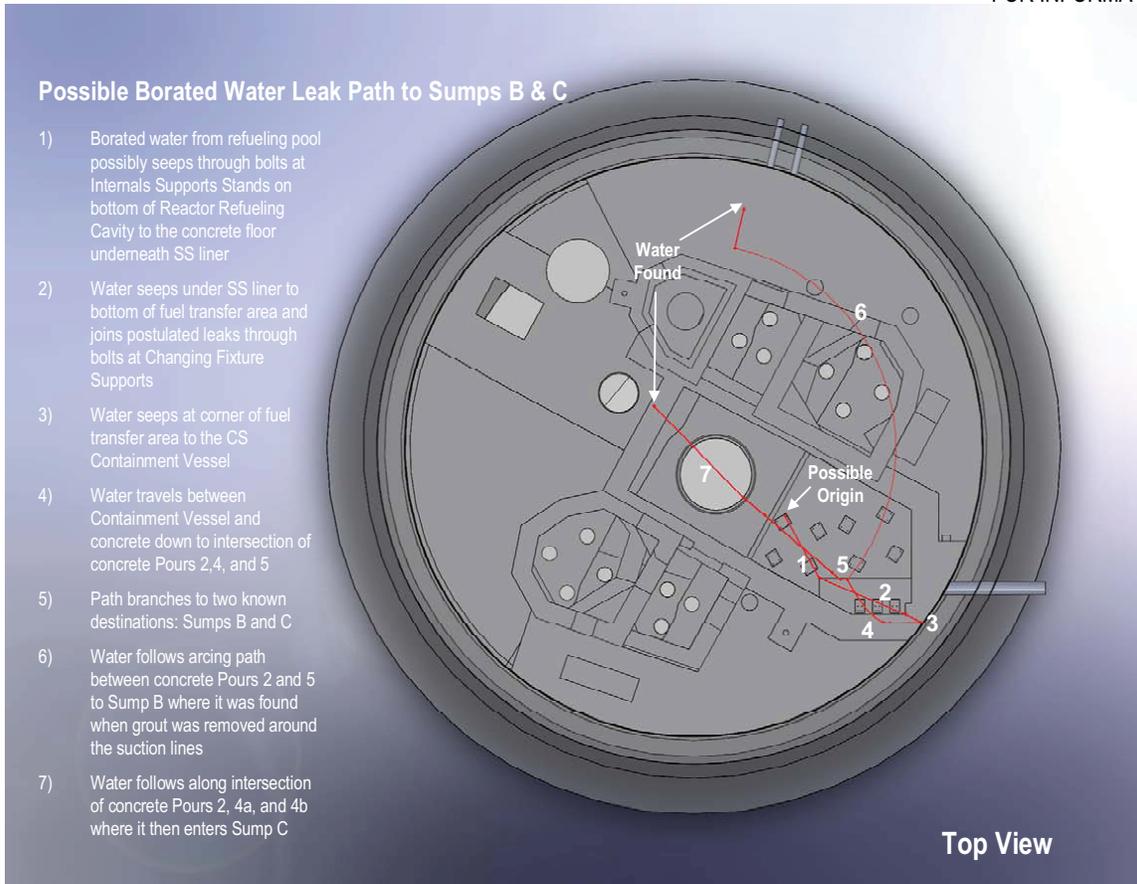
Figure A-2 Possible Borated Water Leak Paths to Sumps B & C in Unit 2 – Top View

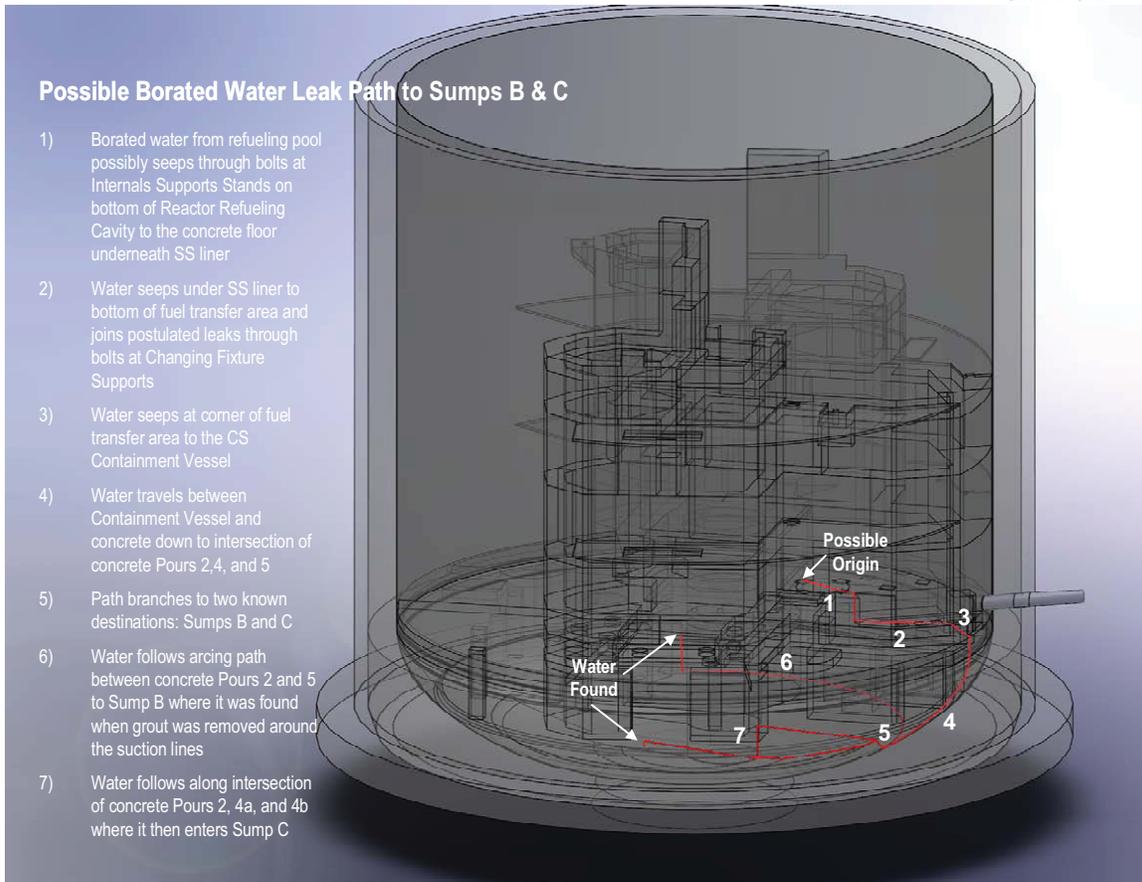
Figure A-3 Possible Borated Water Leak Paths to Sumps B & C in Unit 2 – 3D View

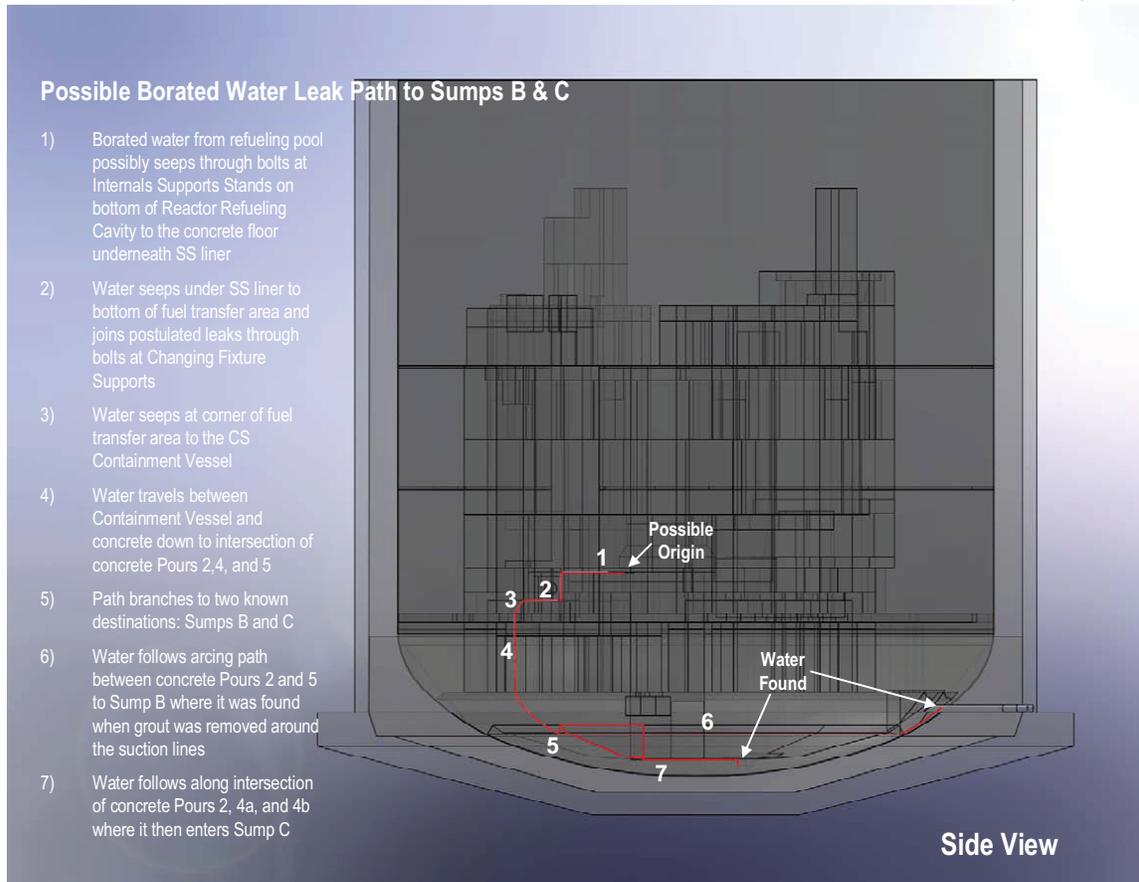
Figure A-4 Possible Borated Water Leak Paths to Sumps B & C in Unit 2 – Transparent Side View

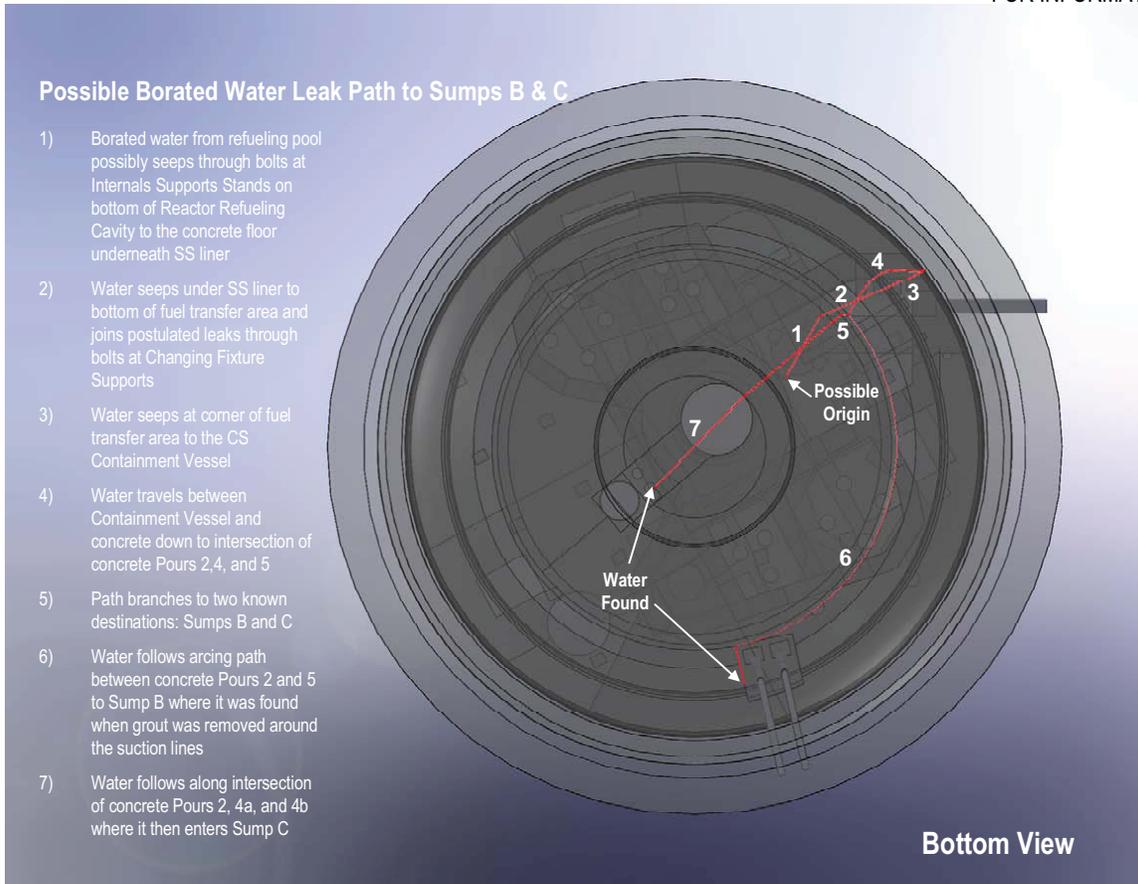
Figure A-5 Possible Borated Water Leak Paths to Sumps B & C in Unit 2 – Transparent Bottom View

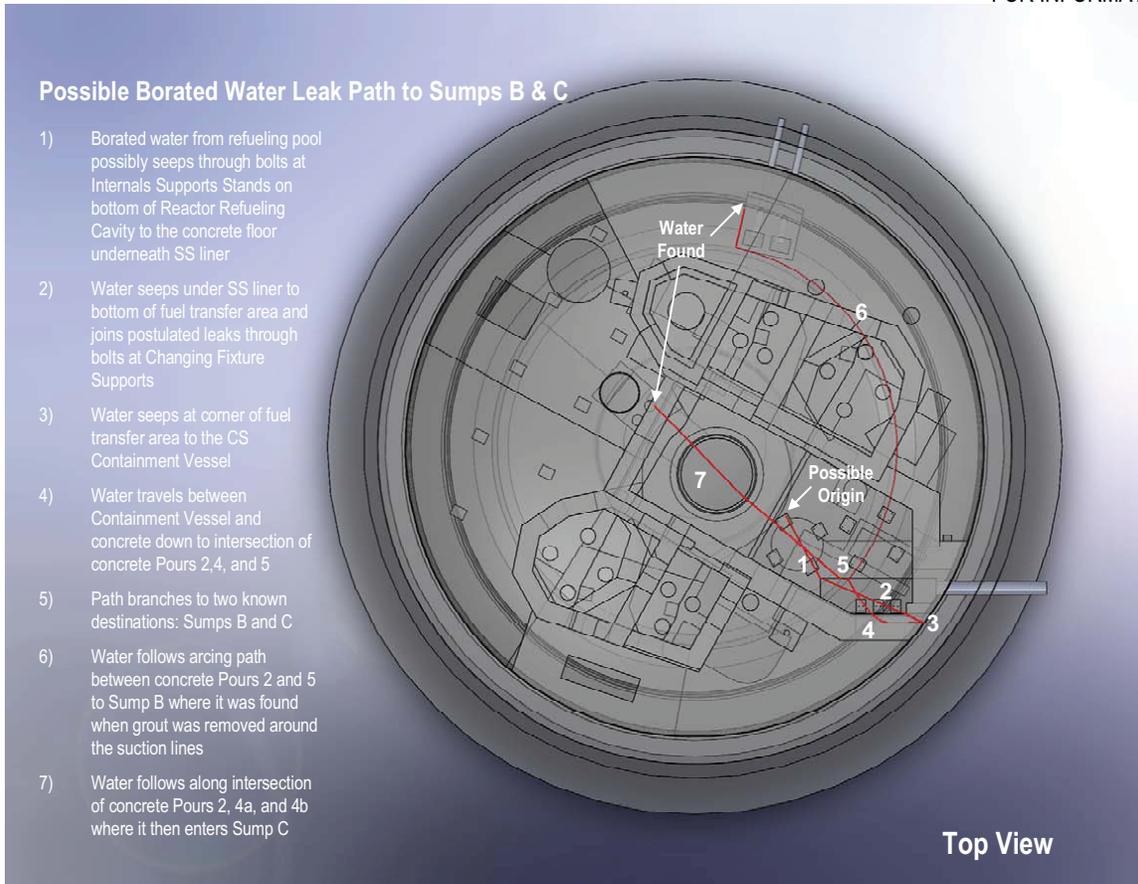
Figure A-6 Possible Borated Water Leak Paths to Sumps B & C in Unit 2 – Transparent Top View

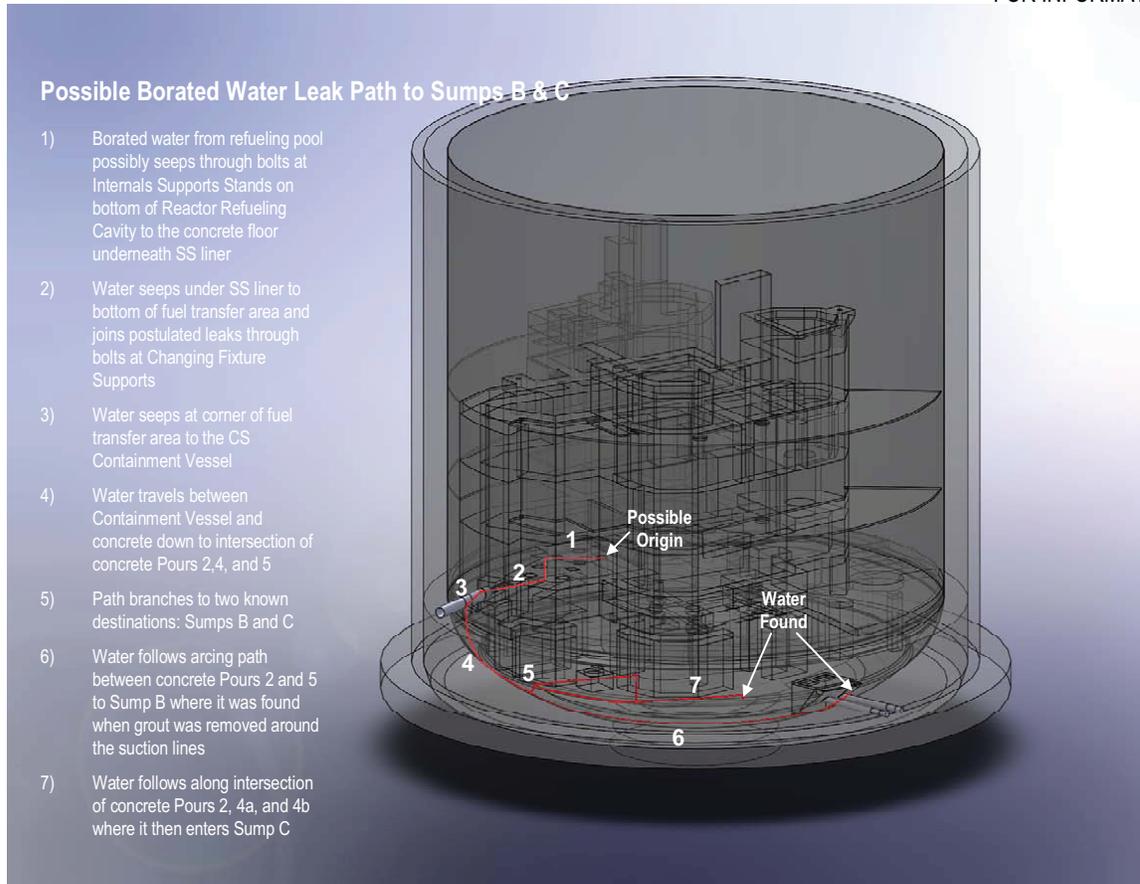
Figure A-7 Possible Borated Water Leak Paths to Sumps B & C in Unit 2 – Alternate Transparent 3D View

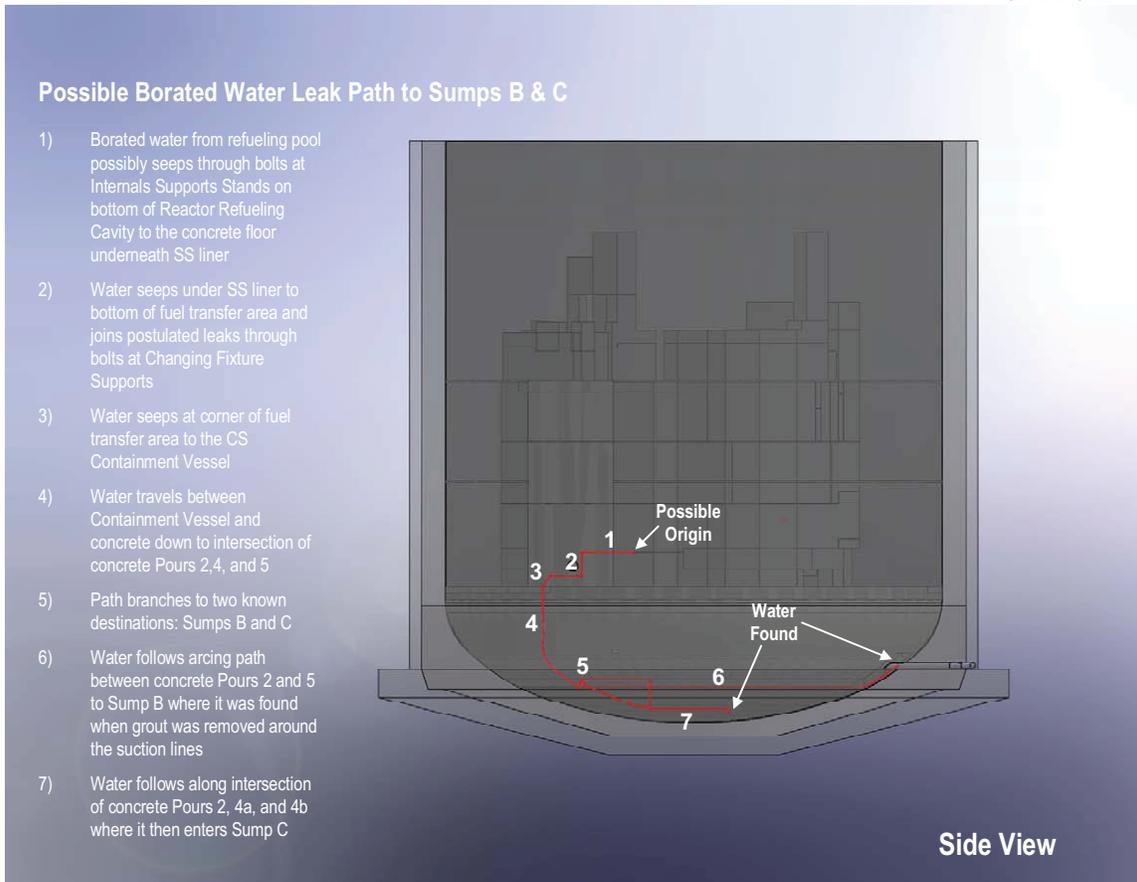
Figure A-8 Possible Borated Water Leak Paths to Sumps B & C in Unit 2 – Side View

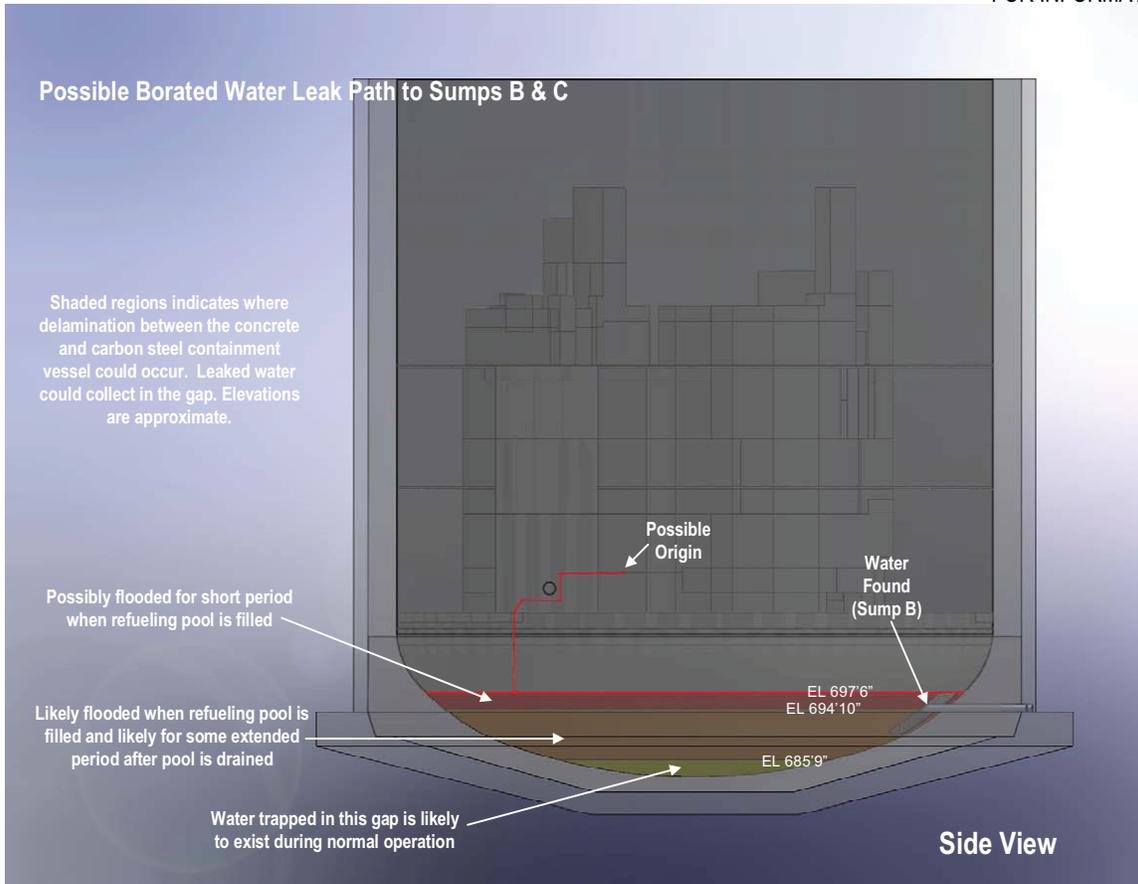
Figure A-9 Lower Regions Wetted by Possible Borated Water Leak Paths to Sumps B & C in Unit 2 – Side View

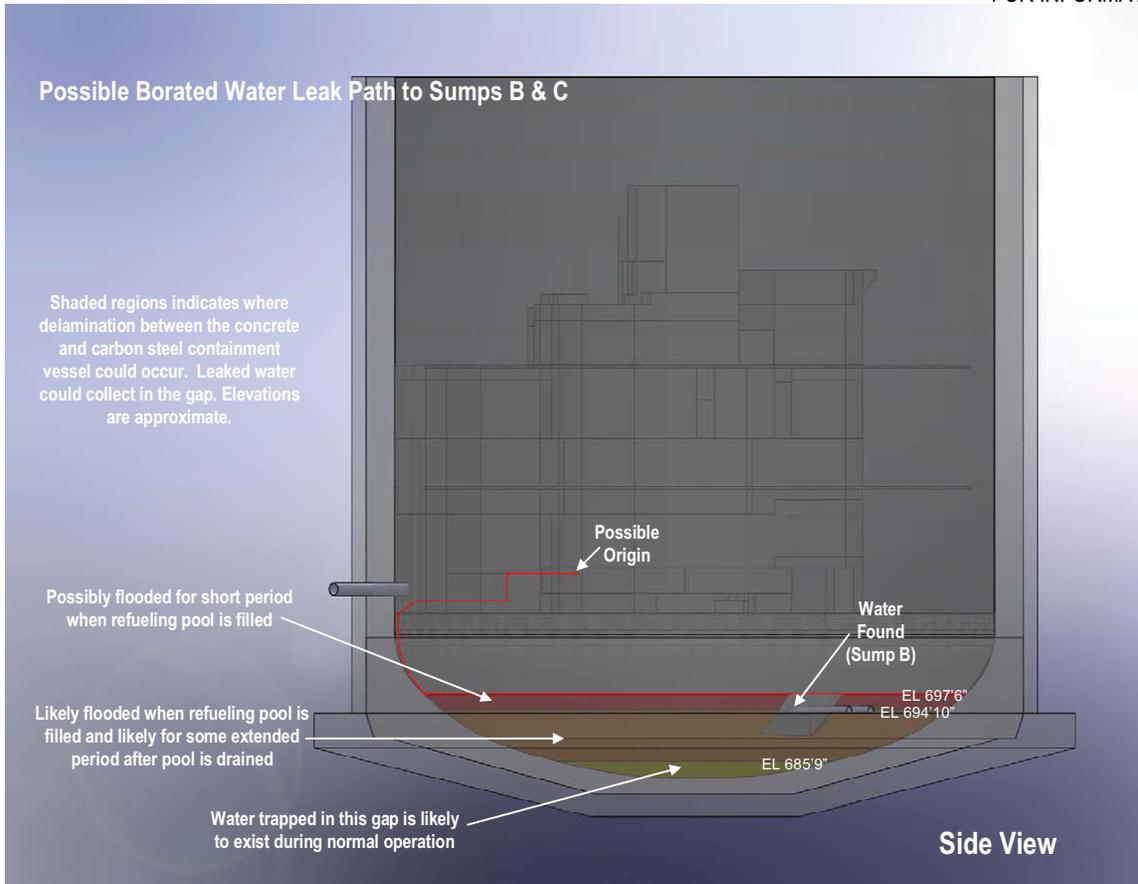
Figure A-10 Lower Regions Wetted by Possible Borated Water Leak Paths to Sumps B & C in Unit 2 – Alternate Side View

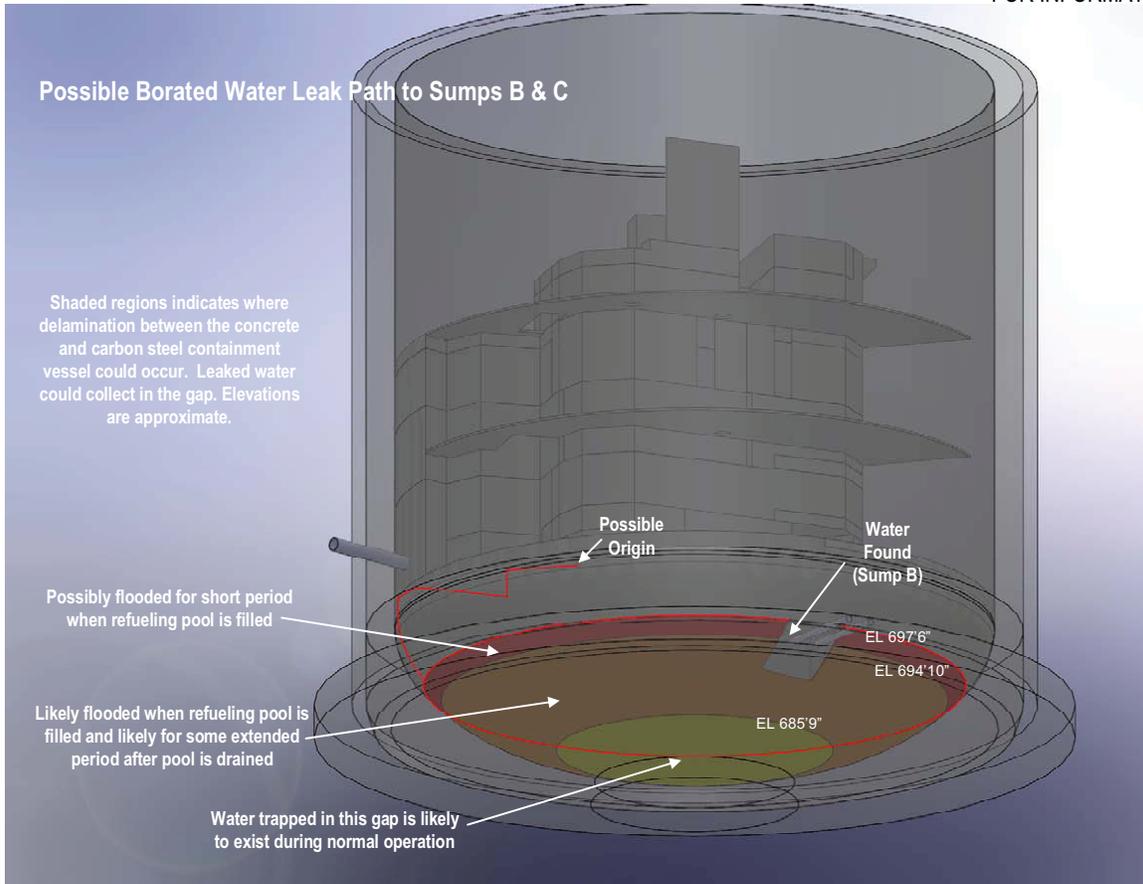
Figure A-11 Lower Regions Wetted by Possible Borated Water Leak Paths to Sumps B & C in Unit 2 – Bottom 3D View

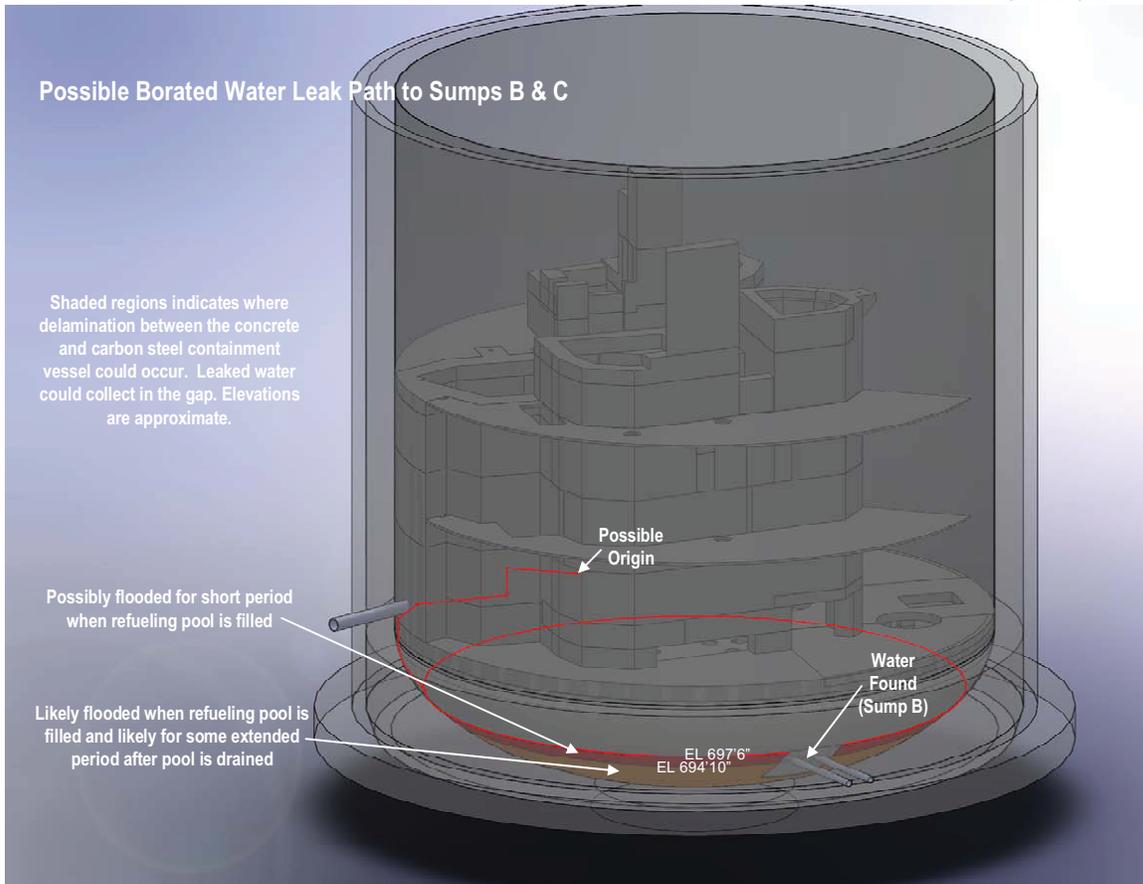
Figure A-12 Lower Regions Wetted by Possible Borated Water Leak Paths to Sumps B & C in Unit 2 – Top 3D View

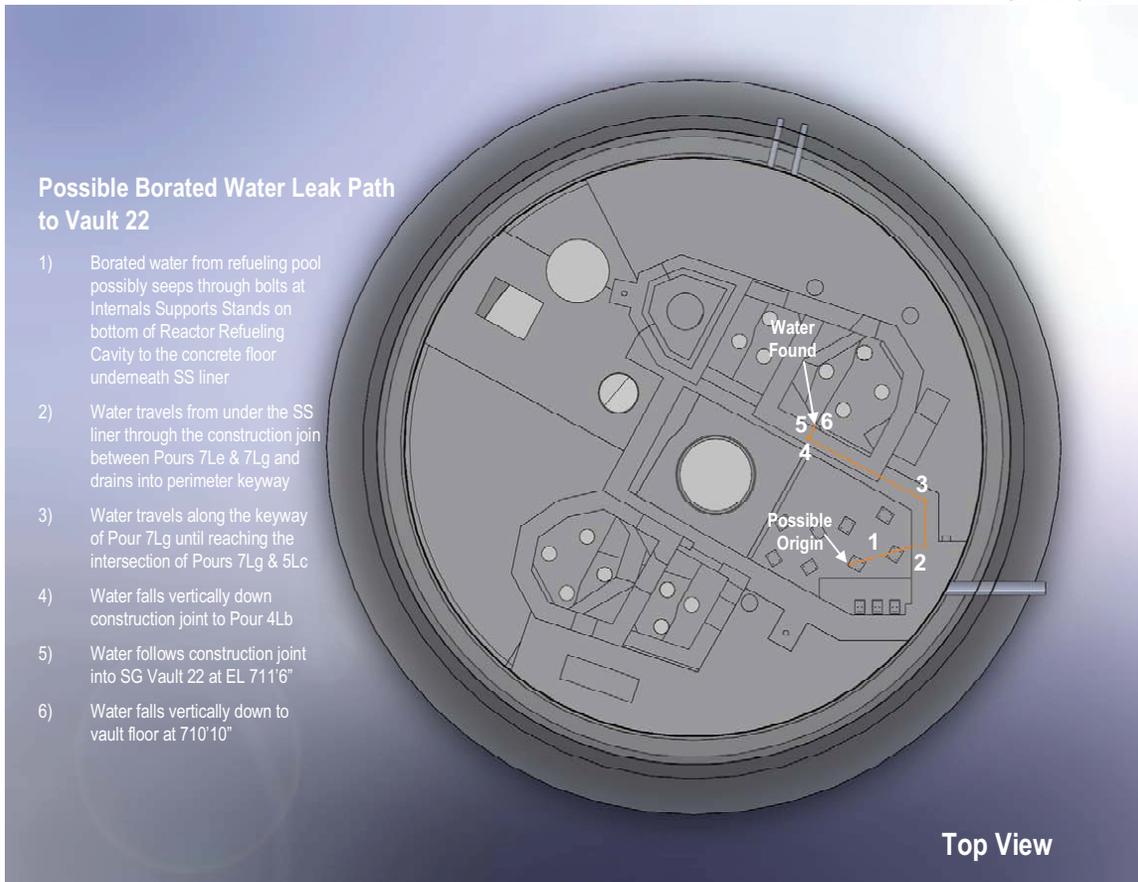
Figure A-13 Possible Borated Water Leak Path to Vault 22 – Top View

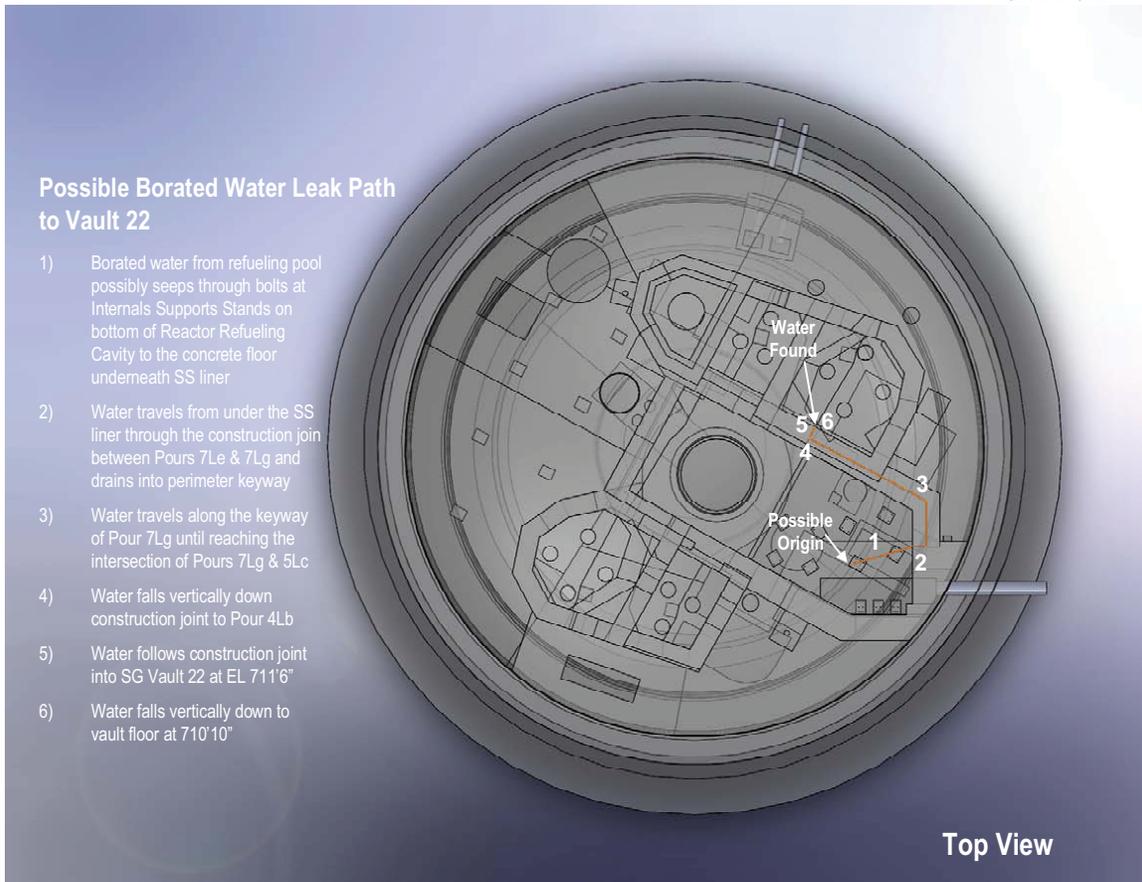
Figure A-14 Possible Borated Water Leak Path to Vault 22 – Transparent Top View

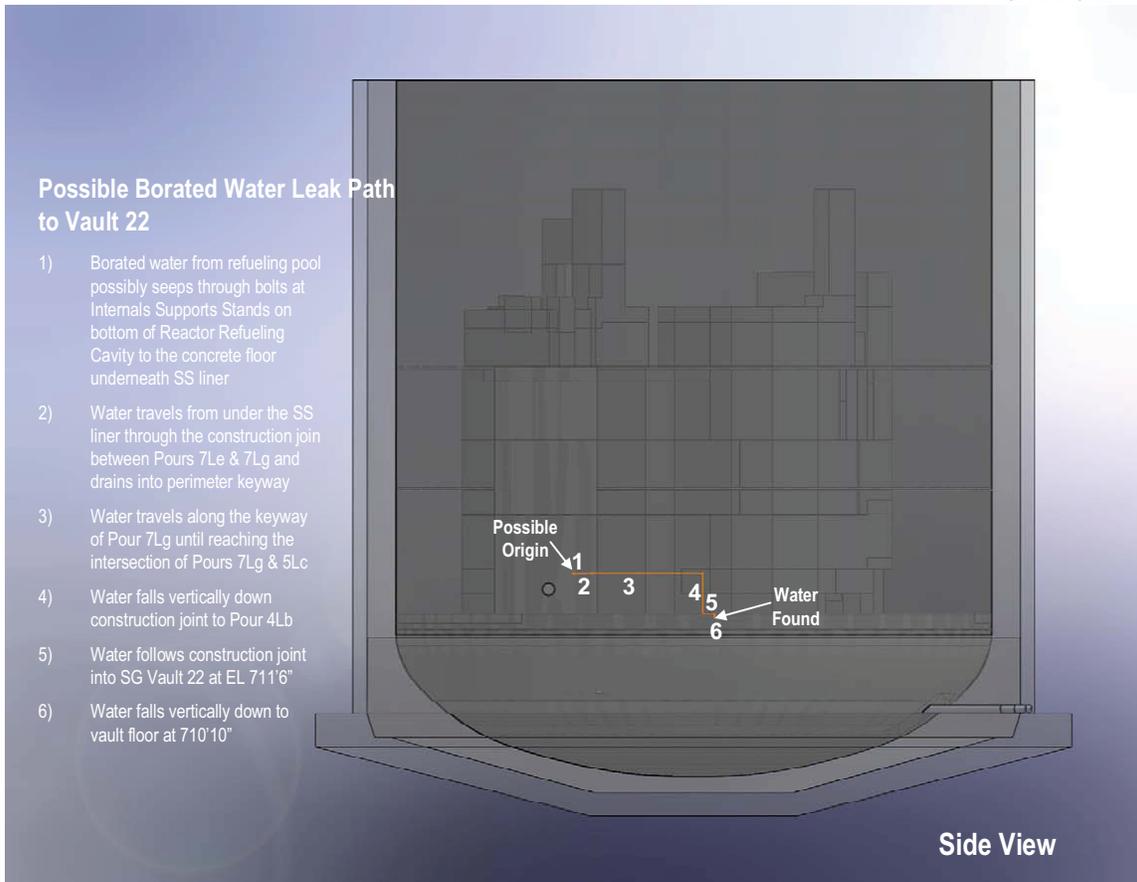
Figure A-15 Possible Borated Water Leak Path to Vault 22 – Side View

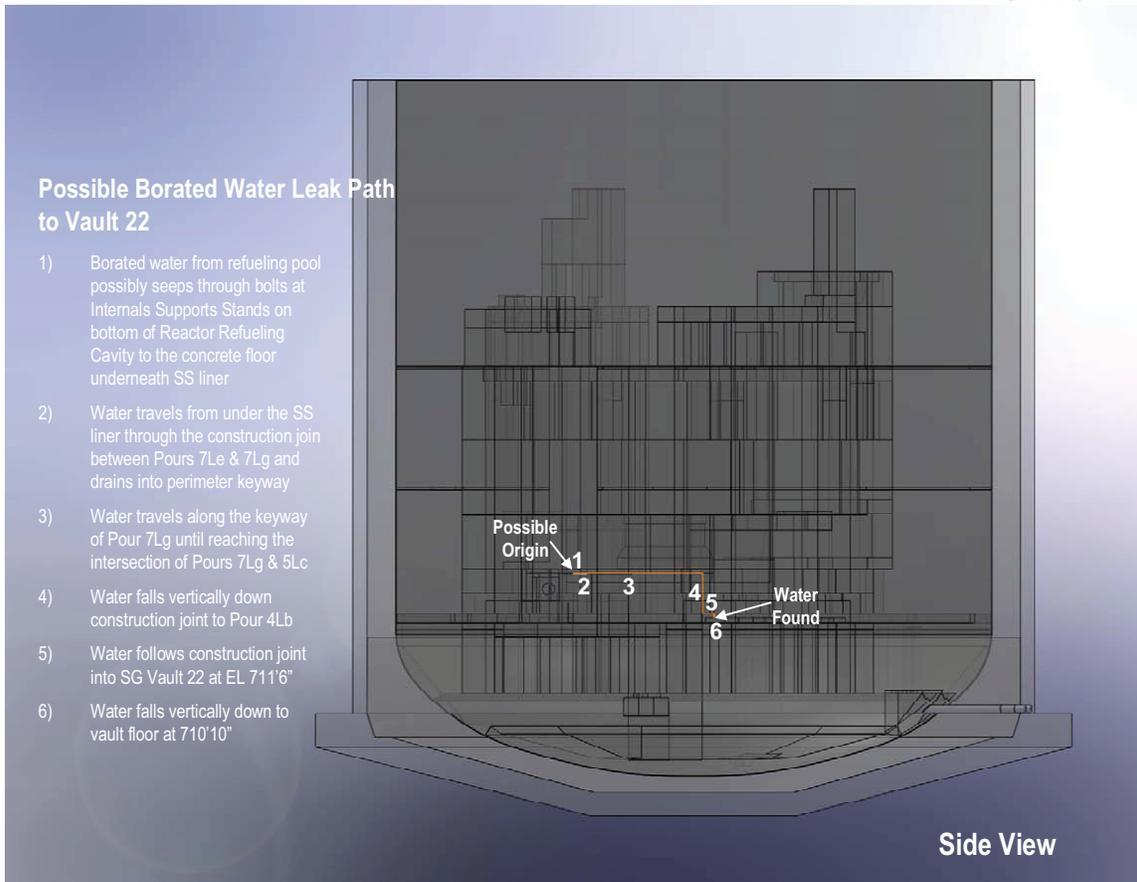
Figure A-16 Possible Borated Water Leak Path to Vault 22 – Transparent Side View

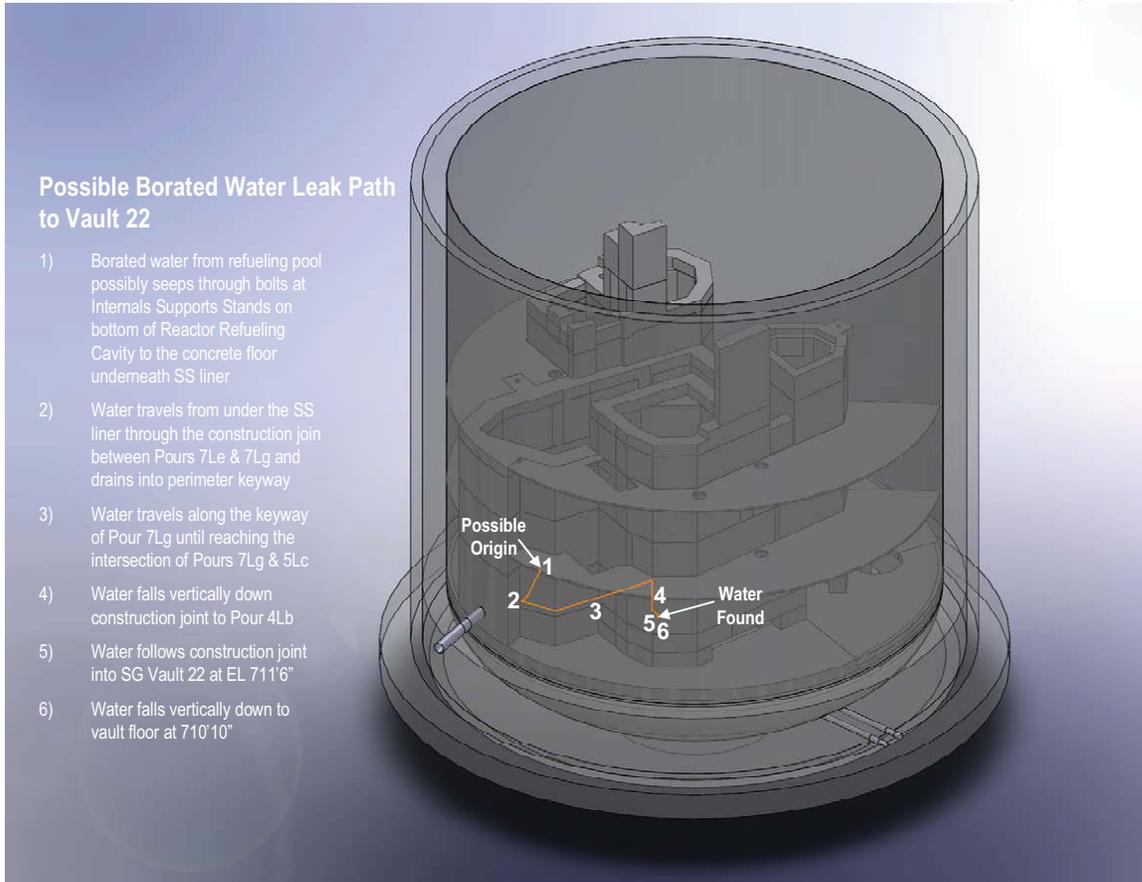
Figure A-17 Possible Borated Water Leak Path to Vault 22 – Top 3D View

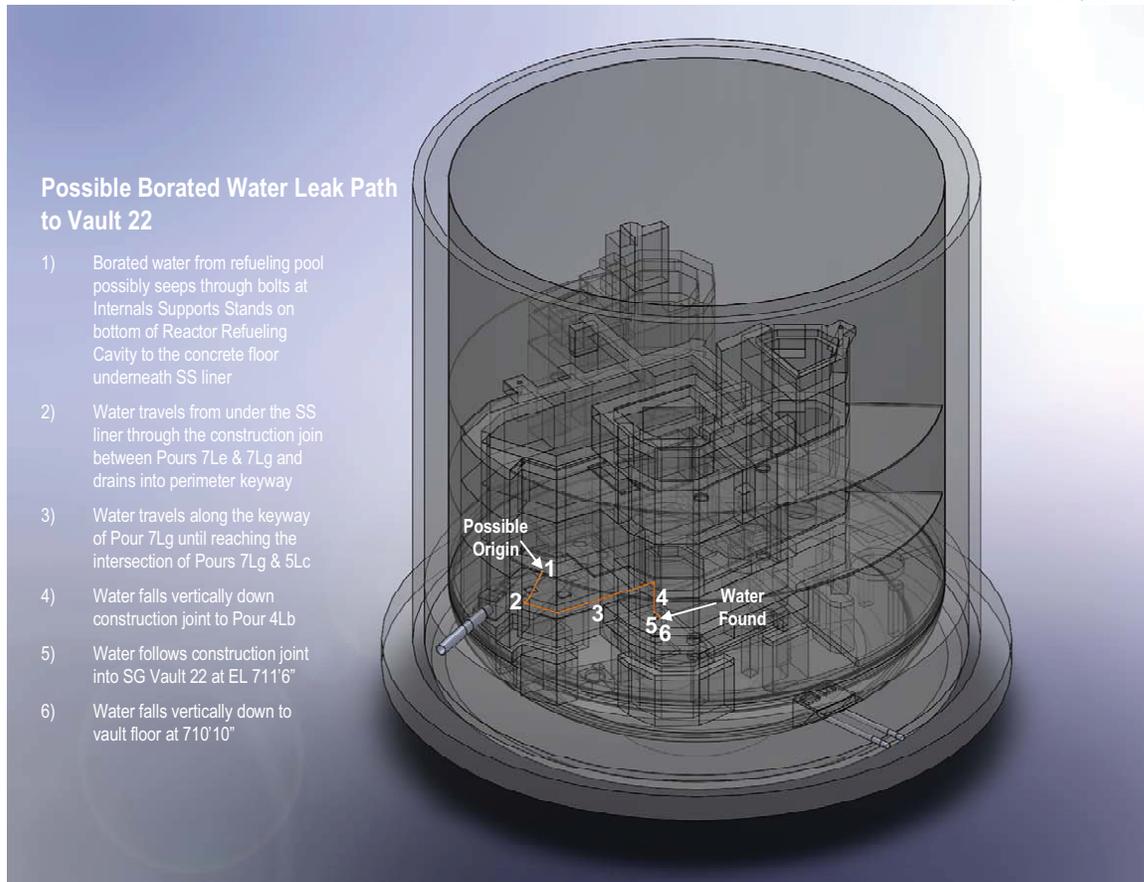
Figure A-18 Possible Borated Water Leak Path to Vault 22 – Transparent Top 3D View

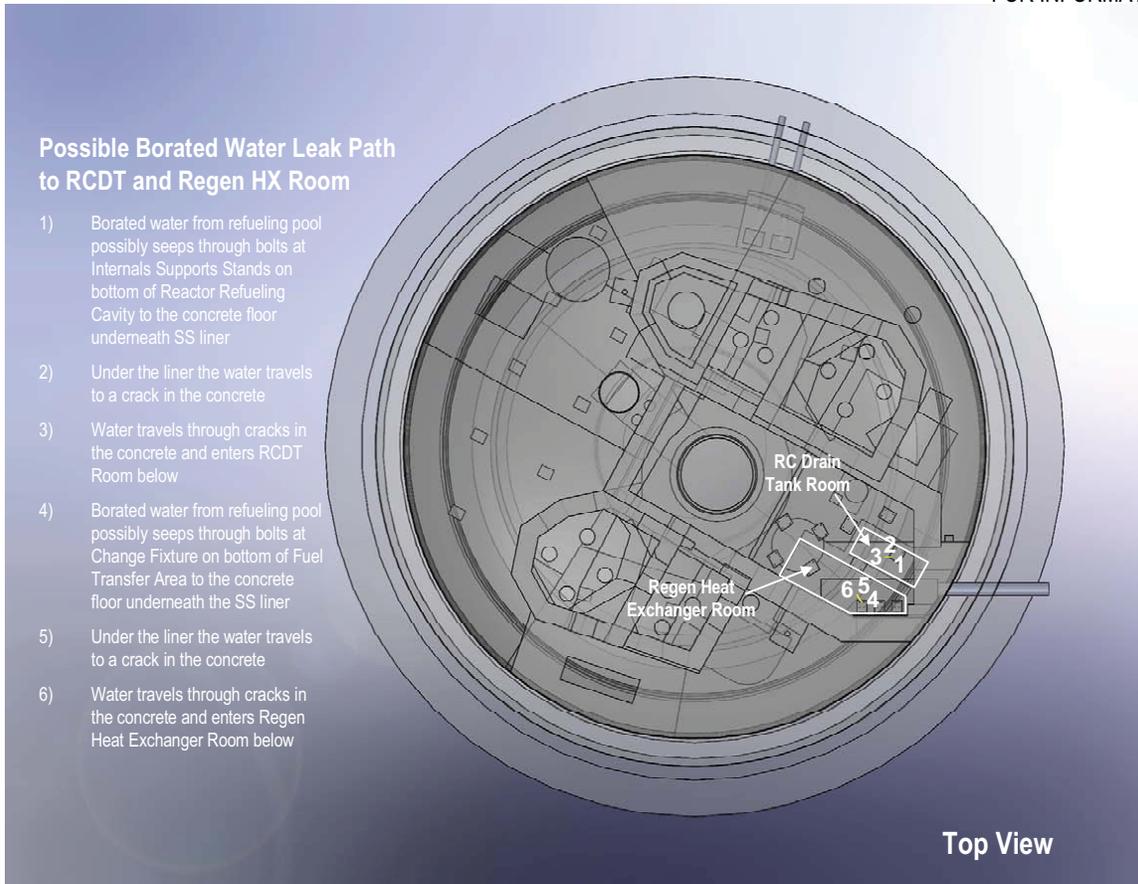
Figure A-19 Possible Borated Water Leak Path to RCDT Space and Regen HX Room in Unit 2 – Top View

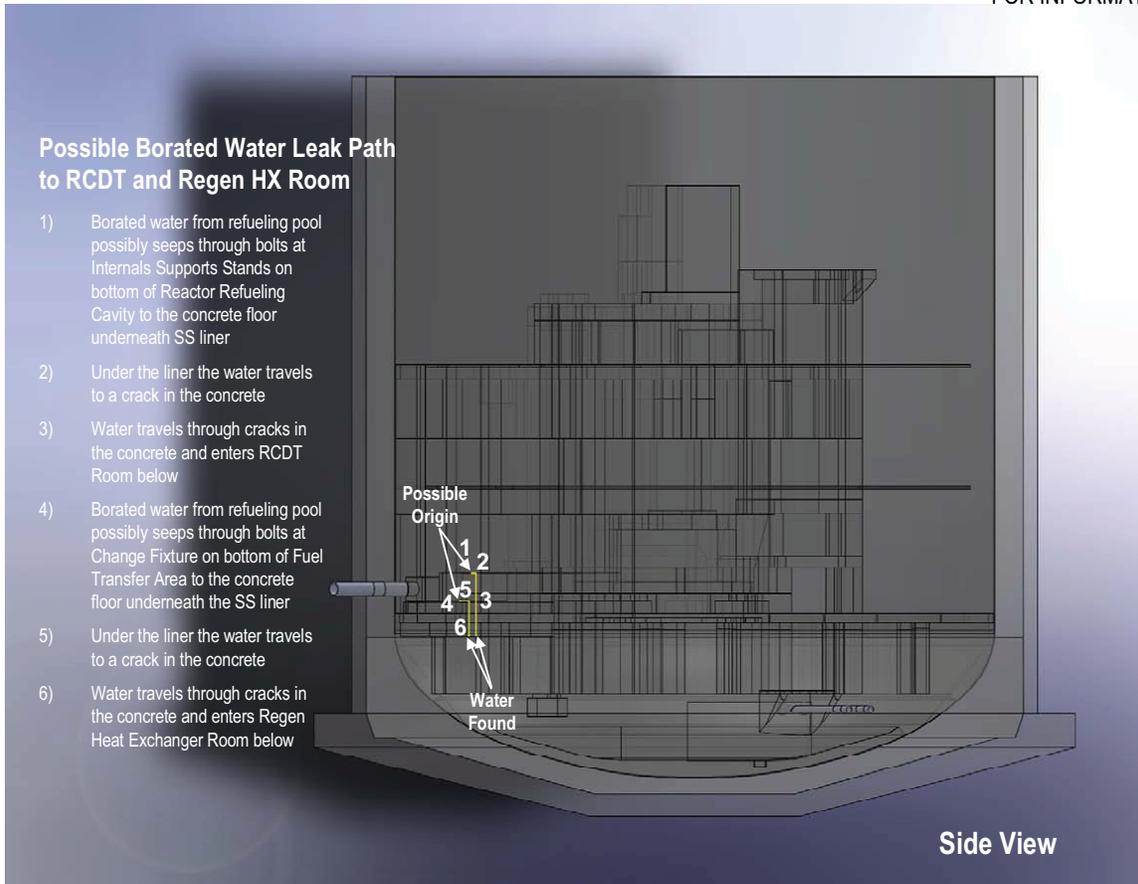
Figure A-20 Possible Borated Water Leak Path to RCDT Space and Regen HX Room in Unit 2 – Side View

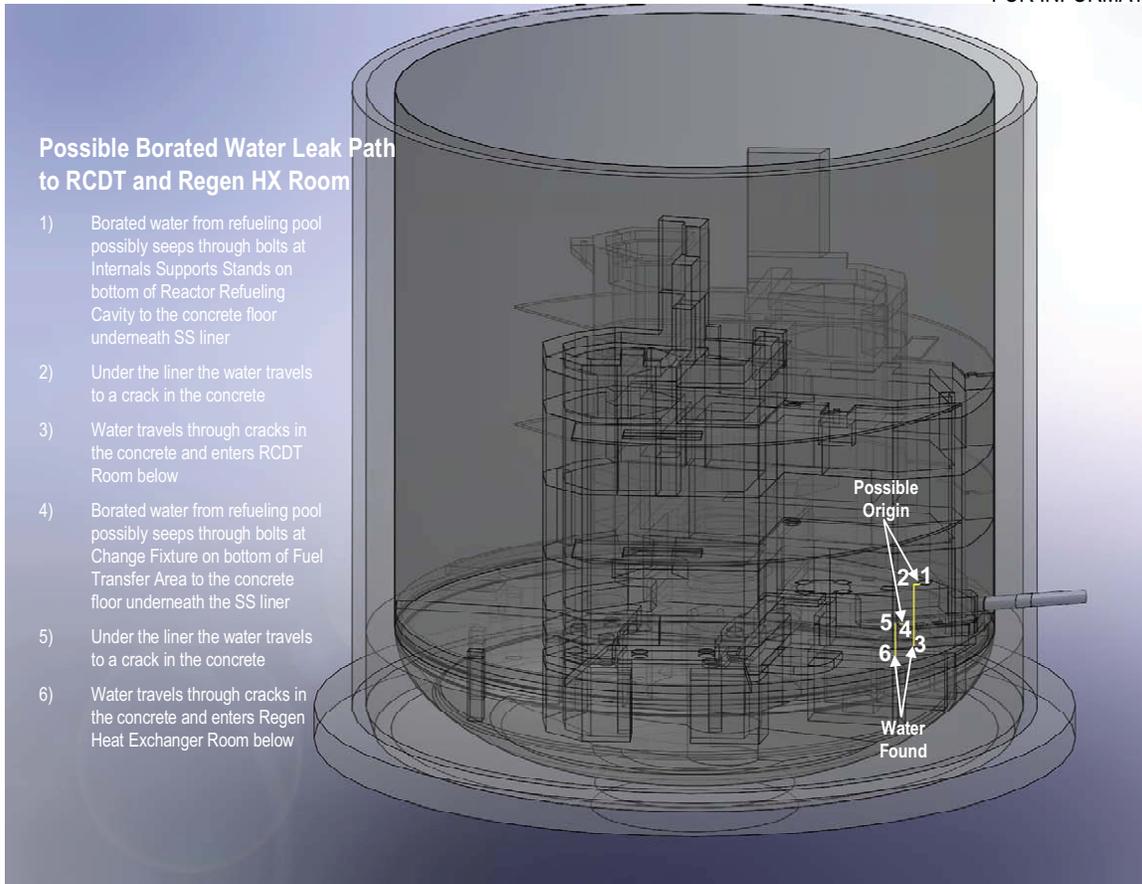
Figure A-21 Possible Borated Water Leak Path to RCDT Space and Regen HX Room in Unit 2 – 3D View
