**RCE REPORT**

***Prairie Island Nuclear Generating Plant***

***[Radioactive Material Shipment Exceeded DOT Limits]***

**RCE 01157726**

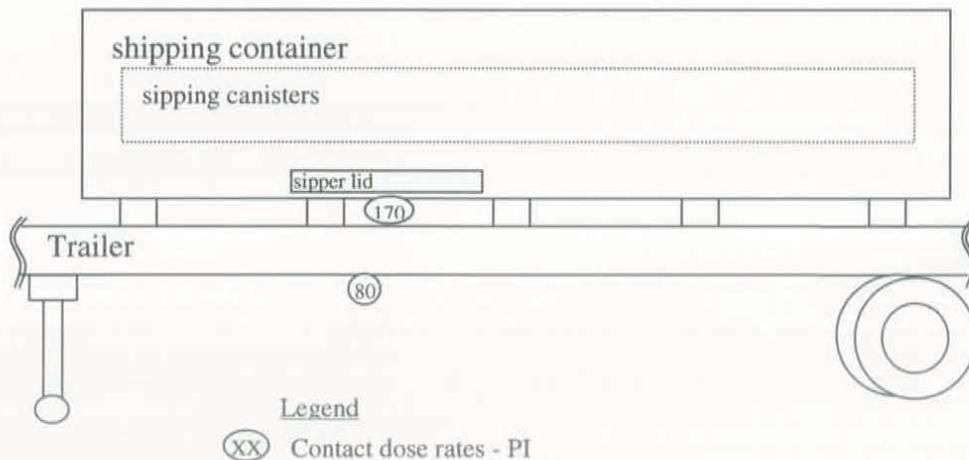
Trailer Configuration and Dose Rates

Subsequent investigation determined the elevated contact readings were the result of a discrete particle fixed to a coated cable in the shipment. The cable containing the discrete particle was a part of a bundle of cables that had shifted during shipment, positioning the area of the cable where the discrete particle was located near the bottom of the shipping container. Contact dose rates with the bottom of the trailer as found at Waltz Mill were 80 mrem/hr, and similar to the trailer bottom maximum contact reading from the Prairie Island pre-transport survey. This value was within acceptable limits when the tractor and trailer were initially surveyed on arrival at Waltz Mill, and met DOT vehicle dose rate requirements.

The location of the elevated radiation levels on the bottom of the box restricted exposure to the general public to radiation levels in excess of regulatory limits during transportation between Prairie Island and Waltz Mill. The shipping container was not repositioned on the trailer or removed while in transit and the trailer was an exclusive use shipment to the Waltz Mill, PA site. The truck was stopped for a maximum total of 5.75
