RCE REPORT**Prairie Island Nuclear Generating Plant**

***11 Turbine-Driven Auxiliary Feedwater Pump Discharge
Pressure Switch Manifold Isolation Mispositioning
Event Date: July 31, 2008***

RCE 01146005

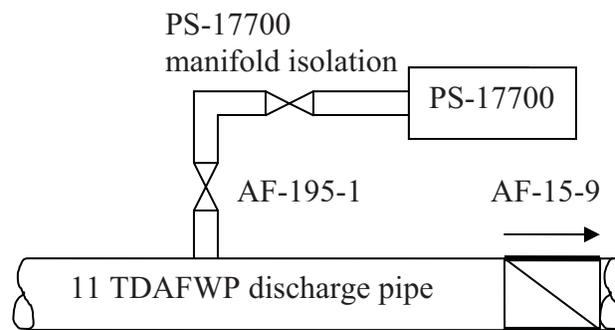
Figure 1: PS-17700 Valve Arrangement

Between March 11, 2008 and July 31, 2008, an I&C technician or plant operator inadvertently operated the manifold block isolation valve for Pressure Switch PS-17700 (11 TDAFWP Lo Discharge Pressure Trip Pressure Switch). During that time period, there were seven surveillance procedures (SPs) completed (SP 1301, SP 1376, SP 1103, and 4 occurrences of SP 1102) that operated valves in the vicinity of the PS-17700 manifold isolation valve. These valves are identical in design to the PS-17700 manifold valve and in close proximity to the valve. There are no steps in the procedures to check the position of PS-17700 manifold isolation valve because none of the procedures operate this valve. None of the personnel interviewed remember any issues with the operation of the manifold valves during their associated surveillance procedures.

The root cause evaluation determined that, since no procedures conducted after C1.6A.1-1 was last performed physically operate the manifold isolation valve for PS-17700, the most likely cause of the mispositioning was inadvertent operation. The most effective tool at avoiding inadvertent mispositioning would be locking the valve. Other tools would be effective at raising awareness of and controlling instrument isolation valves. Examples of these tools are:

The root cause is inadequate configuration controls for components that have the potential to adversely impact the design function of safety related Structures, Systems and Components (SSCs).

- 1) The positions of other valves with similar functions in AFW System have been checked. The suction and discharge pressure switch manifold isolation valves for all four Auxiliary Feed Water Pumps were lock-wired in the open position per CAP 01146005-12.
- 2) A sampling of valve positions was completed to verify the positions of valves with similar functions. Checklists C1.6A.3-1, C1.6A.1-2, and C1.6A.1-1 were completed with no discrepancies noted (CAP 01146005-12).
- 3) For outage 2R25, the checklists required in C1.6A-2 will be completed with both initial and independent verification for all components. (CAP 01146005-27)

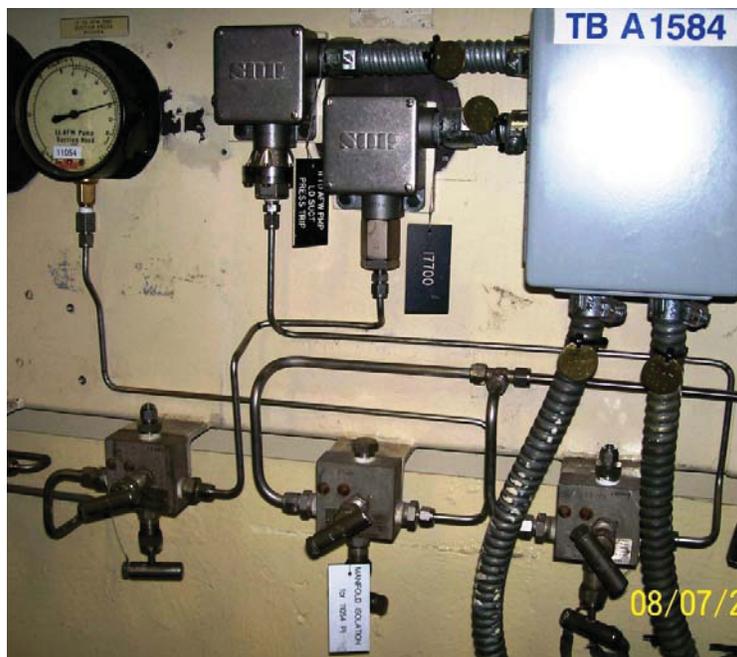
SP 1301 was performed to test all trip and safety related functions of 11 TDAFW Pump and SP 1376 was performed to verify operation of system valves. SP 1103 was performed to verify post-outage AFWP flow. During each of the four subsequent months, SP 1102 was also performed to test manual pump operation. None of these procedures manipulated the PS-17700 isolation valve, but all required the operation of isolation valves in close proximity and of the same type as the isolation valve to the discharge pressure switch (see photograph below).

On July 31, 2008 unit 1 experienced a reactor trip due to a Foxboro unit failure during testing. Subsequent to the trip, 11 TDAFW Pump auto started as designed and tripped 42 seconds later on low discharge pressure. Local and remote indications did not indicate any abnormal operating conditions. A prompt investigation into 11 TDAFW Pump trip revealed the discharge pressure switch was isolated. A time delay in the pump protective circuitry is designed to trip the pump after 35 seconds of a low discharge pressure condition. Monthly SPs (SP 1102) to test the operability of the TDAFW Pump do not test the low discharge pressure trip function of the pump as the selector switch for 11 TDAFW Pump is in manual, bypassing the discharge low pressure trip.

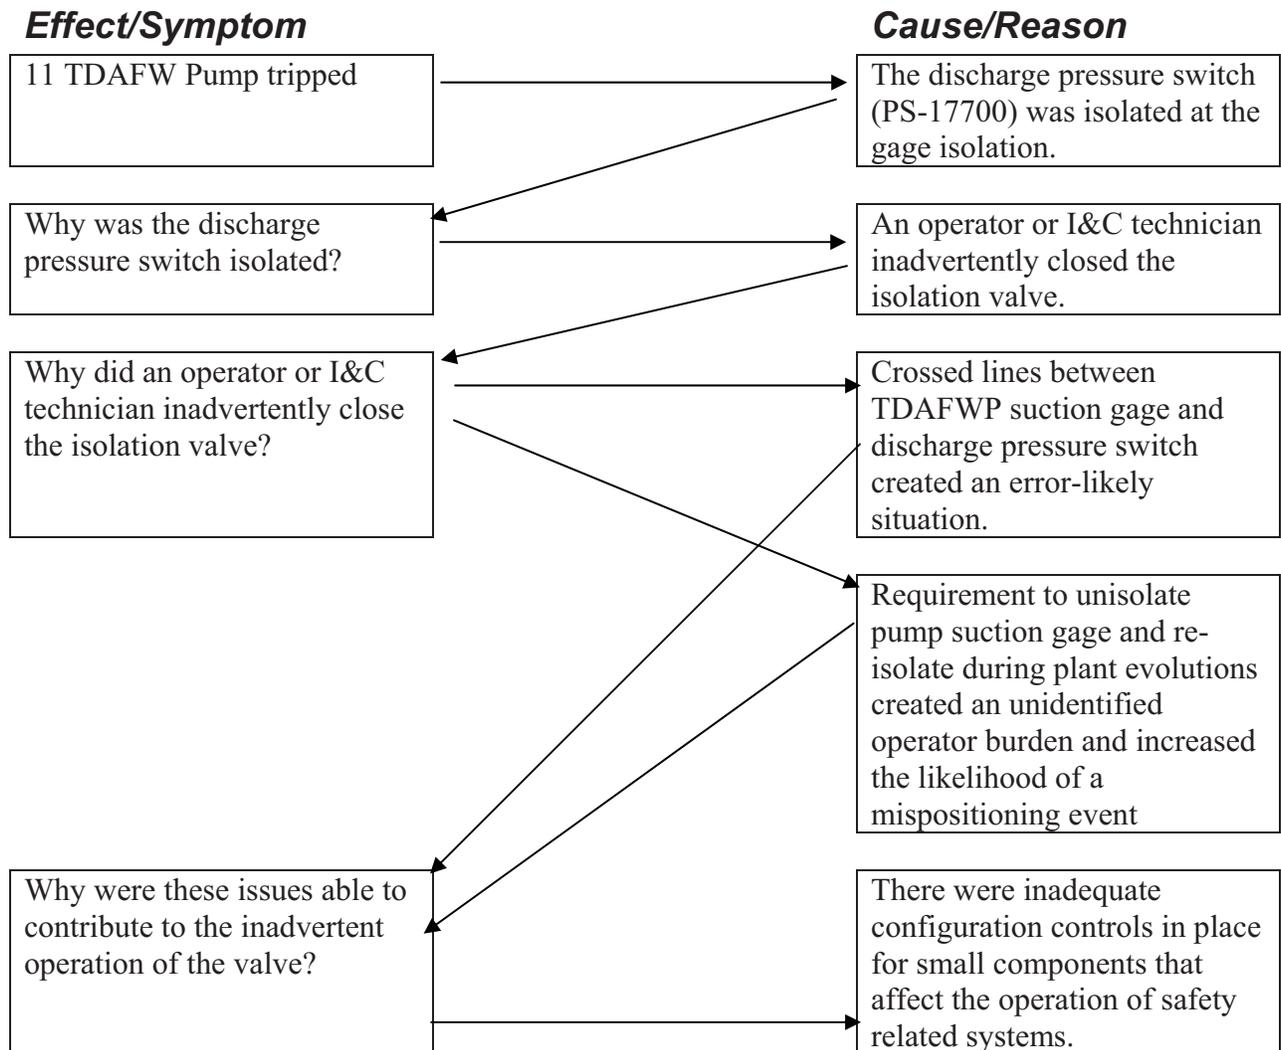
WHY STAIRCASE

The root cause and contributing causes were determined using interviews (Attachment 2), why staircase analysis, barrier failure analysis, failure mode analysis and event and causal factor charting. Why staircase analysis determined that the root cause is inadequate configuration controls for components that adversely impact the design function of safety related SSCs. Failure mode analysis and barrier analysis indicated that a contributing cause was an unresolved operator burden which created an error-likely situation that existed for several years.

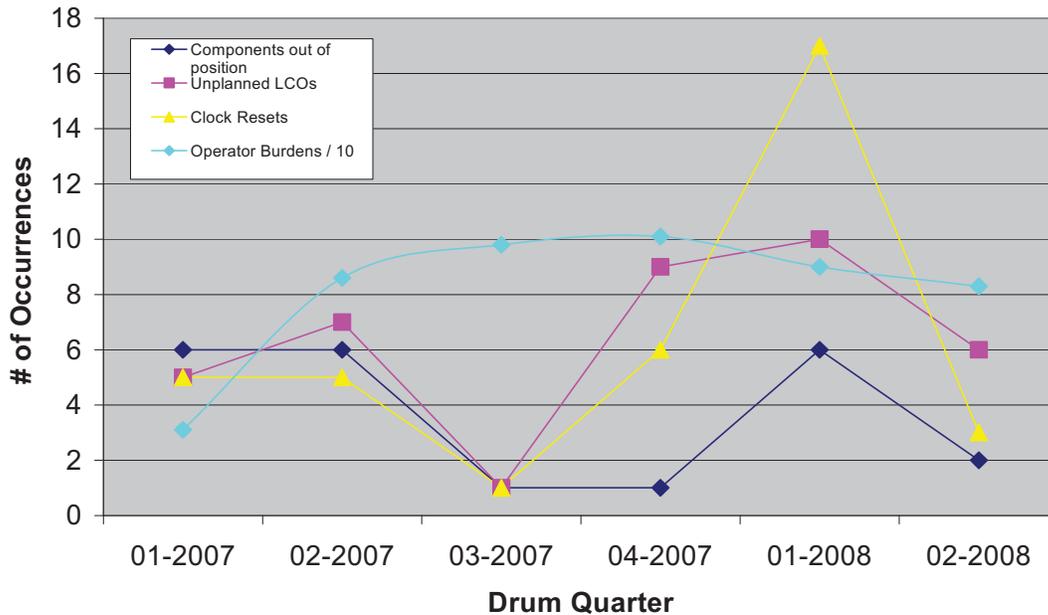
Operations Department KPI Analysis

From the graph of the data, three of the KPIs are leading indicators (components out of position, unplanned LCOs, clock resets). The Operator burdens are a cumulative indicator. There was a dramatic rise in operator burdens, but this was an effort to lower the threshold for defining operator burdens after receiving feedback from the INPO assessment in 2007. This action brought the site in line with the rest of the industry for sensitivity to operator burdens.
