**Indian Point Unit 2
1991 Steam Generator
Inspection, Evaluation and
Repair Activities**

December, 1991

Consolidated Edison Company of New York, Inc.
4 Irving Place
New York, NY 10003

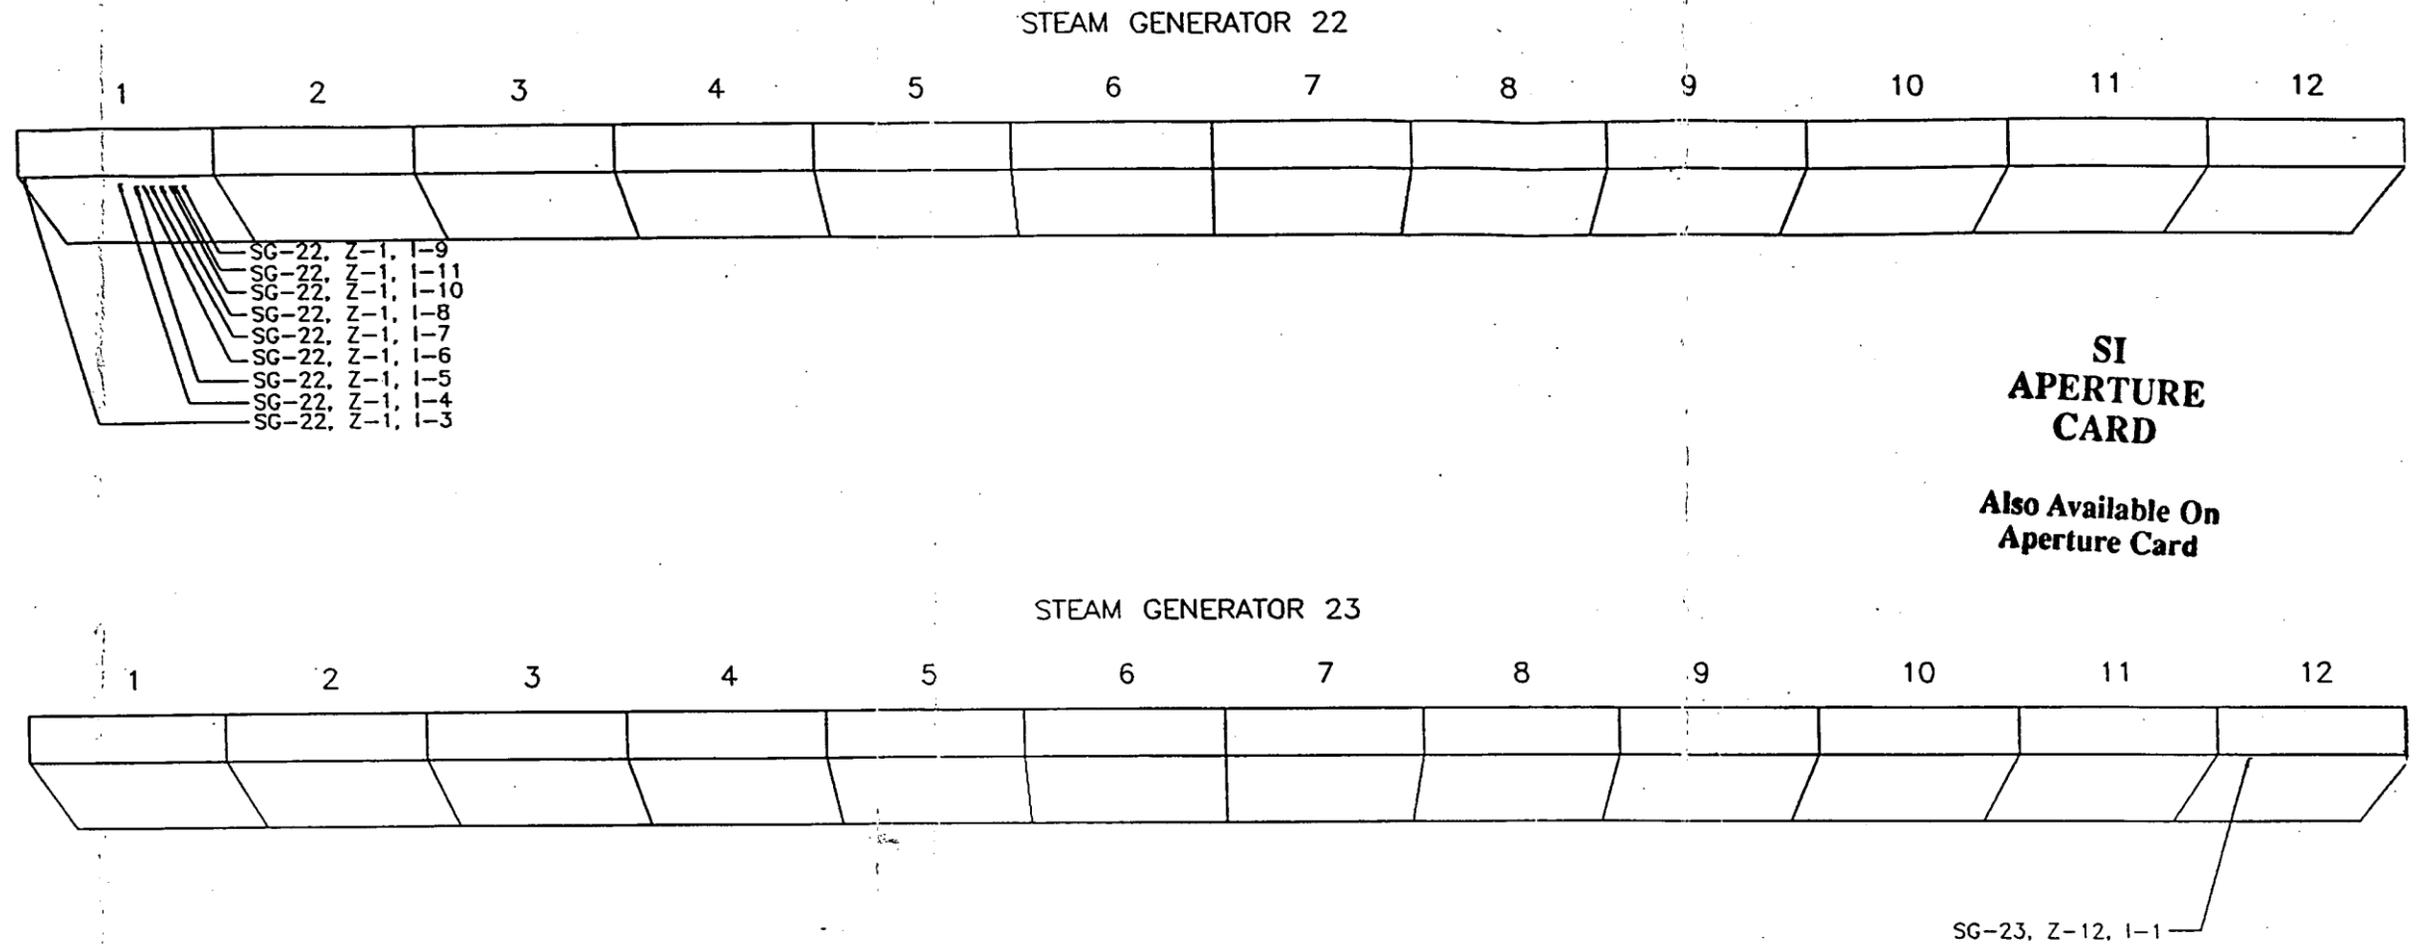
FIGURE 2.2
1991 Girth Weld Cracks
Steam Generator 22 and 23
Locations of Cracks

The magnetic particle examination (MT) of the girth welds in Steam Generators 21 and 24 showed them to be crack free. The initial MT examinations of the girth weld showed a total of 9 cracks in Steam Generator 22 and 1 crack in Steam Generator 23. All the girth weld cracks were localized within two zones in Steam Generators 22 and 23.

Table 2.1 lists the cracks found during the initial inspection in the girth weld (noted by "GW" in the position column). The horizontal location is determined from the start of the zone and is measured clockwise when viewing the feedring from above. The vertical locations are measured relative to the milling machine trackline. The location of these Steam Generator 22 and 23 cracks is presented graphically in Figure 2.2. None of the cracks found in 1991 were located in the weld repair areas of 1989 or 1990.

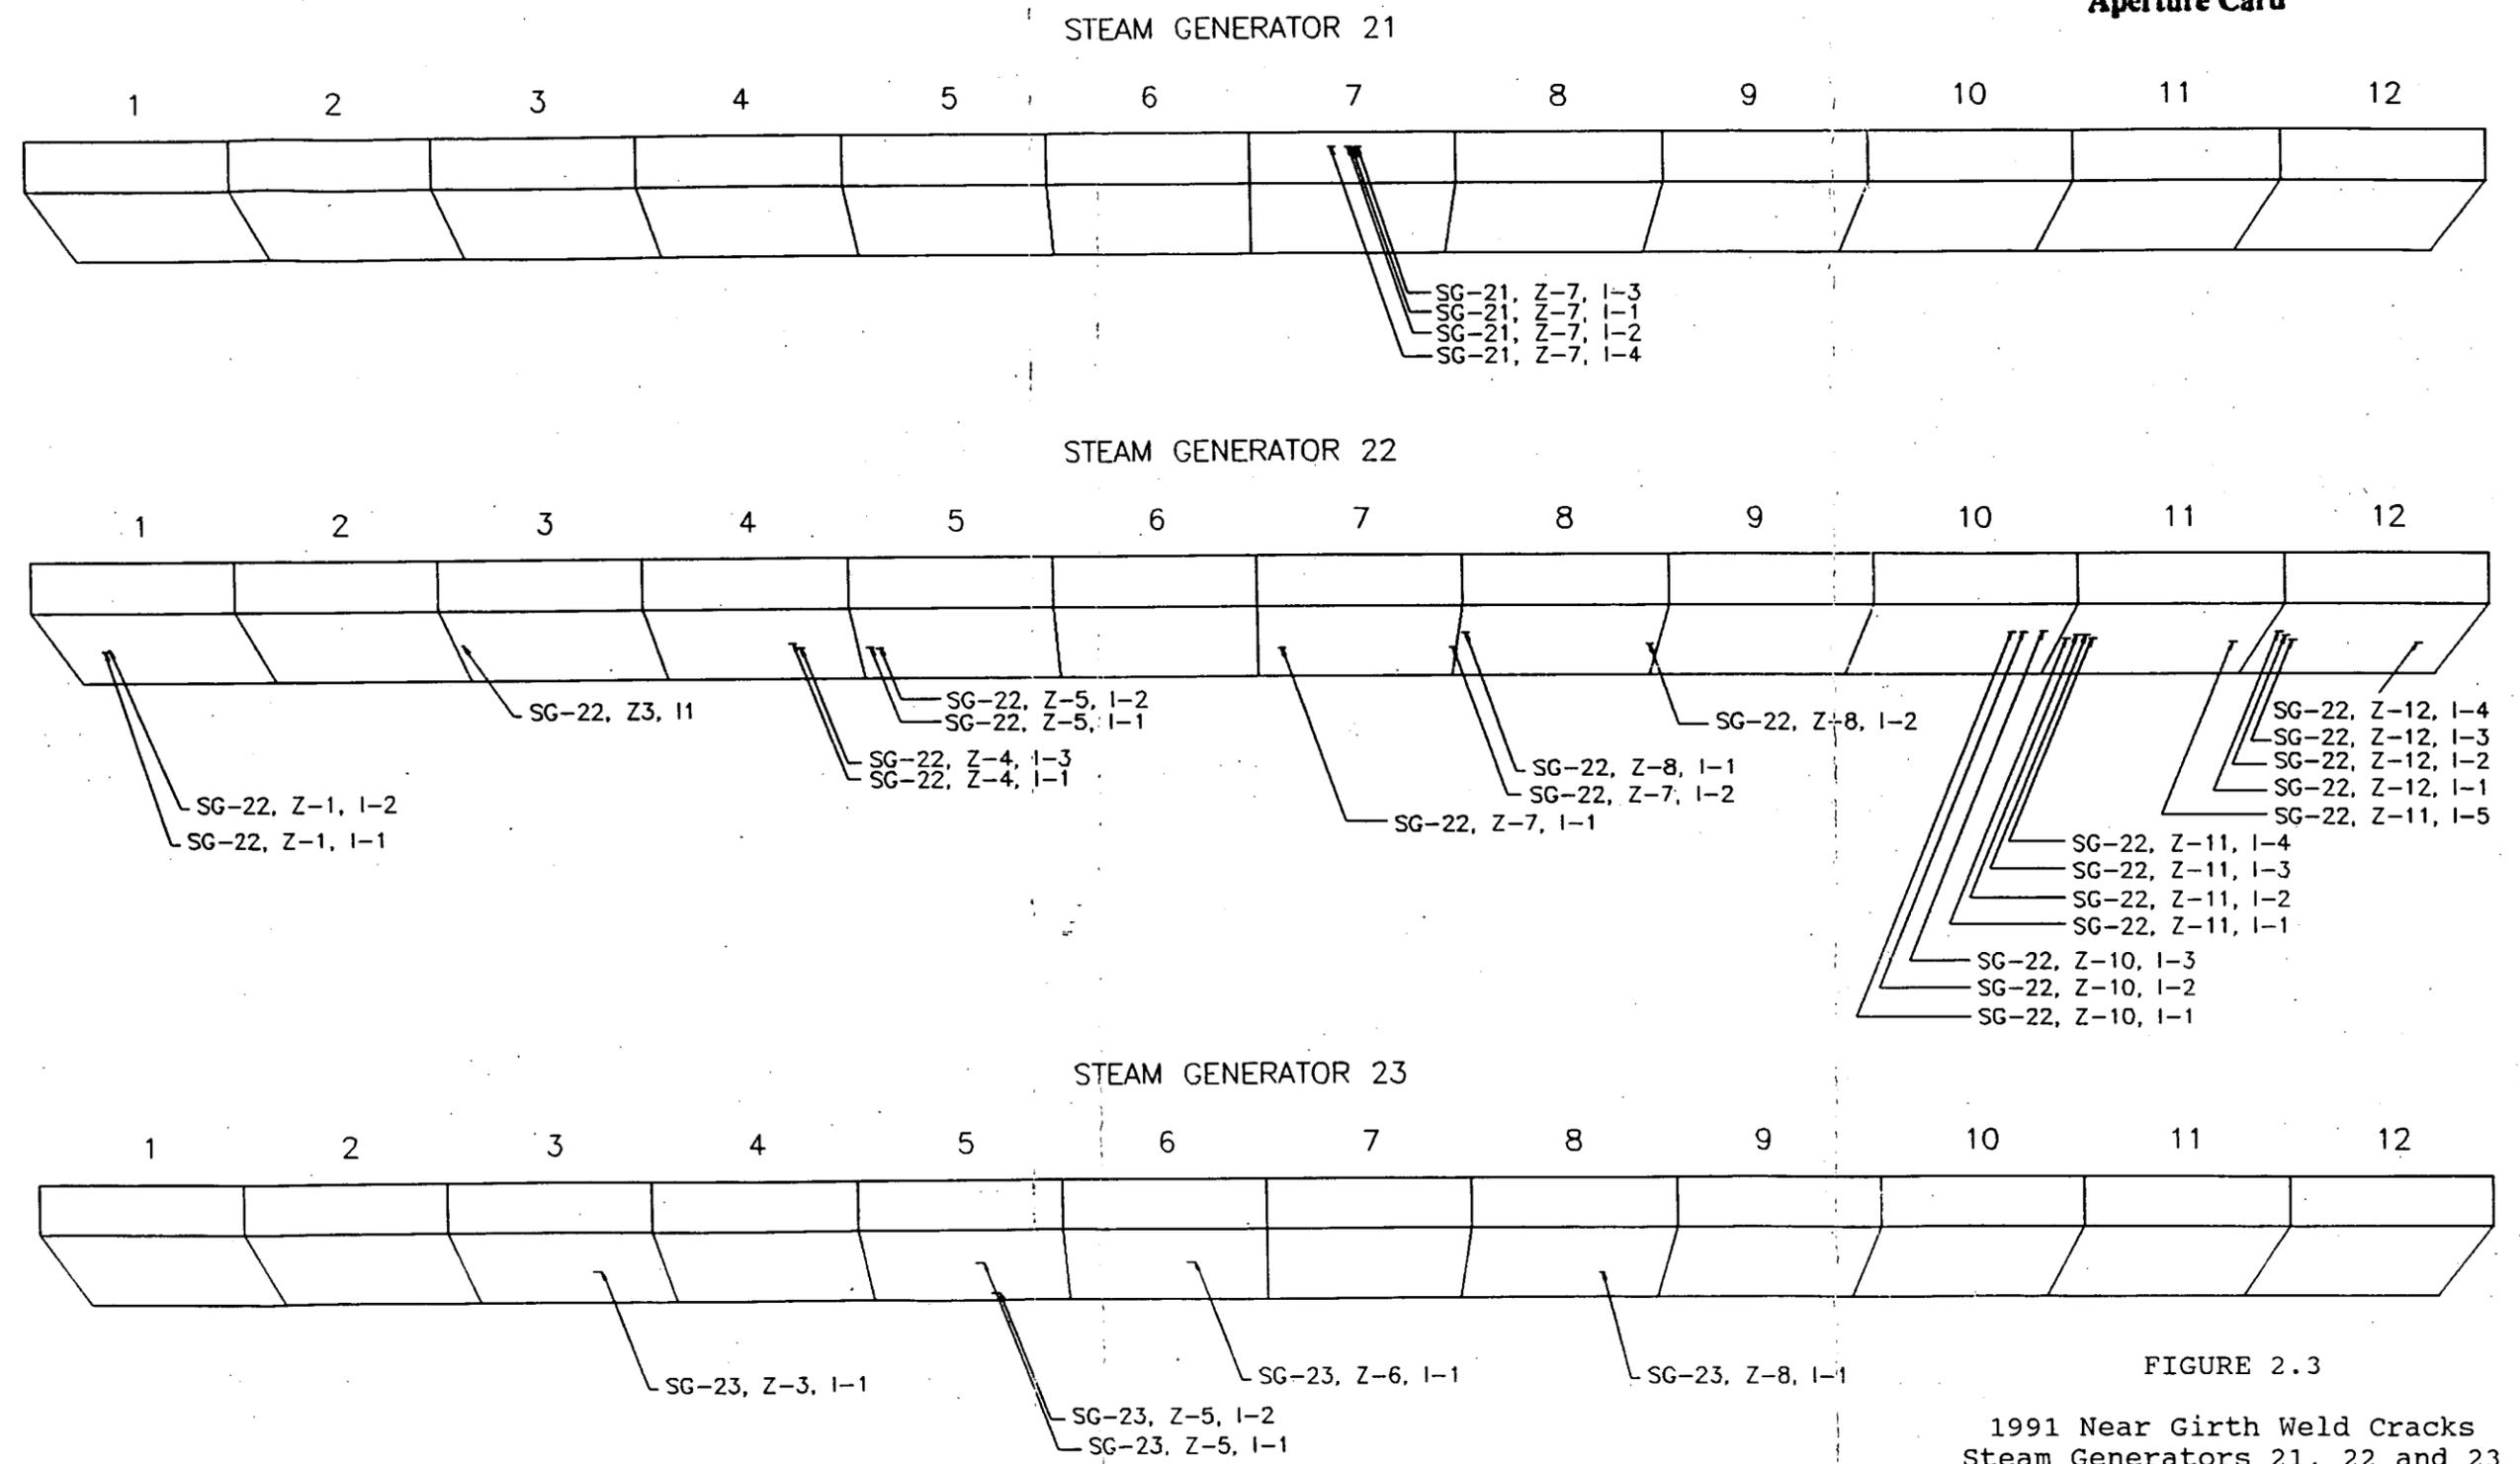
FIGURE 2.3

centerline. Cracks were found above and below the girth weld. These cracks were found at temporary attachment fit-up welds installed during fabrication or field assembly of the vessel. There were four cracks found above the girth weld area in Steam Generator 21. Below the girth weld, twenty three cracks were found in Steam Generator 22 and five cracks were found in Steam Generator 23. No cracks were found in Steam Generator 24.

Table 2.1 lists the cracks found during the initial inspection in the near girth weld area (noted by "A" or "B" in the position column for above or below the girth weld). The locations of these Steam Generator 21, 22, and 23 cracks are presented graphically in Figure 2.3. No cracks were detected in Steam Generator 24.

1991 Near Girth Weld Cracks
Steam Generators 21, 22 and 23

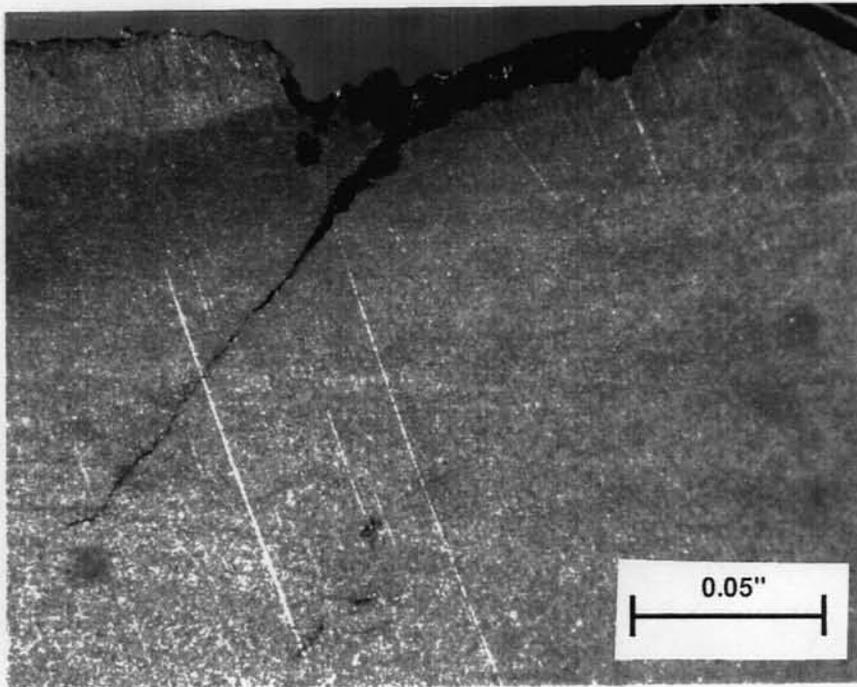
FIGURE 3.5

- 2) Pits provided locations for crack initiation. These boat samples confirm that crack initiation was linked to pitting. The pits provided both amplified stresses and localized chemistry concentration. Reducing the formation of pits will assist in preventing the initiation of cracks.

Section Through Crack Showing Pit Initiation Site
(Boat From Steam Generator 22, Zone 1, Indications 5 & 6)

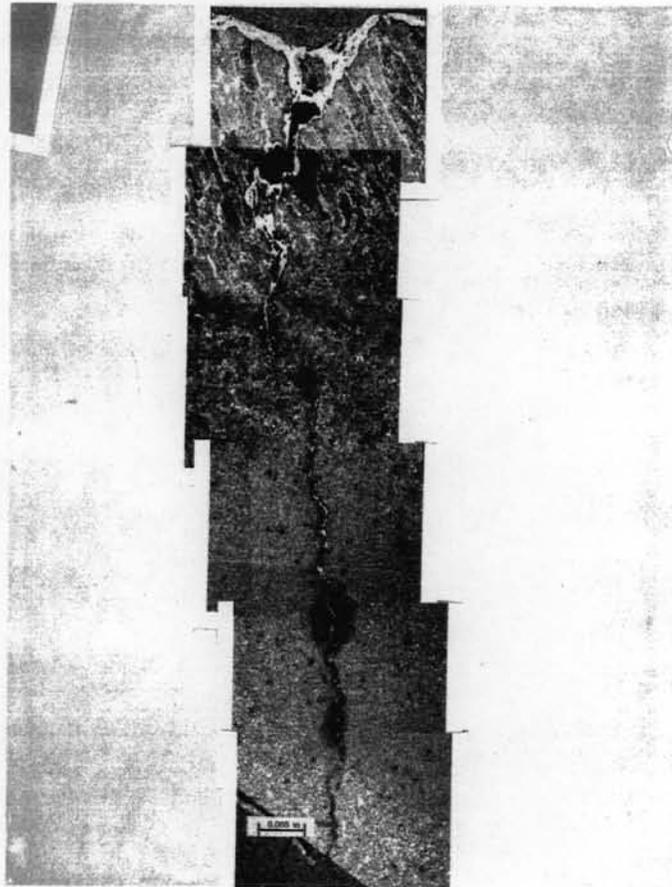
FIGURE 3.6

Section Through Crack Showing Pit Initiation Location
(Boat From Steam Generator 22, Zone 1, Indication 9)

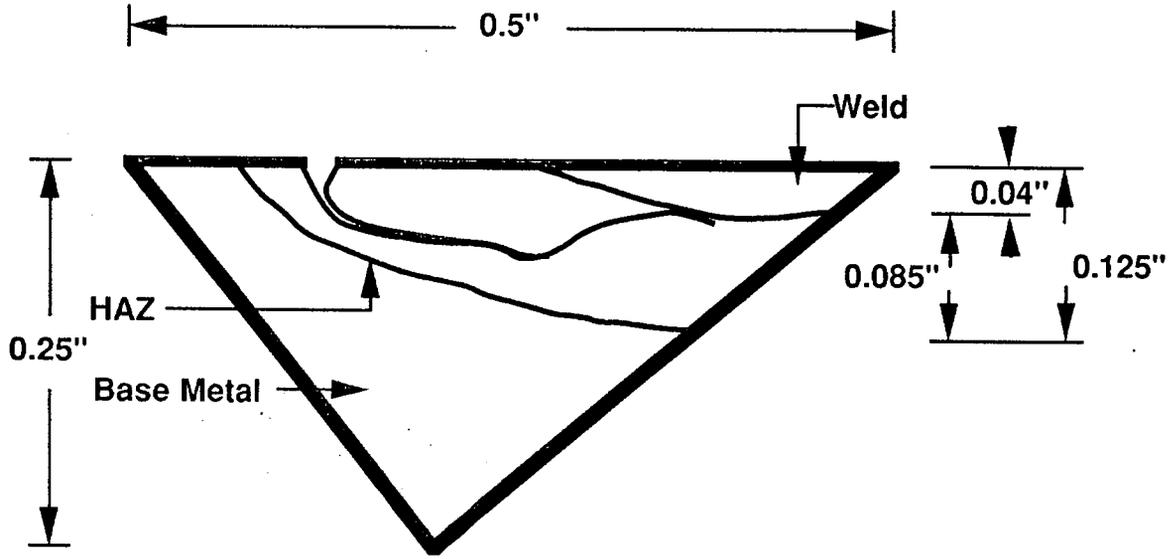
FIGURE 3.9

Section Perpendicular to Crack Plane
 Showing Initiation, Turning of Crack to Follow HAZ,
 and Intersection With Weld Region
 (Boat From Steam Generator 23, Zone 6, Indication 1)

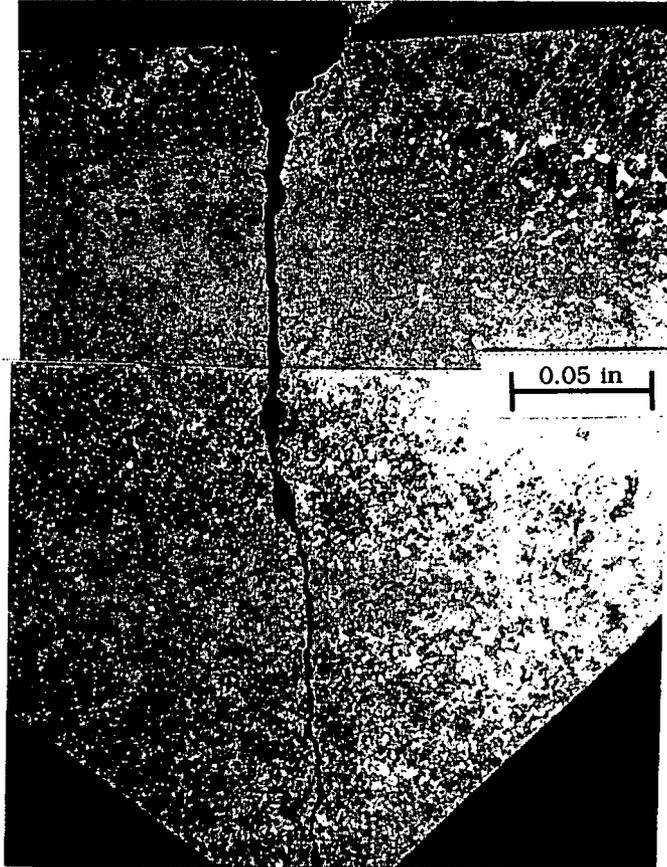
FIGURE 3.10

Etched Section Through Crack to Show Crack Morphology and Weld/Heat Affected Zone. This Crack Formed Near Two Weld Passes and Grew Straight Into the Shell (Boat From Steam Generator 22, Zone 4, Indication 1)

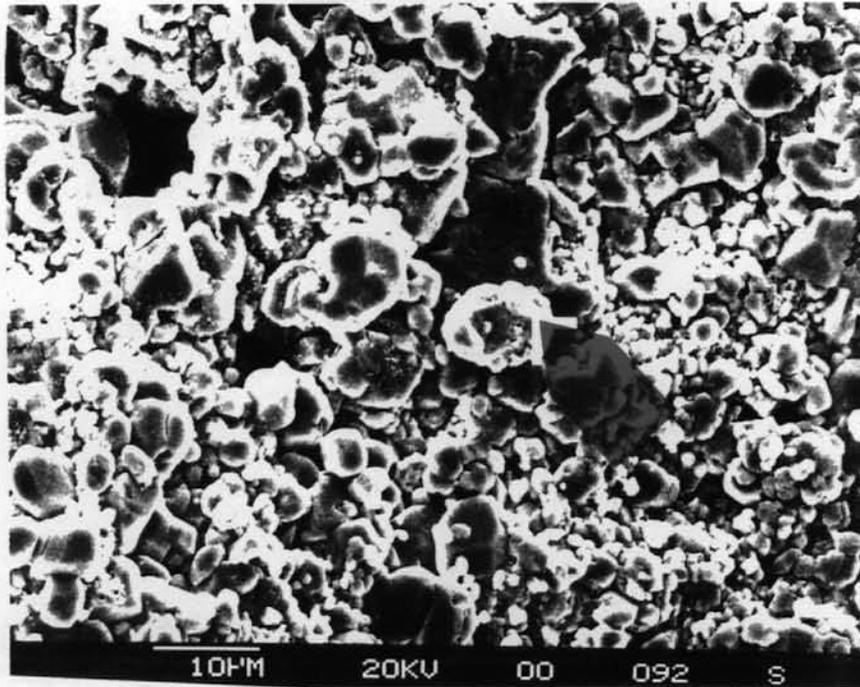
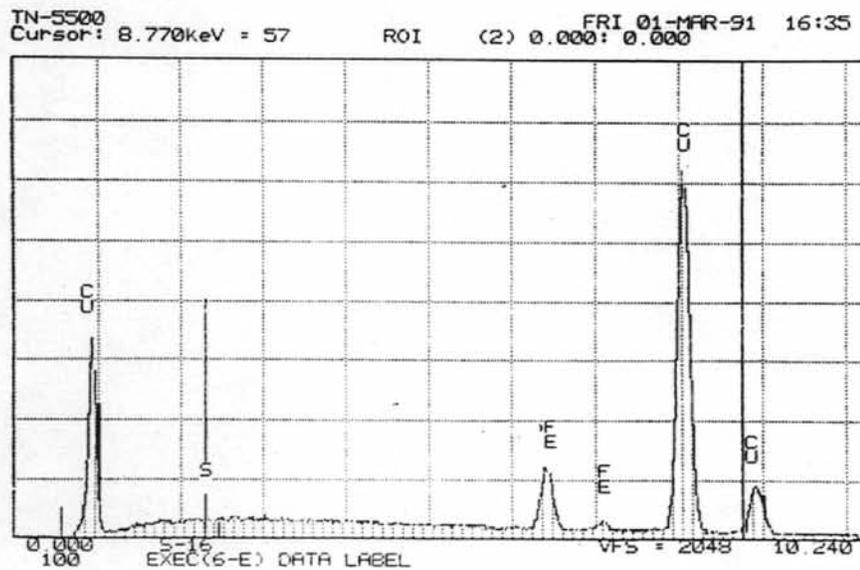
FIGURE 3.12

Fracture Surface Showing Morphology of Copper Particle,
 and X-Ray Spectra for the Copper Particle
 (Boat From Steam Generator 22, Zone 1, Indication 9)

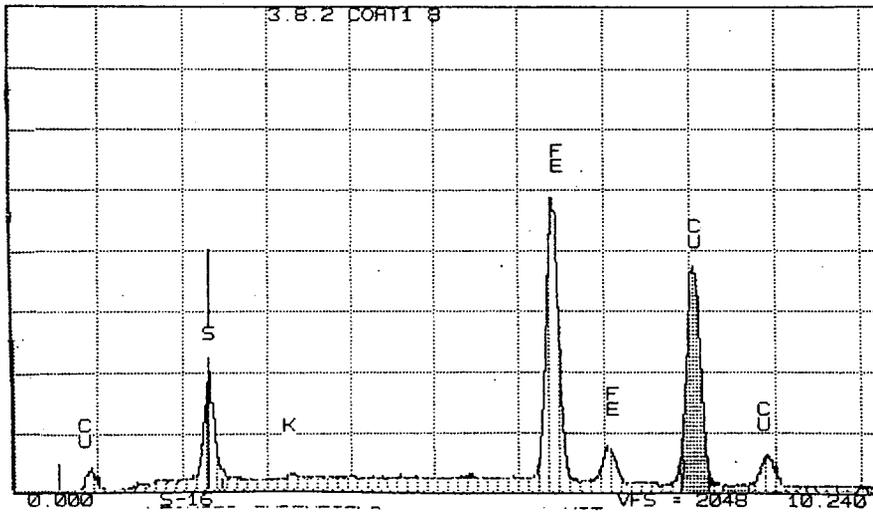
FIGURE 3.13

Fracture Showing Morphology of Copper Sulfide Particle,
 and X-Ray Spectra for the Copper Sulfide Particle
 (Boat From Steam Generator 22, Zone 1, Indications 5 & 6)

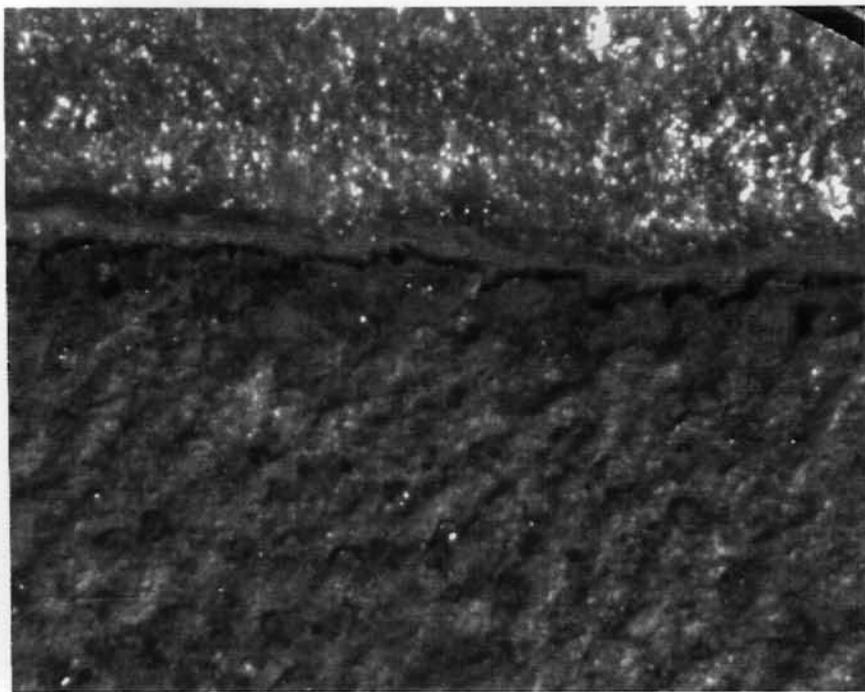
FIGURE 4.21

Coated Sample Coating/Base Metal Interface
Showing Accelerated Localized Corrosion, HT-1, 20X.

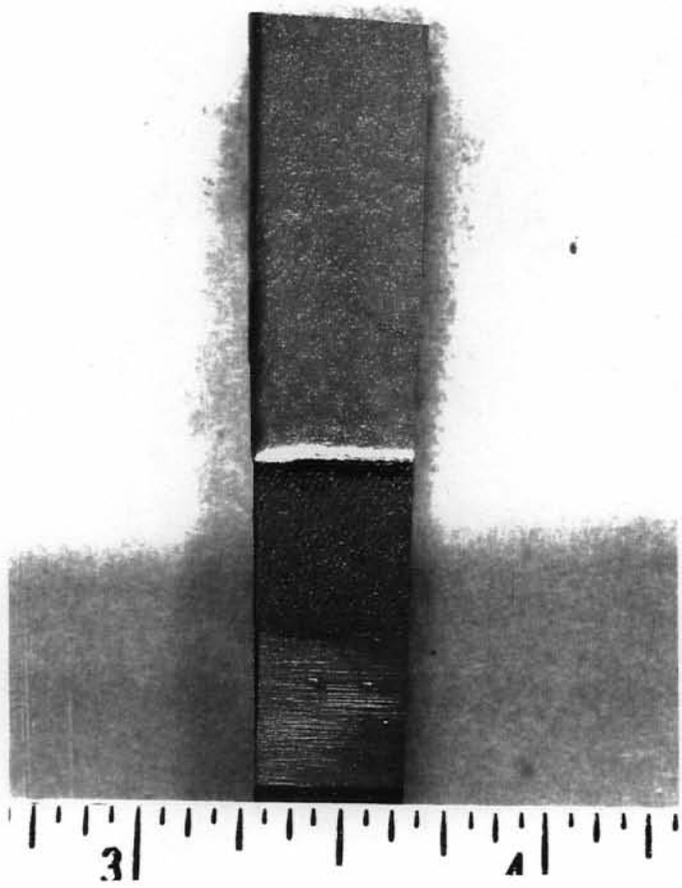
FIGURE 4.26

Photograph of Coated Sample As-Tested, HT-3.
Note Localized Corrosion at Coating/Base Metal Interface.

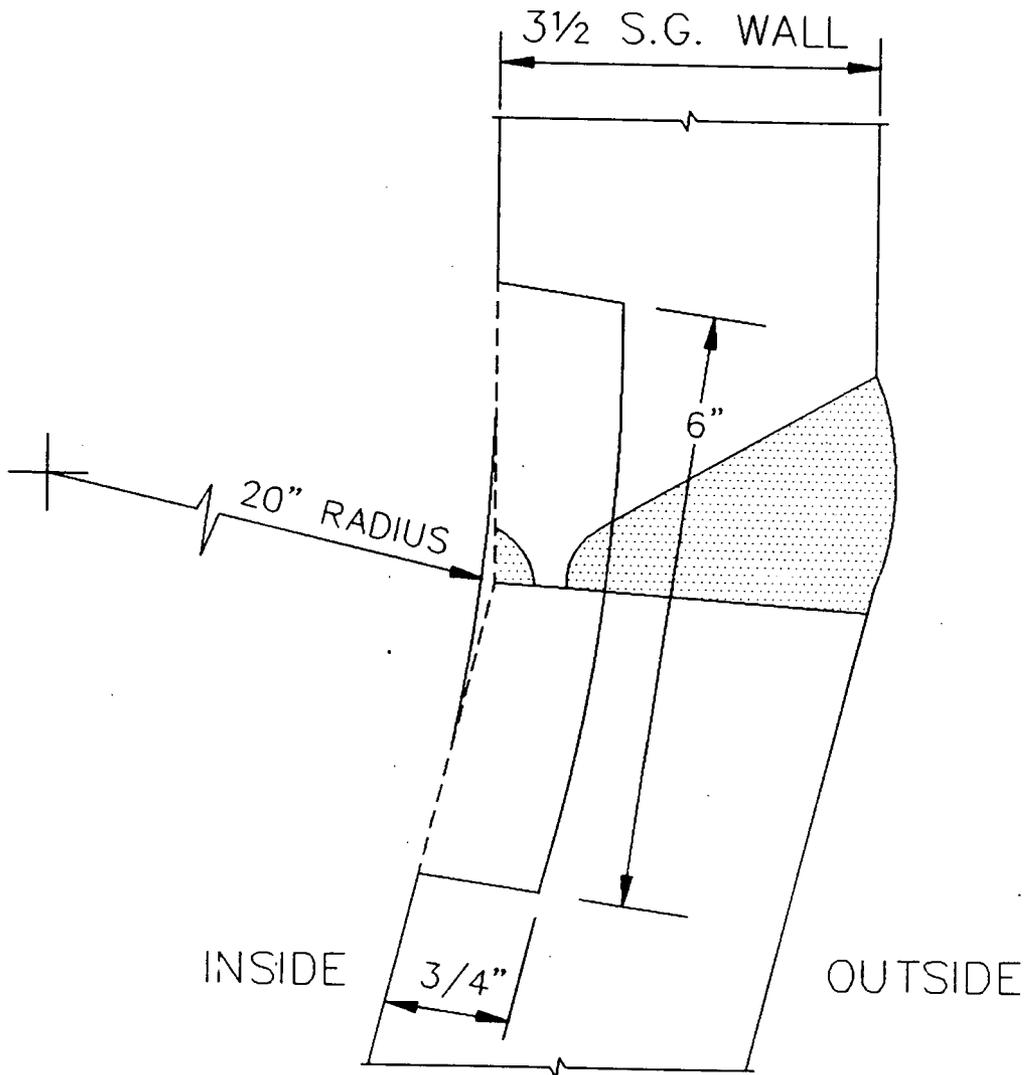
FIGURE 6.1
Girth Weld Showing 20 Inch
Contour Radius

during the Spring 1991 Refueling Outage. The girth weld repair consisted of removal of a section of the girth weld to a nominal depth of 3/4 inch. A band of approximately six inches of the weld was removed in the axial direction around the entire circumference of the shell. The band was centered about the existing weld. The area was rewelded with a carefully selected weld material and weld contour with smooth finish. Weld repairs were also made at locations of cracks in regions above and below the girth weld. A feedwater nozzle sealing sleeve was installed to eliminate the leakage of cold water into the region beneath the thermal sleeve.

- High Stresses - A specifically selected contour in the replacement weld reduced the stress concentration previously caused by the "knee" at the girth weld region. An effective post weld heat treatment reduced the residual stresses in the girth weld. Modifications made earlier to the feedwater system reduced the severity of the transient at the girth weld following a reactor trip.
- Environment - Oxygen control measures during auxiliary feedwater injection have been added to reduce the likelihood of pitting and cracking.
- Material - Low sulphur material was utilized in the replacement weld. This material will have a higher resistance to pit formation.

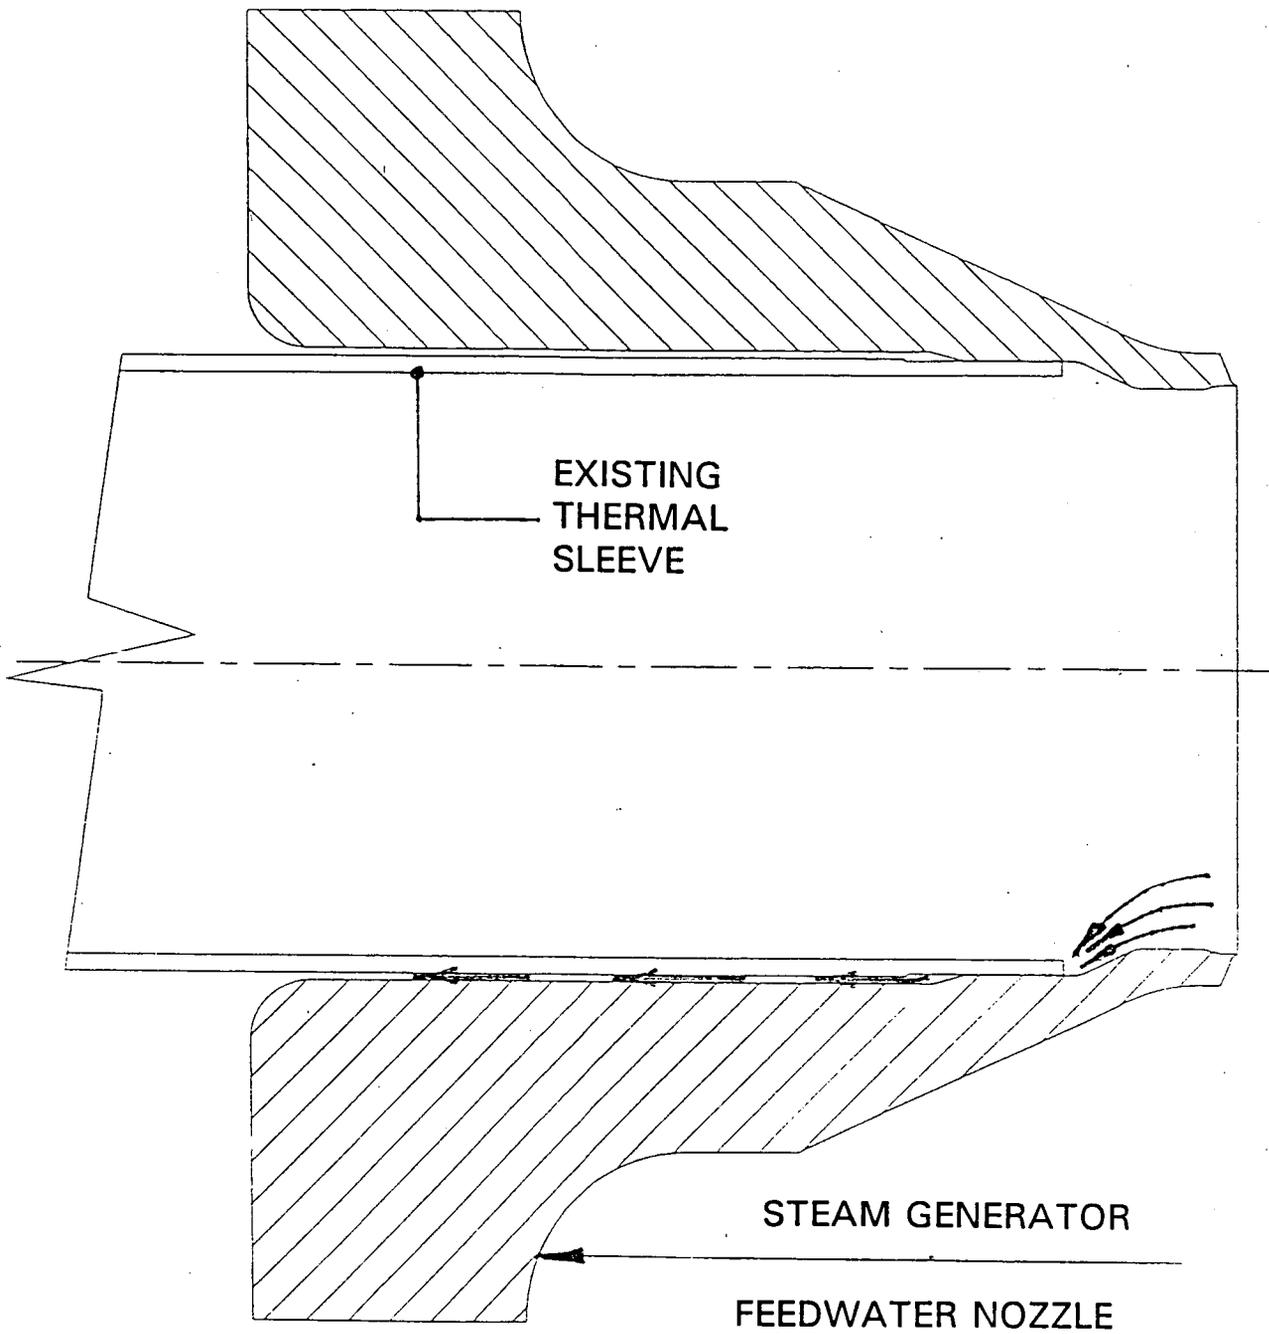
FIGURE 8.2

Cracking had been noted in the bore and knuckle of the feedwater nozzles. This cracking was caused by the leakage of cold auxiliary feedwater under the existing thermal sleeve during low flow cold water injection. A sealing sleeve was installed in the feedwater nozzle which will mitigate the mechanism responsible for cracks in the nozzle region.

Existing Feedwater Nozzle and Sleeve
Leakage Flow Path Shown
