**Indian Point Unit 2
1991 Steam Generator
Inspection, Evaluation and
Repair Activities**

December, 1991

Consolidated Edison Company of New York, Inc.
4 Irving Place
New York, NY 10003

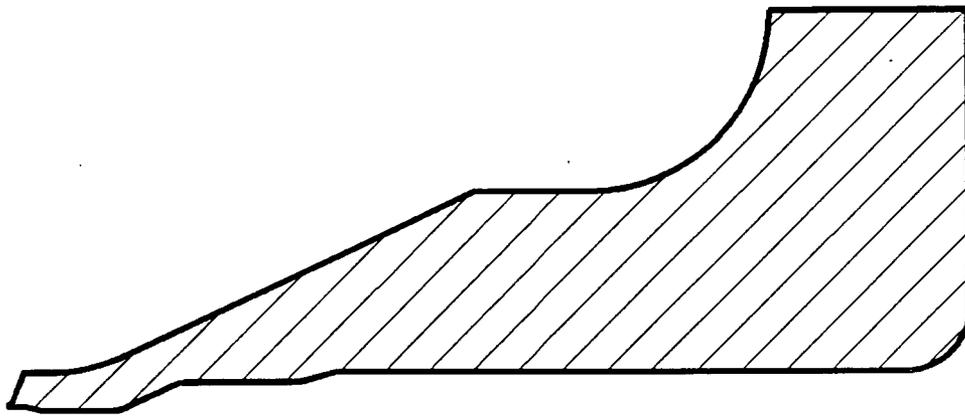
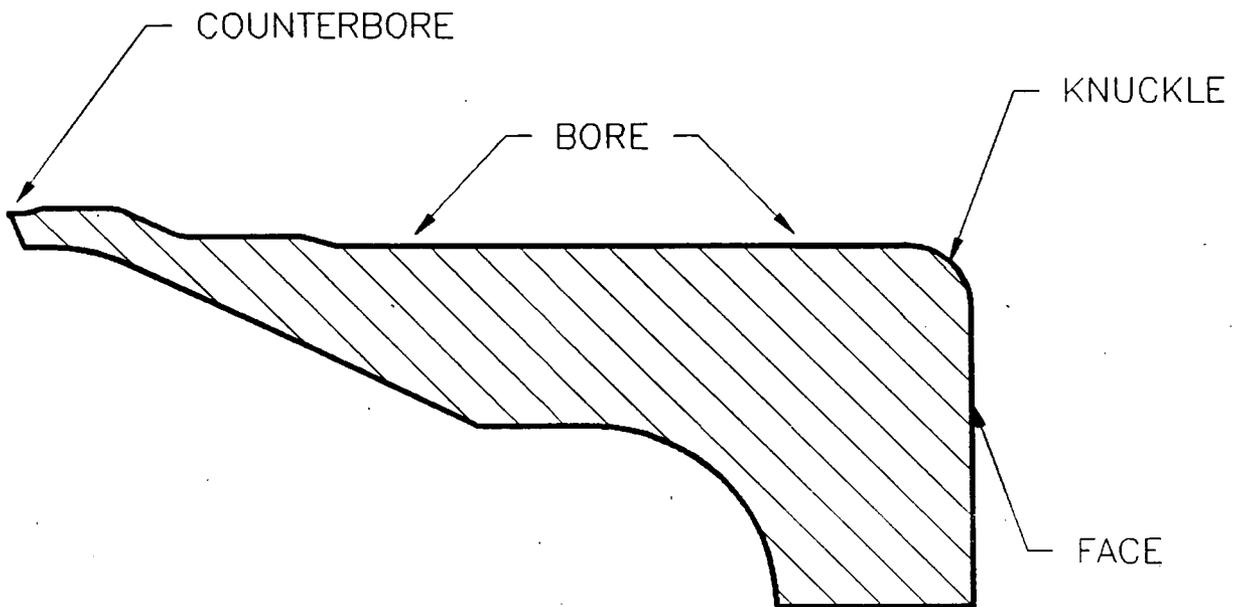
FIGURE 2.4
Feedwater Nozzle

A UT examination was conducted on the feedwater nozzle of Steam Generator 24. Portions of the bore and part of the knuckle area were inspected by UT from the external surface. Figure 2.4 shows the feedwater nozzle. In this UT inspection on the knuckle in Steam Generator 24, no cracking was detected.

On all four steam generators, the knuckle of the feedwater nozzle forging was also inspected by liquid penetrant (PT). One crack was found on the face near the knuckle in Steam Generator 22. The crack was located near the 7 o'clock position and measured 1/2 inch long. The crack was removed by grinding to a depth of 0.050 inch. The location of this crack was dimensionally consistent with the location of one of the original welded feedwater tee support brackets.
