# An Investigation of the Contributors to Wrong Unit or Wrong Train Events

**U.S. Nuclear Regulatory  
Commission**

Manuscript Completed: April 1986  
Date Published: April 1986

**Division of Human Factors Technology  
Office of Nuclear Reactor Regulation  
U.S. Nuclear Regulatory Commission  
Washington, D.C. 20555**

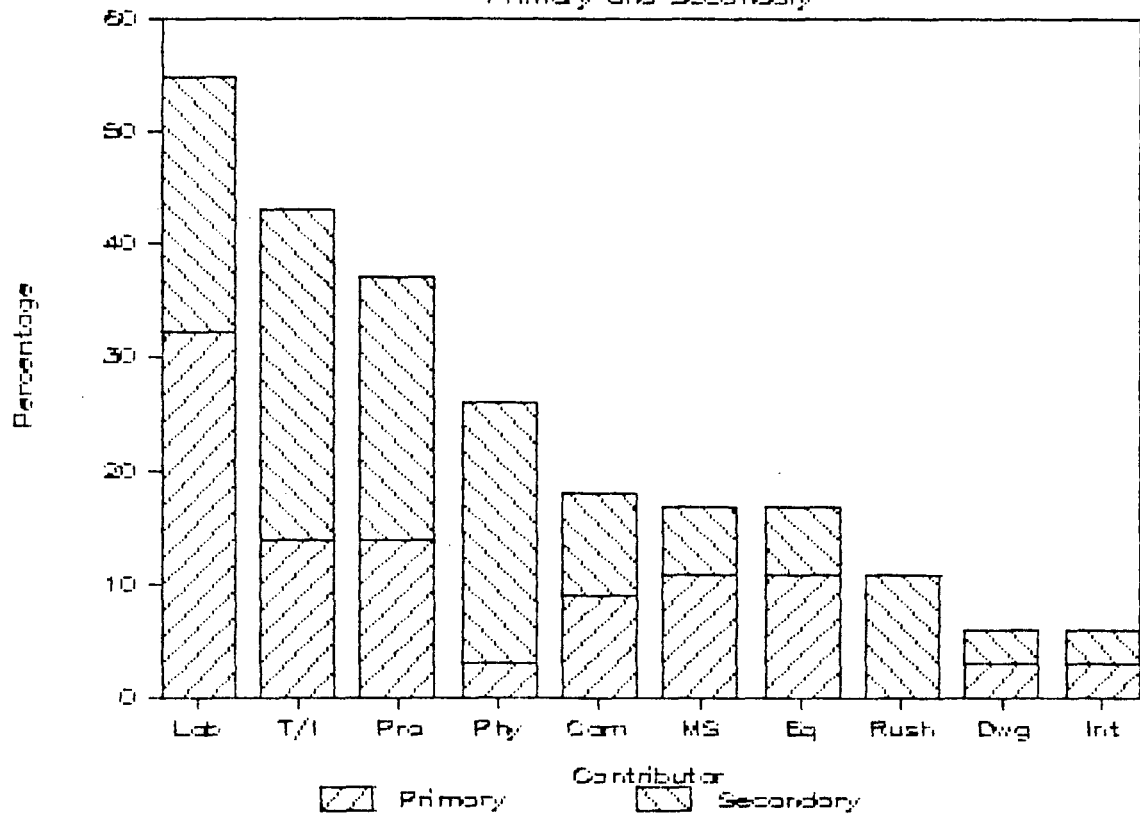
Figure 1.  
Contributors to WU/WT Events  
Primary and Secondary

- Inadequate labeling contributed to 54 percent of the 35 events evaluated. Labeling was the primary contributor in 32 percent of the events and a secondary contributor in 23 percent of the events.

- Inadequate training and staff inexperience contributed to 43 percent of the 35 events, being the primary contributor to the wrong unit/wrong train error in 14 percent of the events and a secondary contributor in 29 percent of the events.

- Poorly human factored or incorrect procedures contributed to 37 percent of 35 events. Procedures were the primary contributor in 14 percent of the events and the secondary contributor in 23 percent.

- When taken together, labeling, training, and procedures were the primary contributors to human error in 60 percent of the wrong unit/wrong train events investigated.
