### Root Cause Investigation Report

**Title:** The station's failure to recognize and respond to unacceptable conditions with respect to temporary tritium storage in a timely fashion resulting in release of tritiated water outside the intended control area.

**Event Date:** March 13, 2006

**Report Date:** March 22, 2006

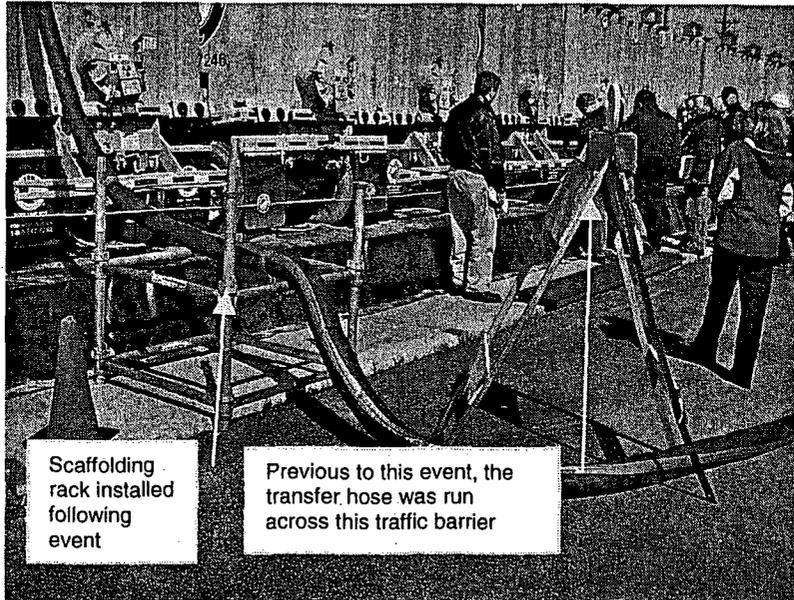
On 03/13/2006, at approximately 1015, the Radwaste Coordinator performed a visual inspection on FRAC tank Farm #1. He noticed the traffic barrier suspending the transfer hose above the berm was knocked down and the transfer hose was lying across the berm wall with no leakage occurring. This was potentially caused by high winds experienced during inclement weather (47 mph wind gusts per the metrological tower on the day of the event) (**Causal Factor #1 – Root Cause #1**). He notified the Duty RP

Photo 1 - Transfer Hose to FRAC Farm #1

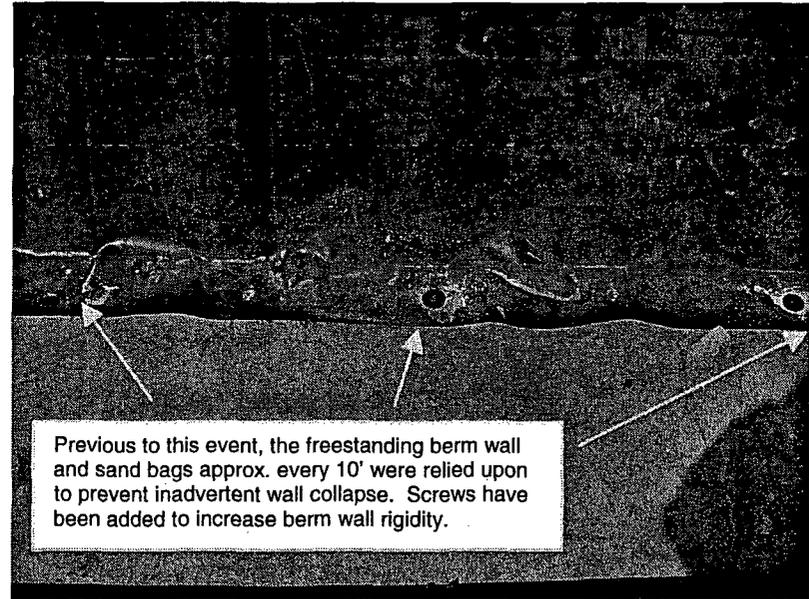
Further discussions with the vendor during this investigation concluded that the use of sandbags is intended for temporary means to accommodate truck traffic. The vendor does not recommend long-term use of sandbags for securing the berm walls, since the sandbags do not adequately prevent tangential movement of the berm wall towards the interior of the berm structure. However, the instructions provided with the berm did not provide this additional guidance. The berm installed at FRAC Tank Farm #1, was installed with sand bags placed approximately every 10 feet on the exterior, and no anchorage to the concrete pad provided **(Causal Factor #1 – Root Cause #1, repeated)**.

Photo 2 - Screws installed to Prevent Berm Wall Movement

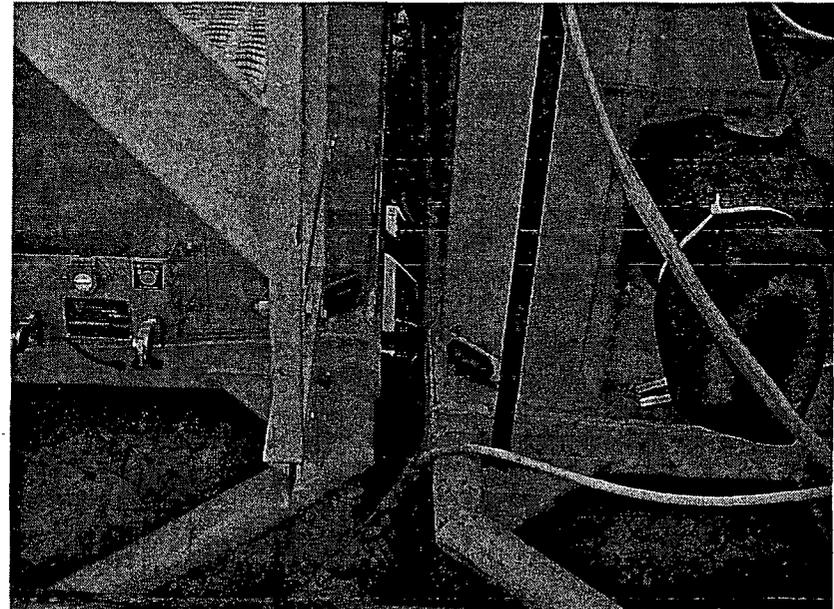
The interviews determined that standing snow or water was present in the berm area of FRAC Tank Farm #1 during times when maintenance went to the tank farm. Those interviewed also thought that since the water was allowed to stand in the berm area the presence of the water was acceptable. The interviewees indicated that RP had on occasion, directed the use of grating or other devices, when work was required in the berm area with water present to prevent exposure to potentially tritiated water (**Causal Factor #2 – Root Cause #2**).

Photo 4 - Residual water on berm floor

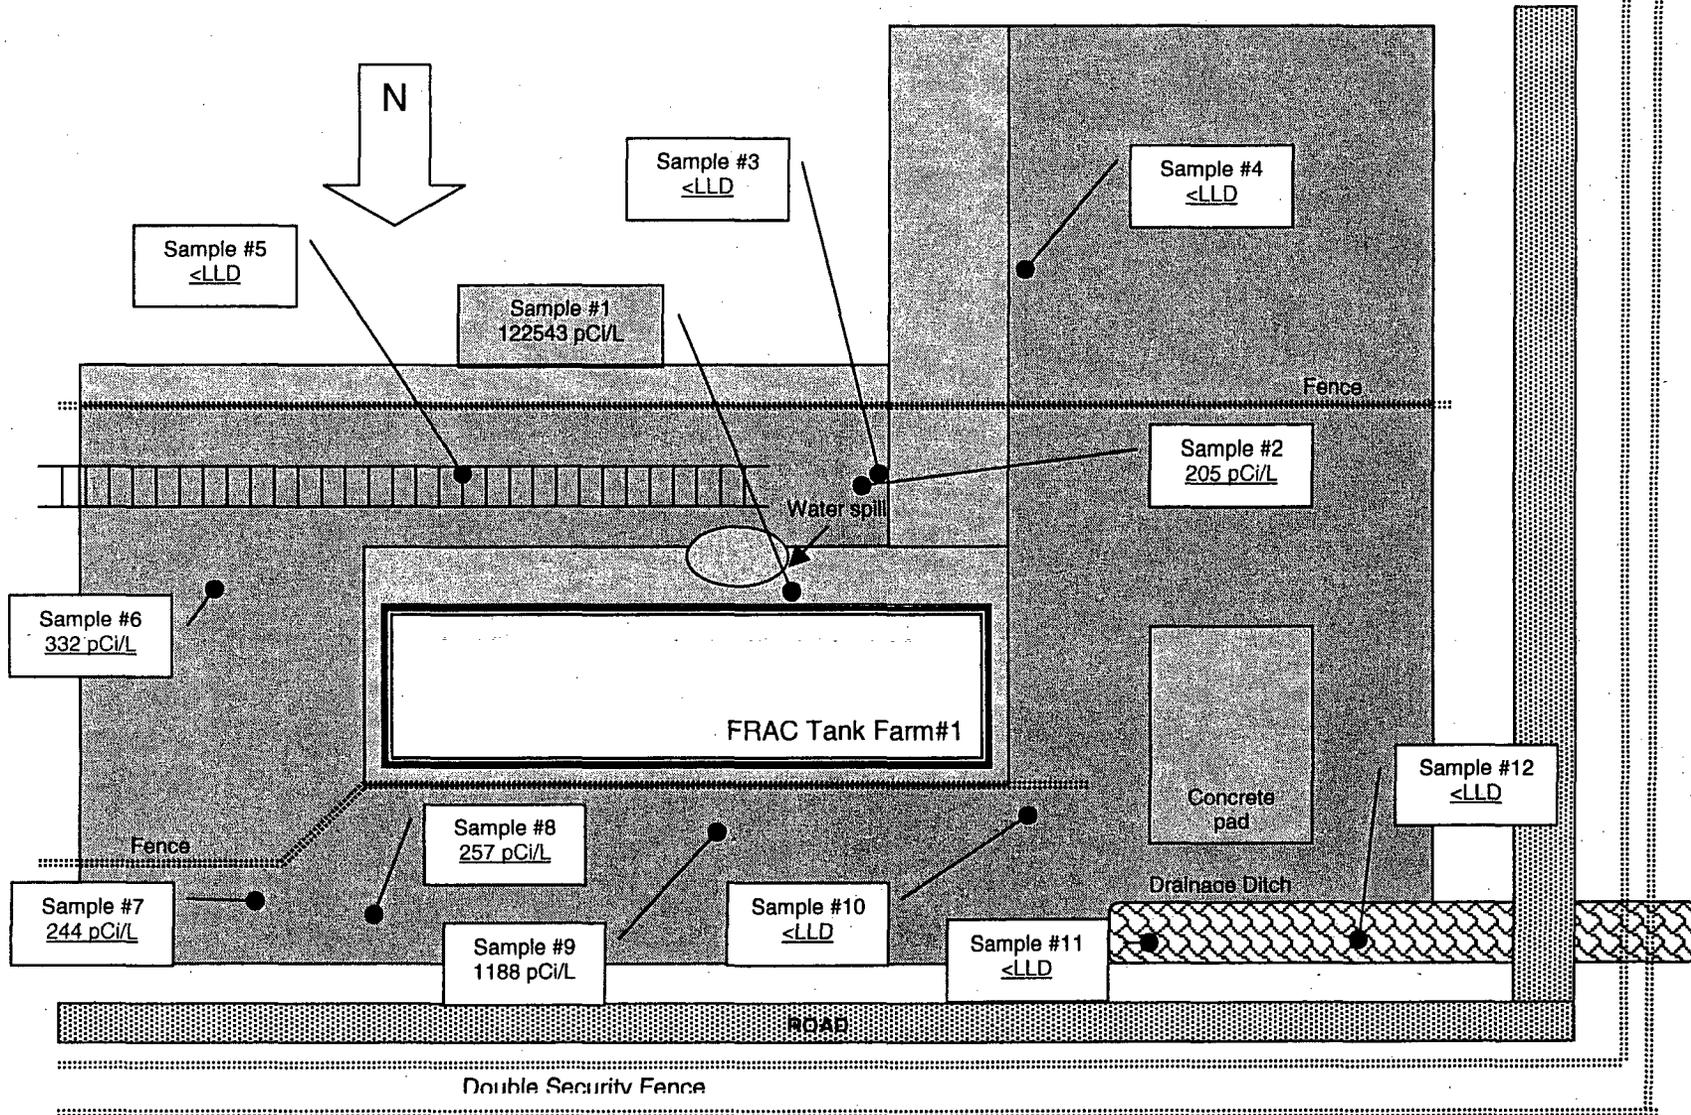
### FRAC Tank Farm #1 Sample Results from March 13, 2006 Soil/Water Samples Attachment 6

is estimated that 240 gallons of water was pumped back into the berm. The initial water sample results were 183,000 pCi/L. Sample results from the off-site laboratory determined that the highest level of tritium in the soil samples was 122,543 pCi/L (See Attachment 6 for FRAC Tank Farm #1 soil and water sample results).
